A NEW EARTH FISSURE
NEAR WINTERSBURG,
MARICOPA COUNTY, ARIZONA

Arizona Geological Survey
Open-File Report 01-10

Raymond C. Harris
Arizona Geological Survey

November 2001

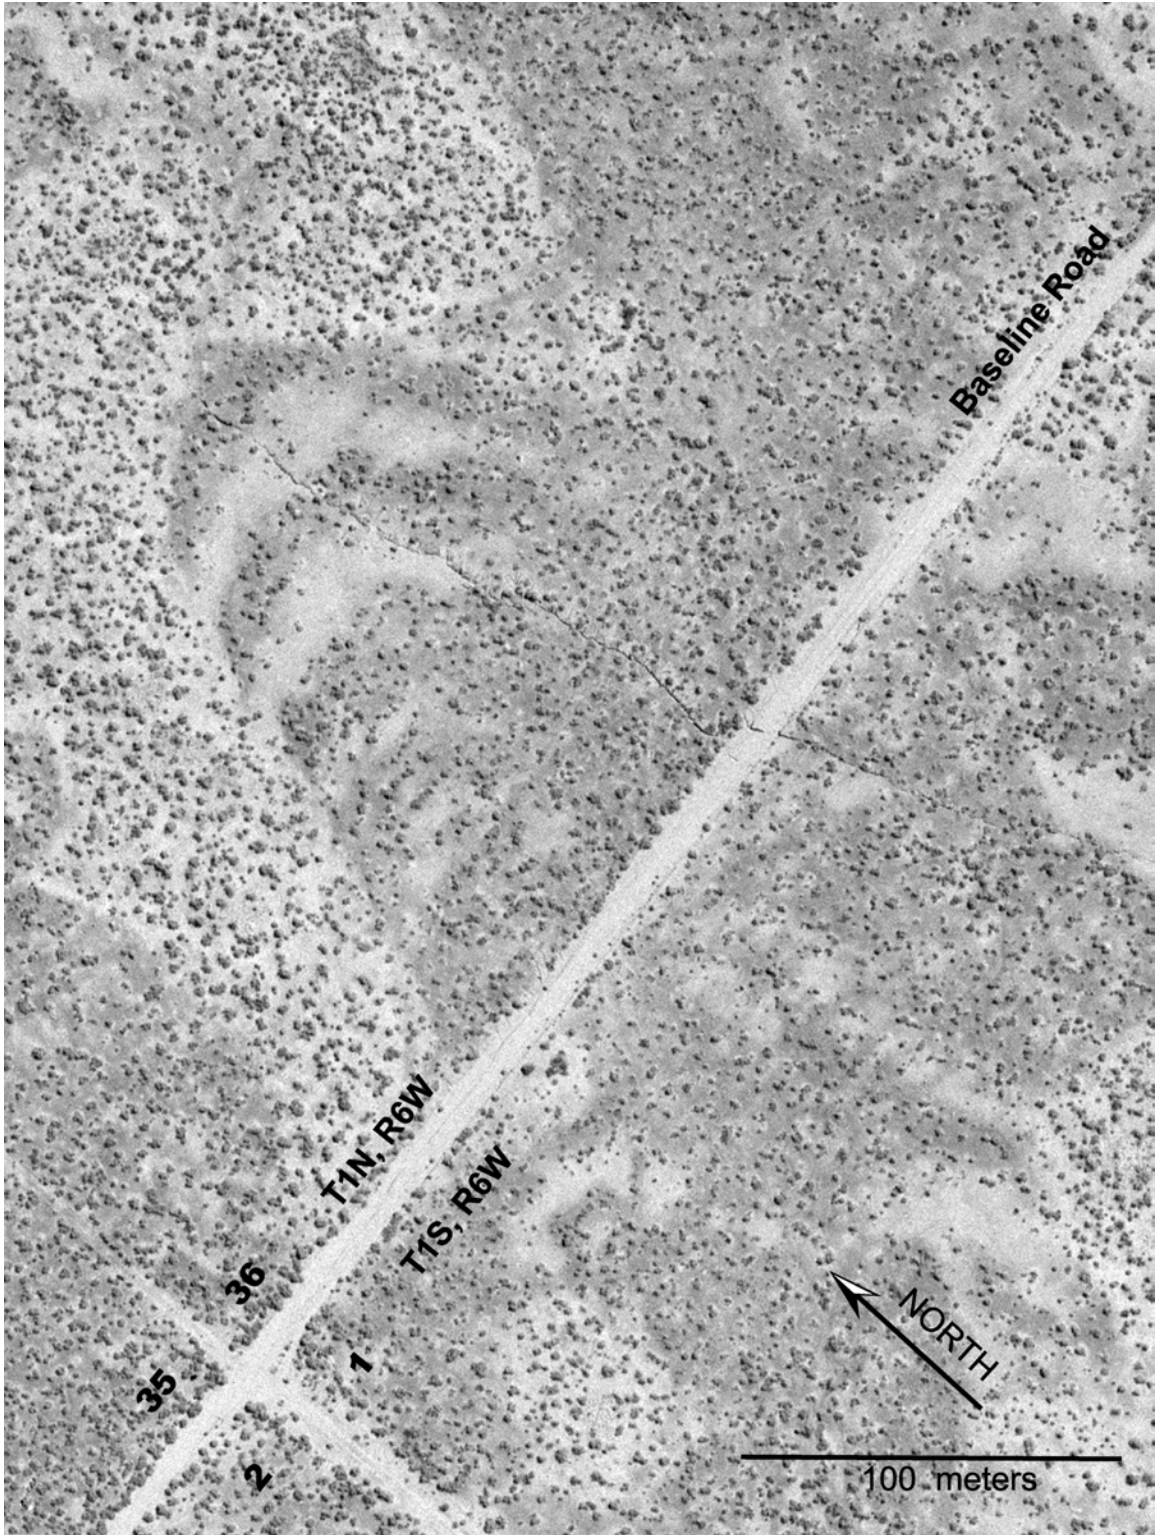
The fissure is nearly north-south and is 307 m (1007 ft) long (Figure 4). The fissure is very young, with narrow, steep sides and a highly irregular apparent depth ranging from <1 foot to >8 feet over short distances. In two locations the fissure is en echelon (Figure 5), with NW-SE steps. There is no discernable vertical offset across the fissure.

Figure 4. Detailed aerial view of new earth fissure.

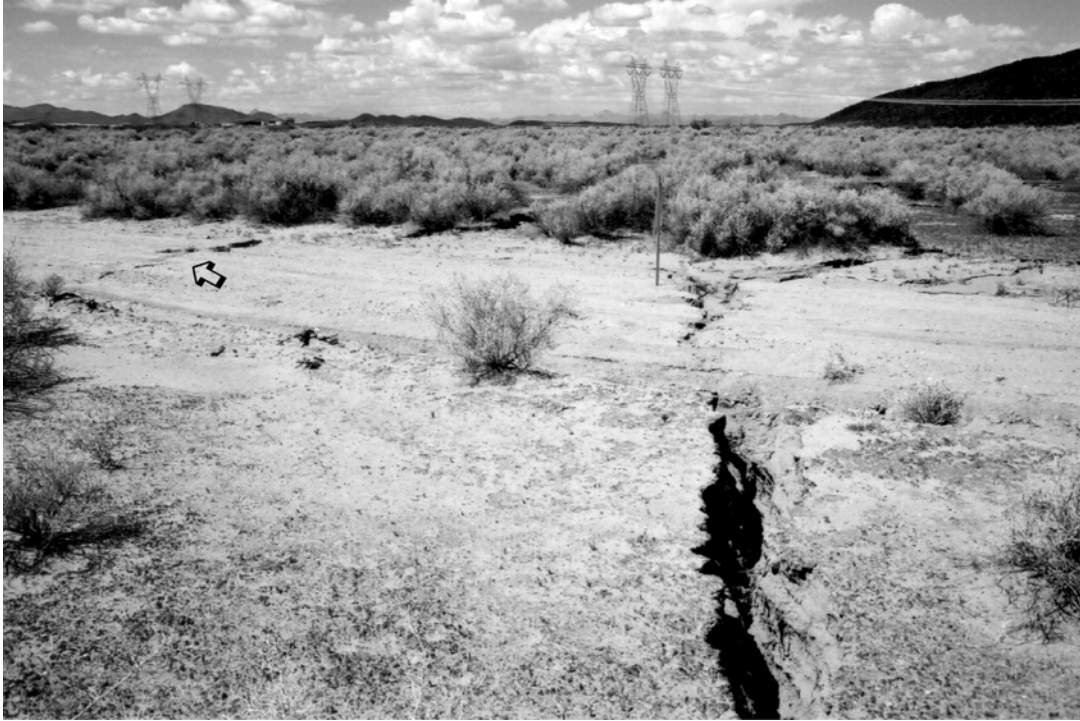
Figure 5. En echelon section of earth fissure crossing Baseline Road, looking NW. Fissure is 6-12 inches wide here. Second earth fissure crosses road at far left (arrow).

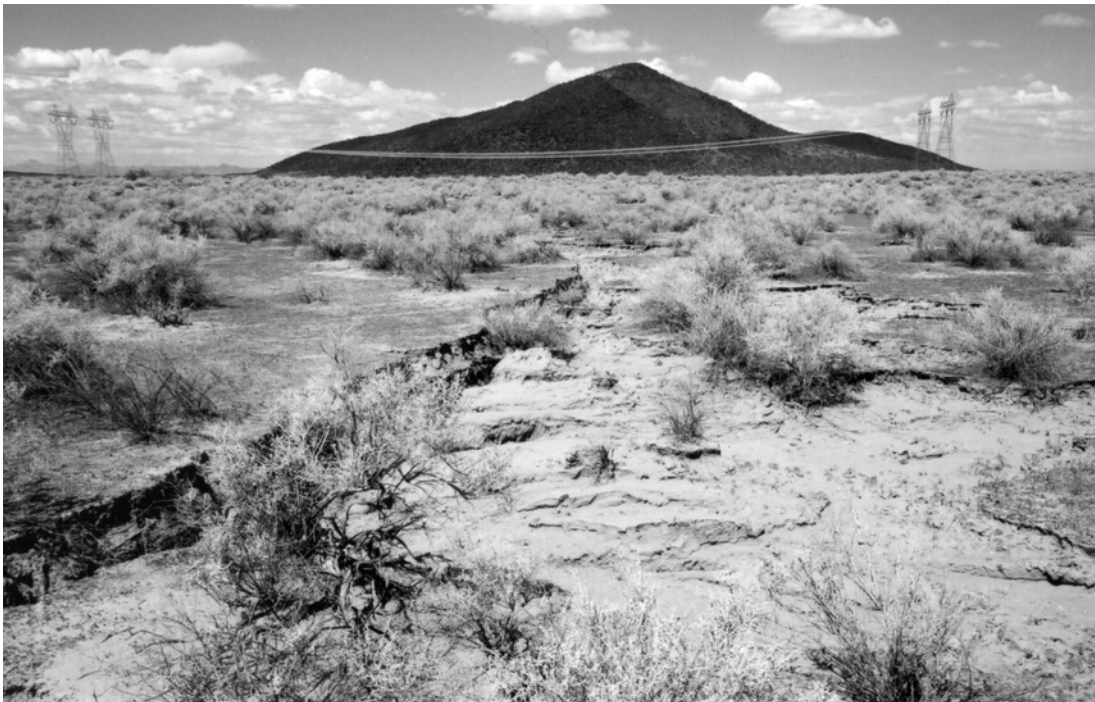
At the time of the first visit in mid September, little material had sloughed off into the fissure, only enough to open a narrow trench. Erosional downcutting of 4-12 inches has created miniature badlands up to 10 feet wide on the uphill (east) side of the crack (Figure 6). At the time of a follow-up visit in early November, the edges of fissure were noticeably rounded off from a small rainstorm the previous day. Much of the fissure had been partially filled in but there had not been enough runoff to enlarged it.

Figure 6. Section of earth fissure north of Baseline Road, showing erosion on uphill (east) side. Fissure is 12-18 inches wide, 1-6 feet deep in this section.

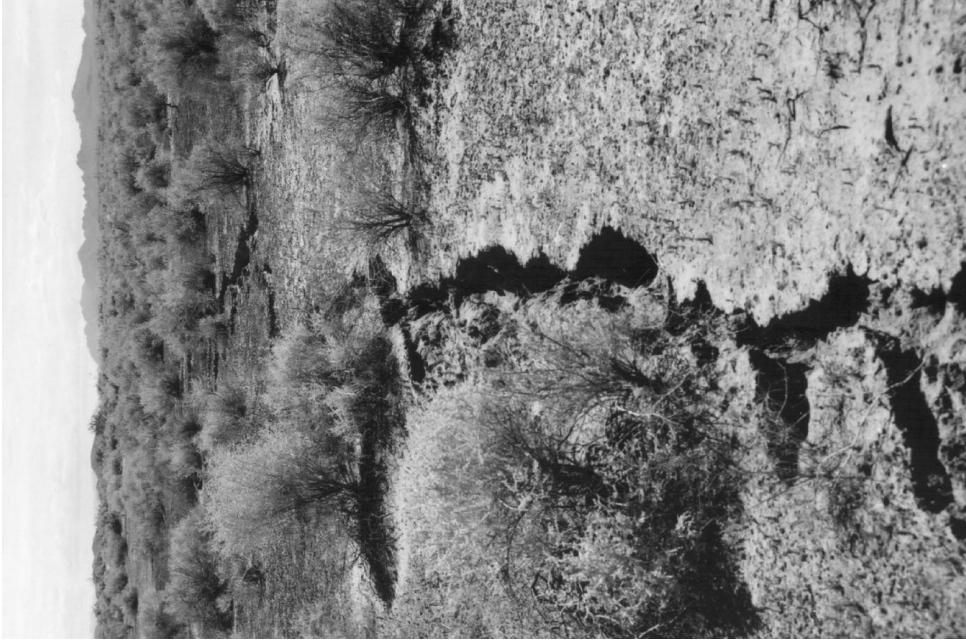
Both ends of the fissure are characterized by a gradual fading of the trench to miniature grabens and then to a hairline crack. The final 50 feet of both ends are slightly curved. Typical segments of the fissure are shown in Figures 7 and 8.

Figure 7. Typical section of earth fissure south of Baseline Road, looking south. Fissure here is 6-12 inches wide, with minor erosion on uphill (east) side.

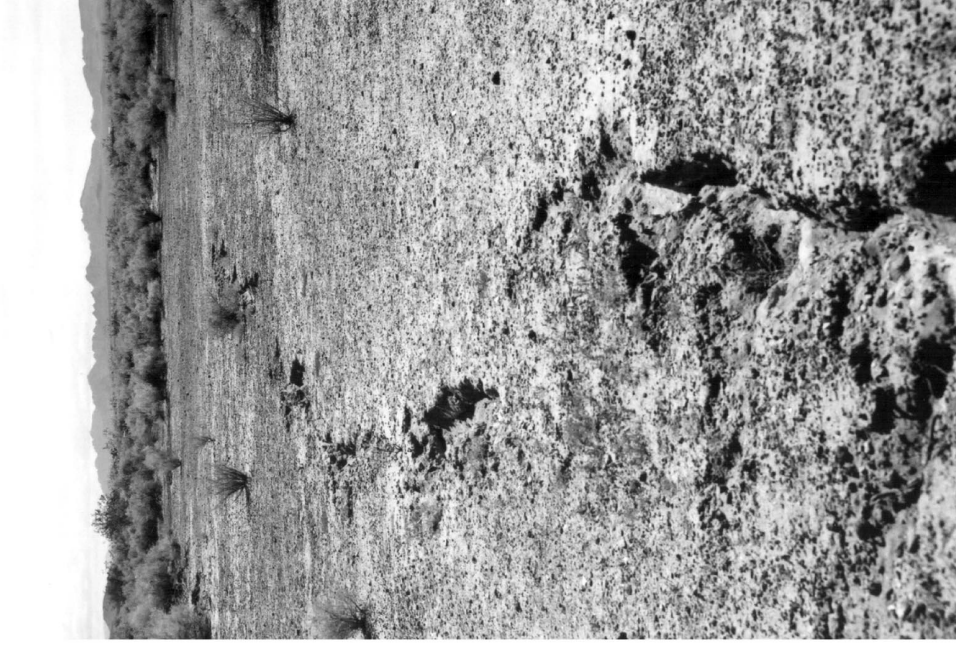
Figure 8. South end of earth fissure, looking south. Fissure decreases in size from 6-10 inches in foreground to hairline crack near far end of clearing.

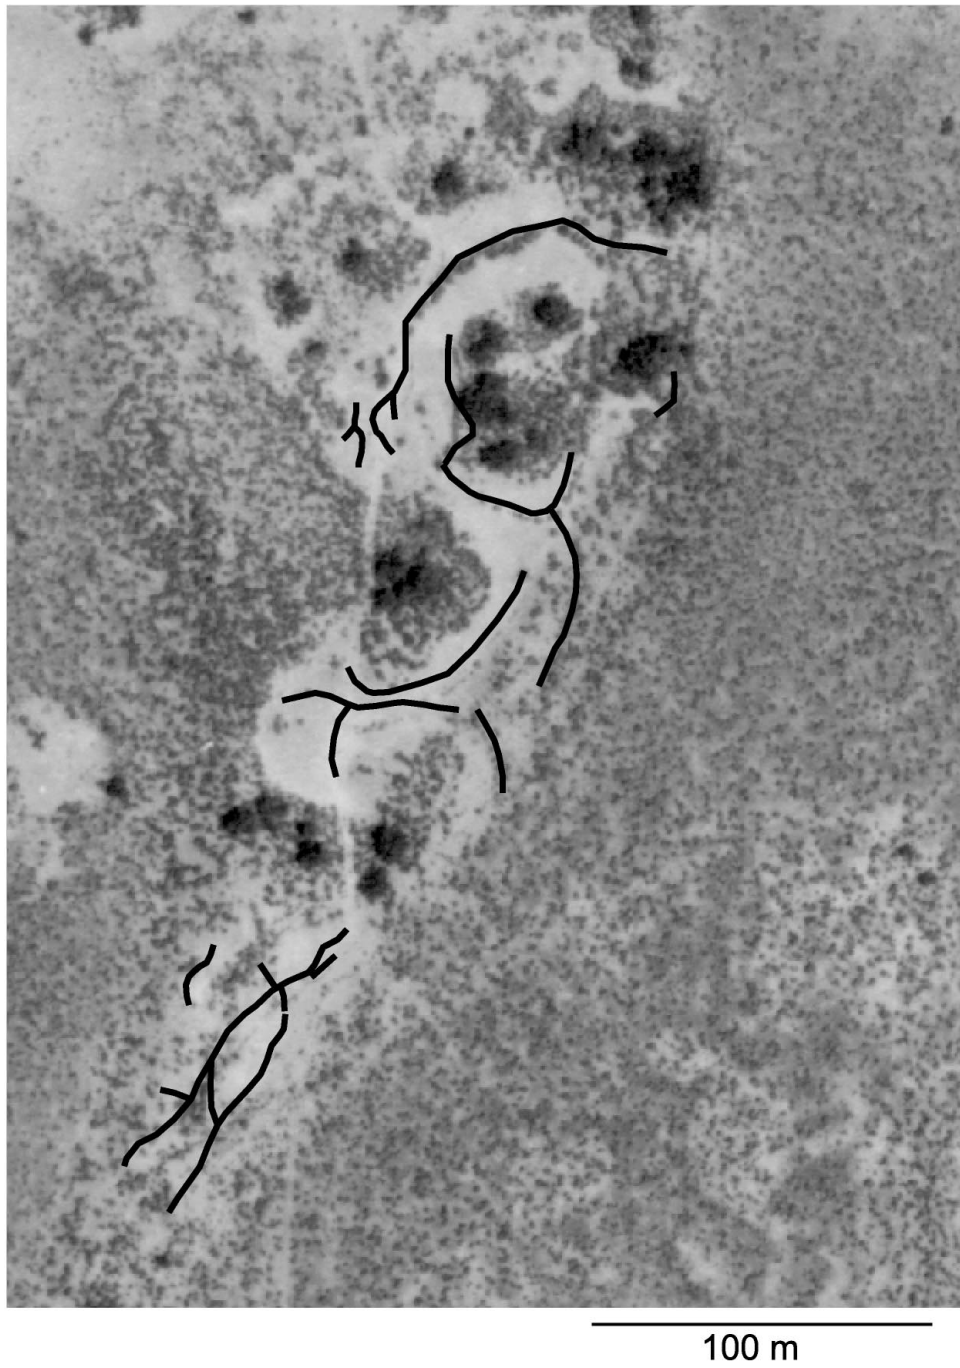
Northwest of the new earth fissure is a small area of giant desiccation cracks, plotted in detail in Figure 9. The polygonal cracks are probably not related directly to the earth fissure, but do share the aspect of their opening at the surface in response to heavy rain. (In this report, the term *fissure* is reserved for earth fissures caused by subsidence from groundwater pumping. Ruptures resulting from desiccation are called *cracks*.) Similar polygonal desiccation cracks are found in several locations in southeastern Arizona, such as Willcox (Anderson, 1978; Holzer, 1980) and along Interstate 10 between Bowie and San Simon (Holzer, 1980; Harris, 1997). Photos in Figures 10-16 show typical features of these desiccation cracks.

Figure 9. Area of giant polygonal desiccation cracks, northwest of new earth fissure. These cracks are similar in size and shape to other known desiccation cracks in southeastern Arizona.

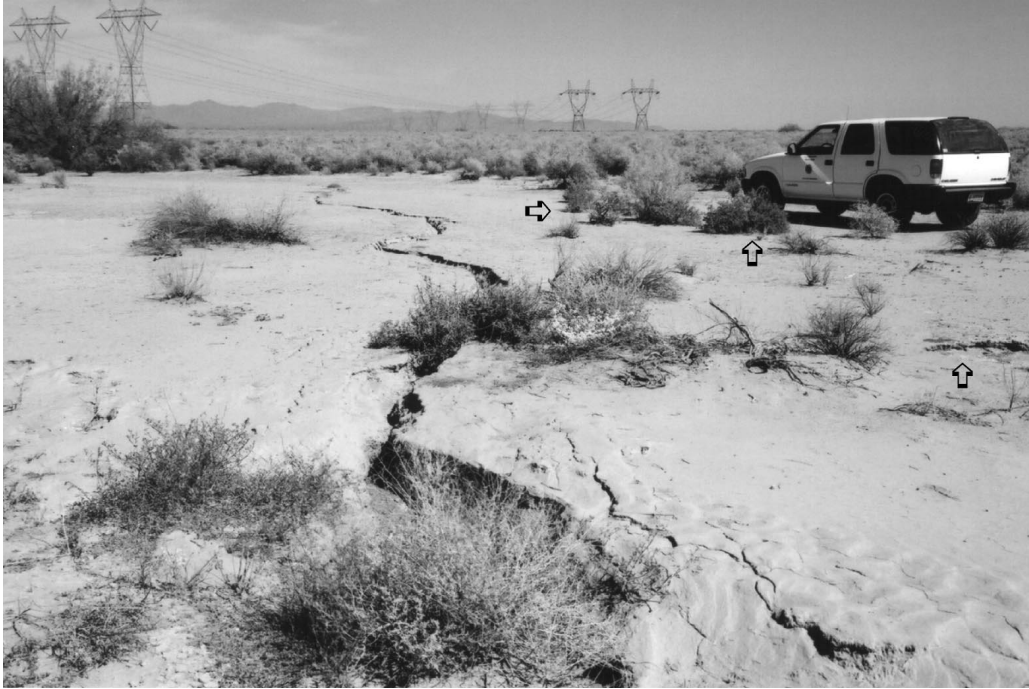
Figure 10. New generation desiccation crack (center), with lack of vegetation. An older, reactivated crack is defined by the alignment of mature vegetation on the left side of the vehicle. A third crack (center right edge) joins the large crack at the center of the photo.

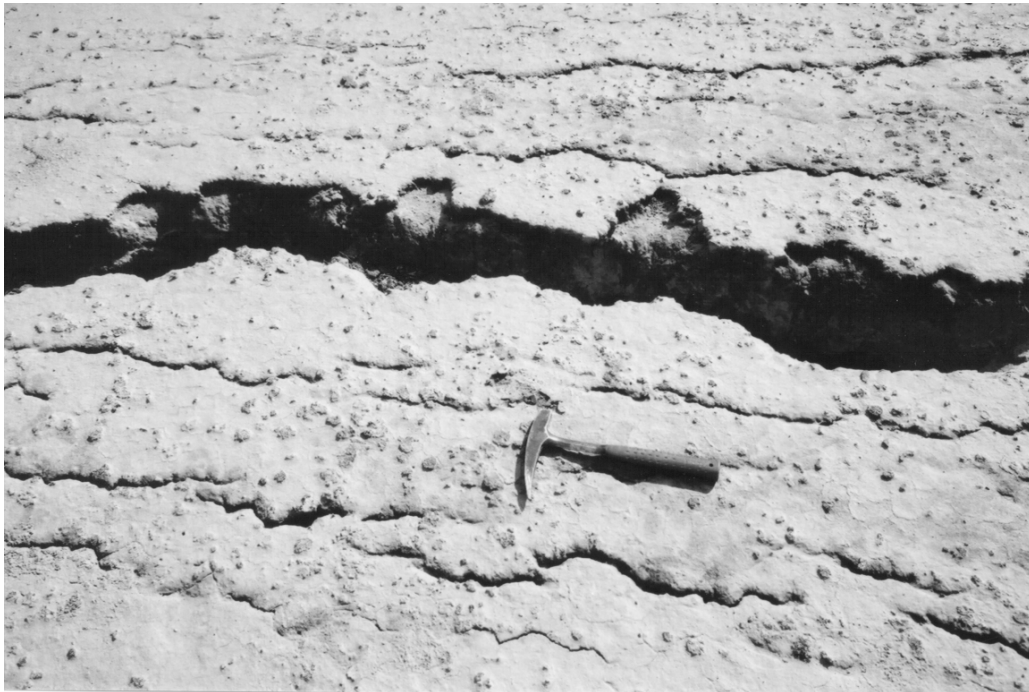
Figure 11. Close up of large, new crack shown in Figure 10, above. Parallel small cracks indicate further collapse and enlargement of the crack is likely in the event of another heavy rain.

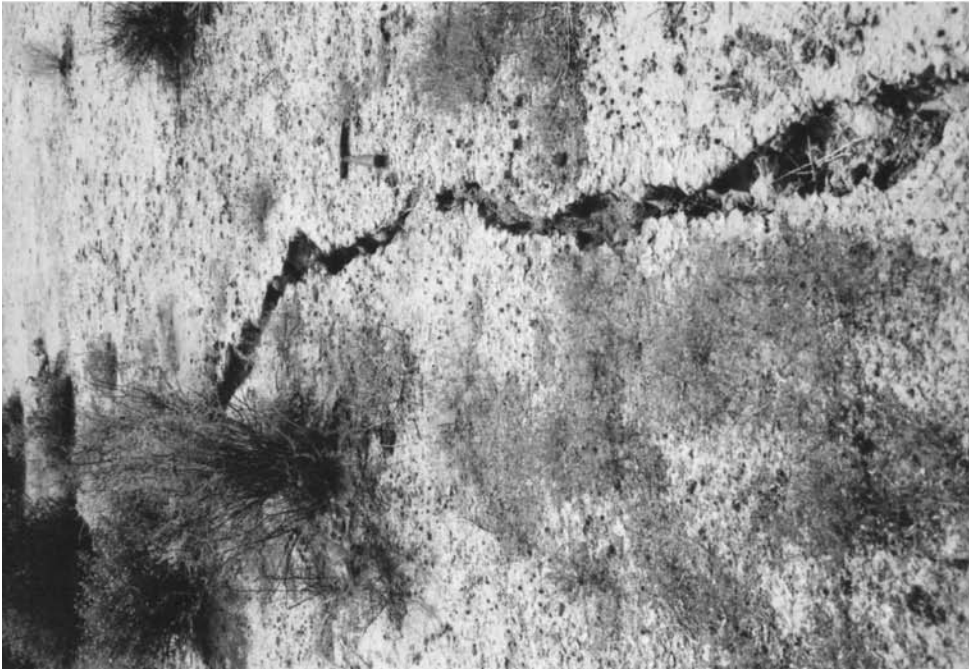
Figure 12. New desiccation crack, with vertical sides, sharp angles, and lack of vegetation. Rock hammer for scale.

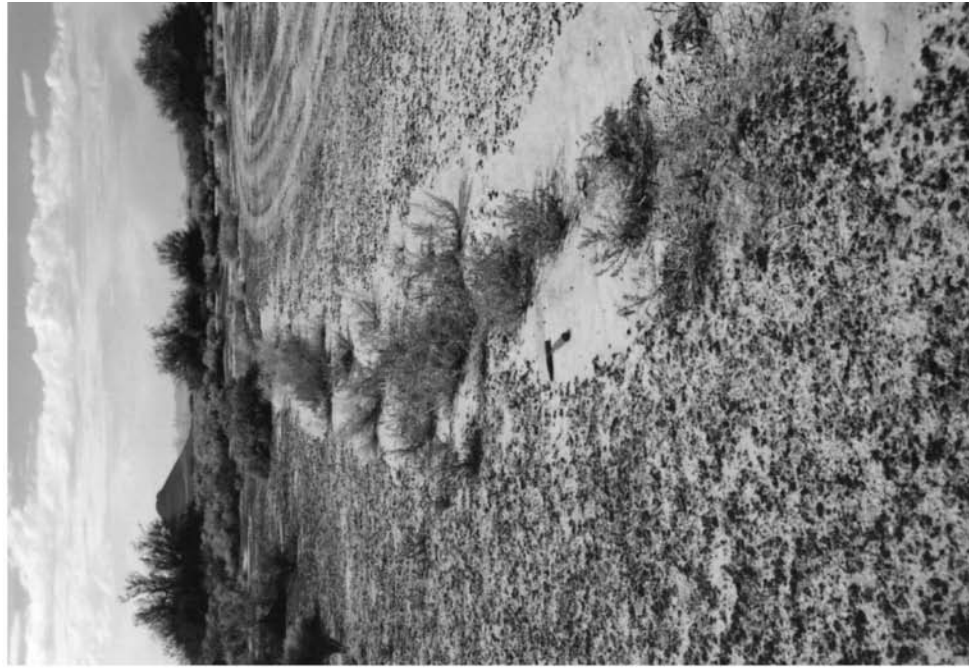
Figure 13. Older generation desiccation crack with well-developed vegetation alignment. Rock hammer for scale.

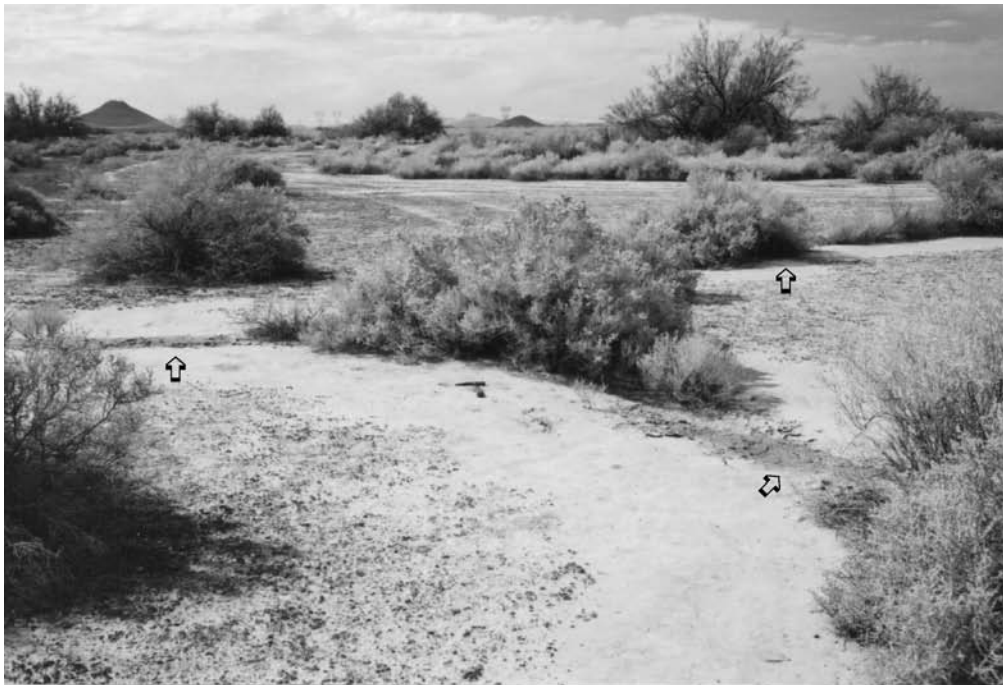
Figure 14. Junction of desiccation cracks by hammer at center of photo. Arrows point to three separate cracks. Note alignment of mature vegetation in the cracks, indicating that the cracks are old features, recently reactivated.

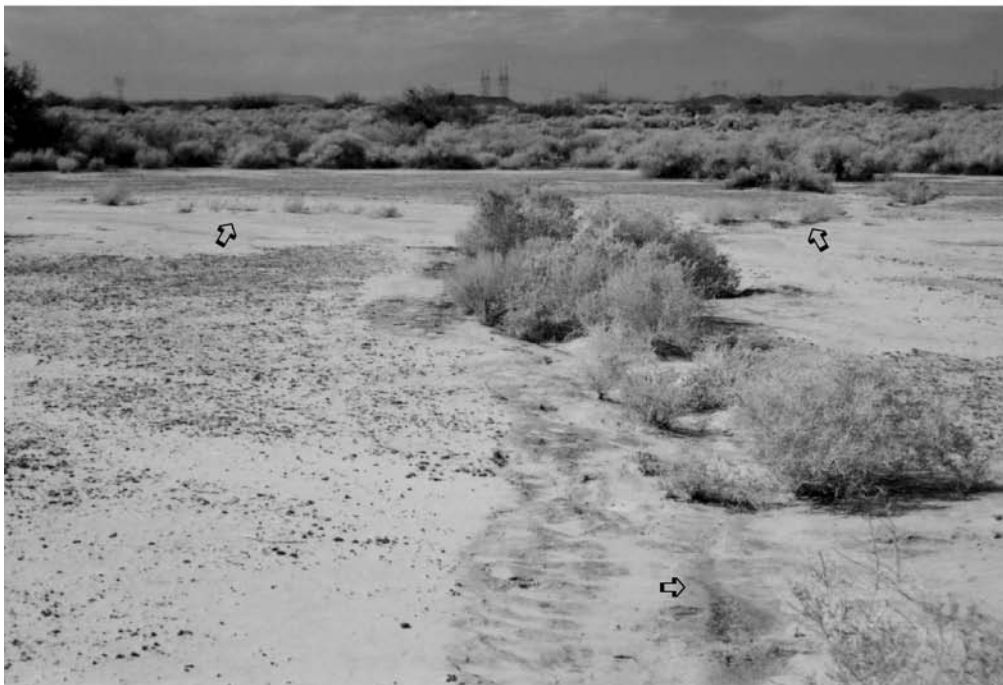
Figure 15. Junction of three cracks (arrows) at center of photo. Alignment of mature vegetation indicates this is at least the second cycle of cracking.

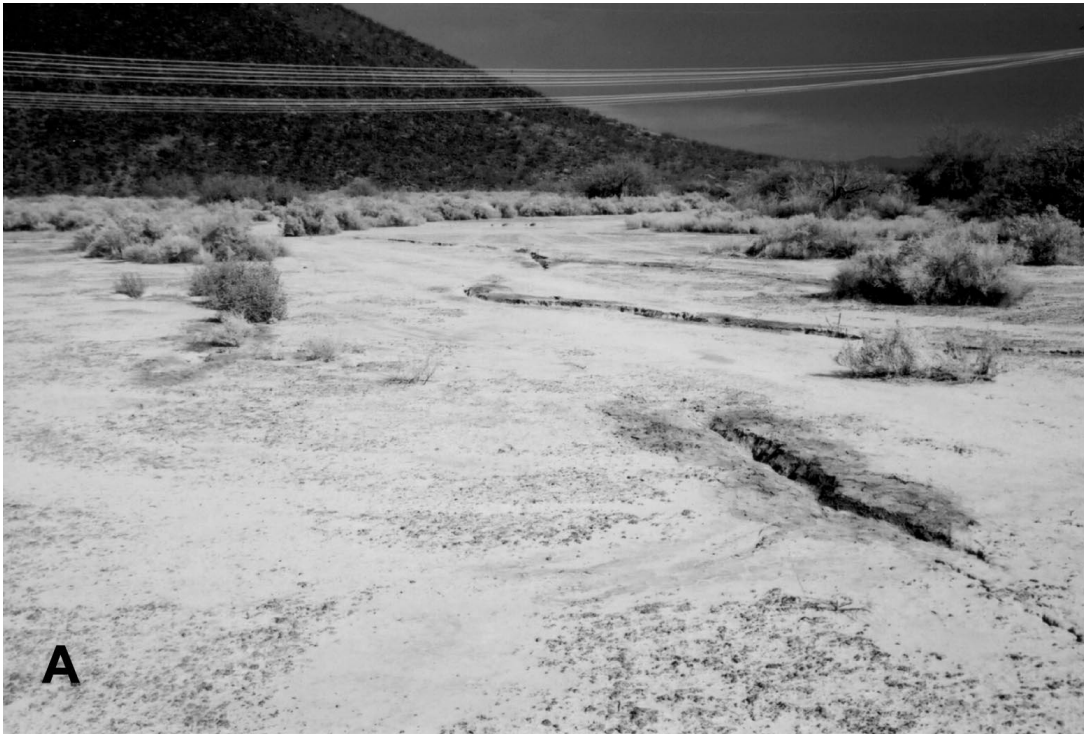
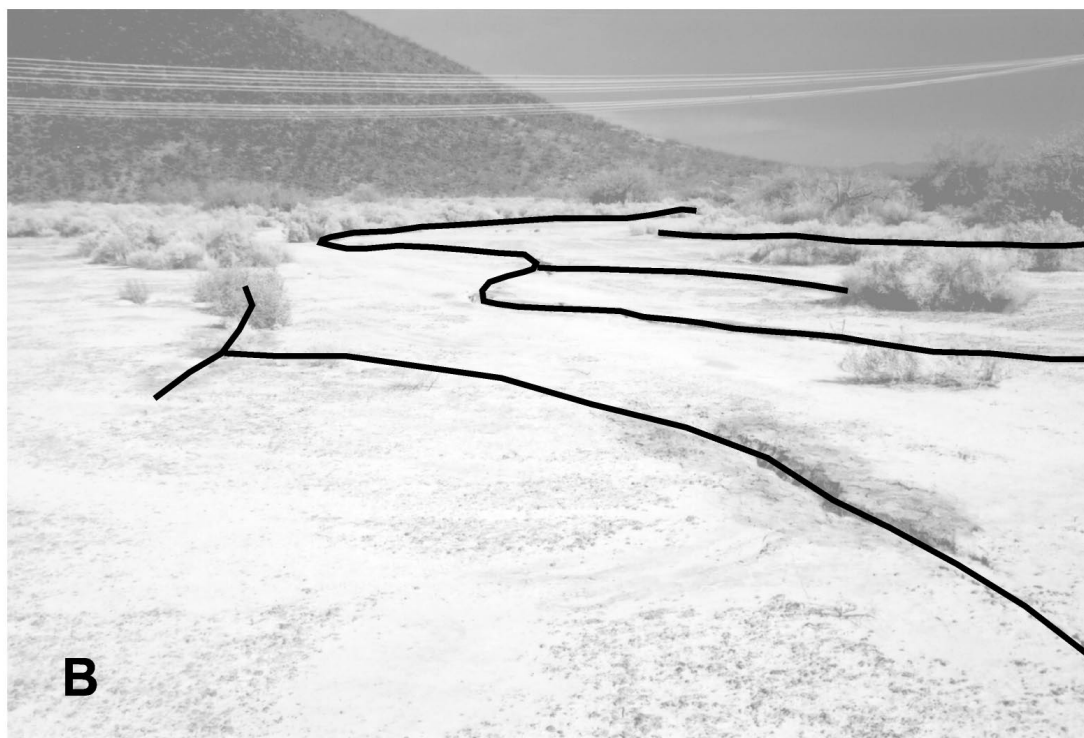
Figure 16. **(A)** View of northern-most group of desiccation cracks. **(B)** Trace of cracks plotted. Note new cracks in foreground lack vegetation, whereas older cracks in background are marked by very mature vegetation alignments.
