REVISITING EARTH FISSURES NEAR LUKE AIR FORCE BASE, CENTRAL MARICOPA COUNTY, ARIZONA

Joseph P. Cook
Arizona Geological Survey

OPEN-FILE REPORT OFR-13-15

October 2013

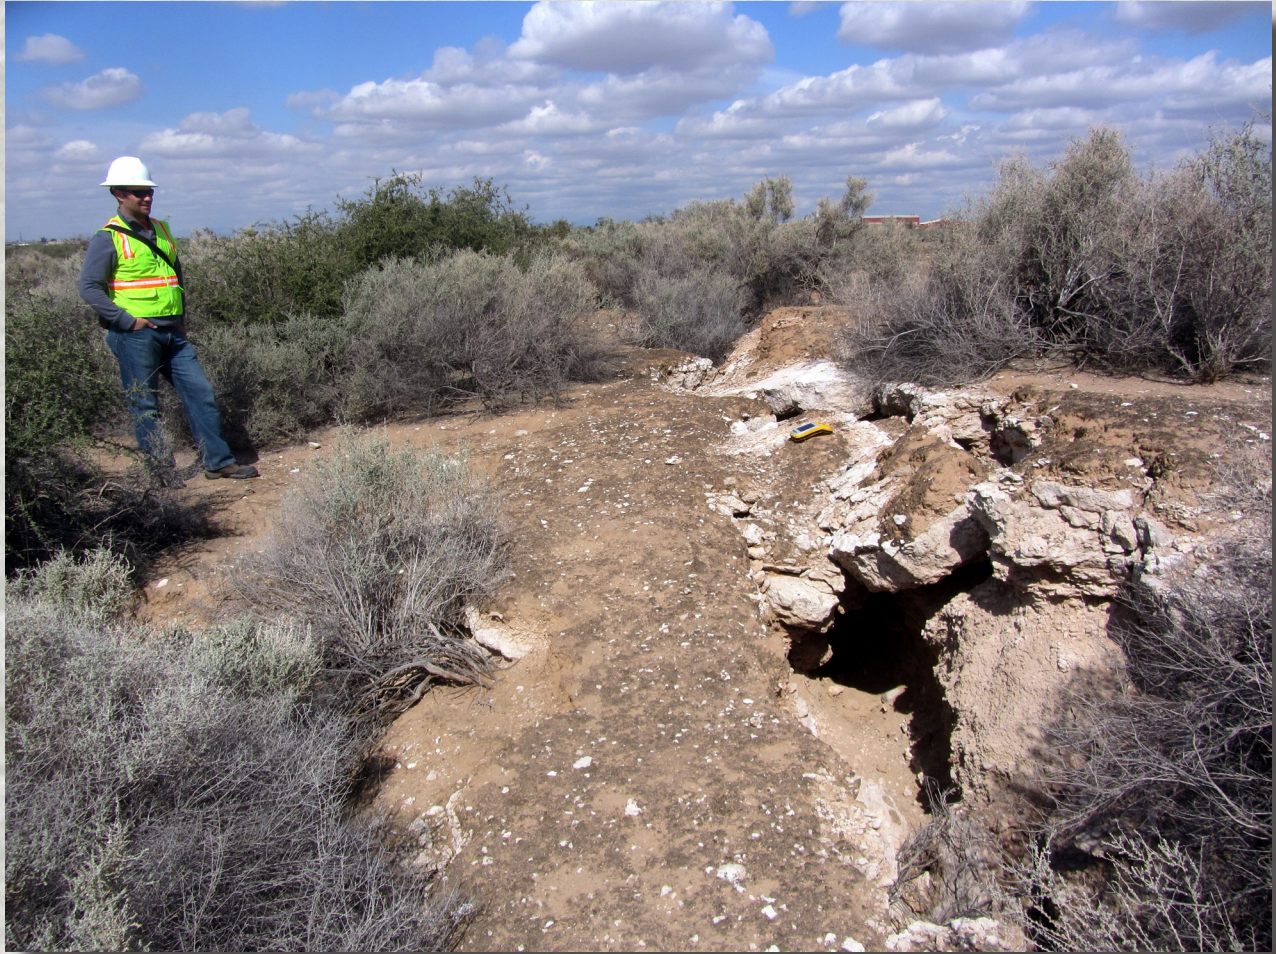
Strongly cemented carbonate beds drape across an earth fissure near Luke Air Force Base.

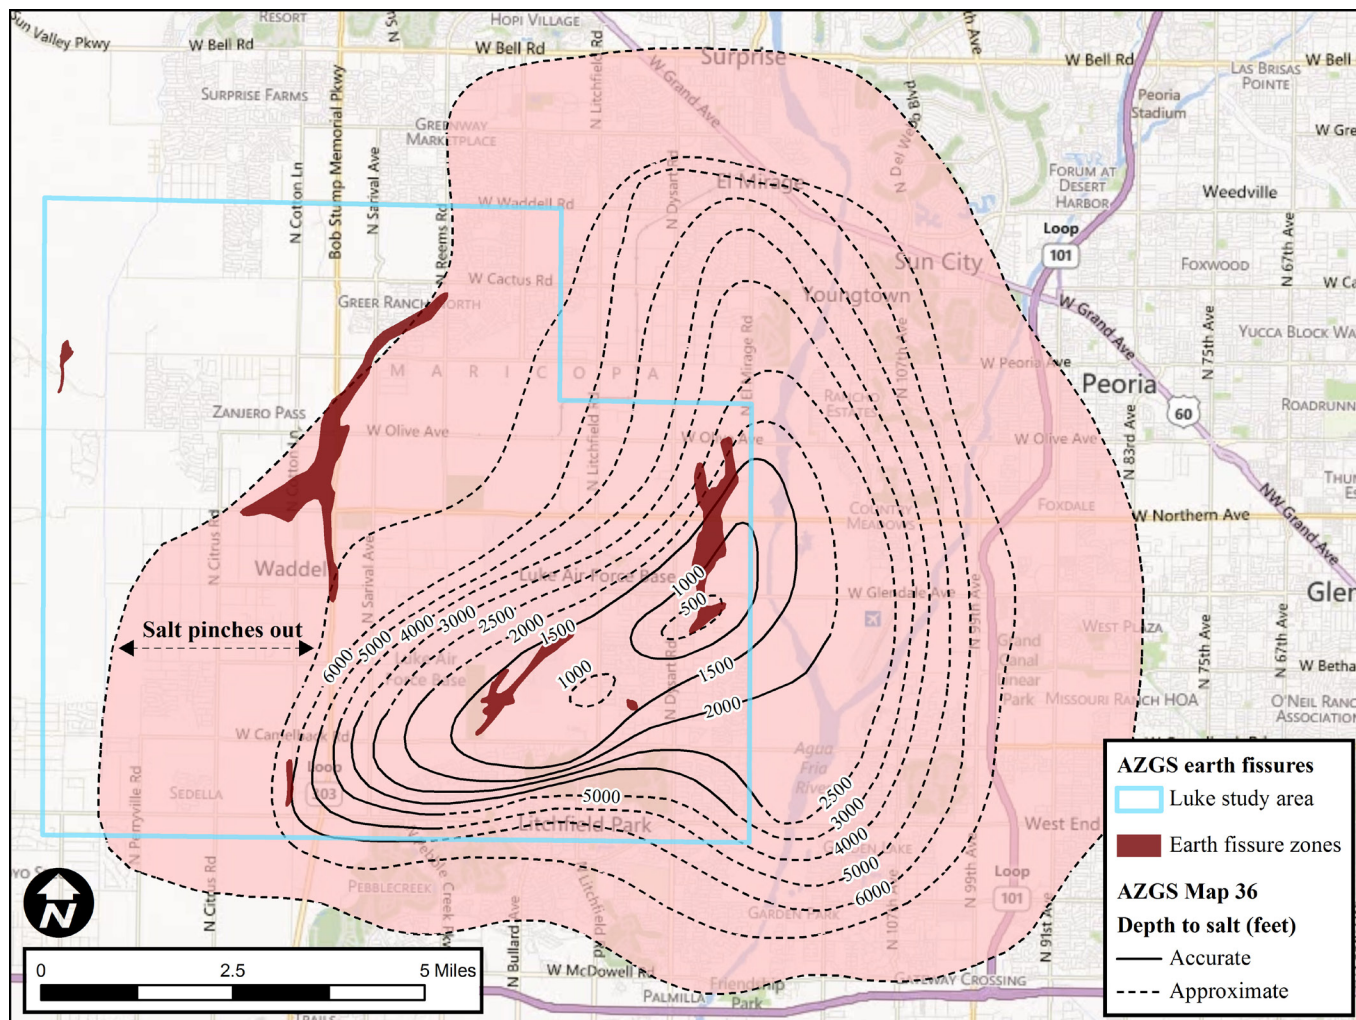
Figure 2. Location of earth fissure zones relative to near-surface salt deposits in the Luke earth fissure study area. Dramatic subsidence of over 18 feet centered several miles northwest of the salt dome crest has driven the formation of earth fissure zones above the ridge of the underlying salt dome. Fissure zones nearer the west edge of the study area may be related to subsidence over buried bedrock ridges, clay bodies, or other subsurface irregularities. Depth to salt contours digitized from Rauzi's (2002a) Luke salt deposit map.

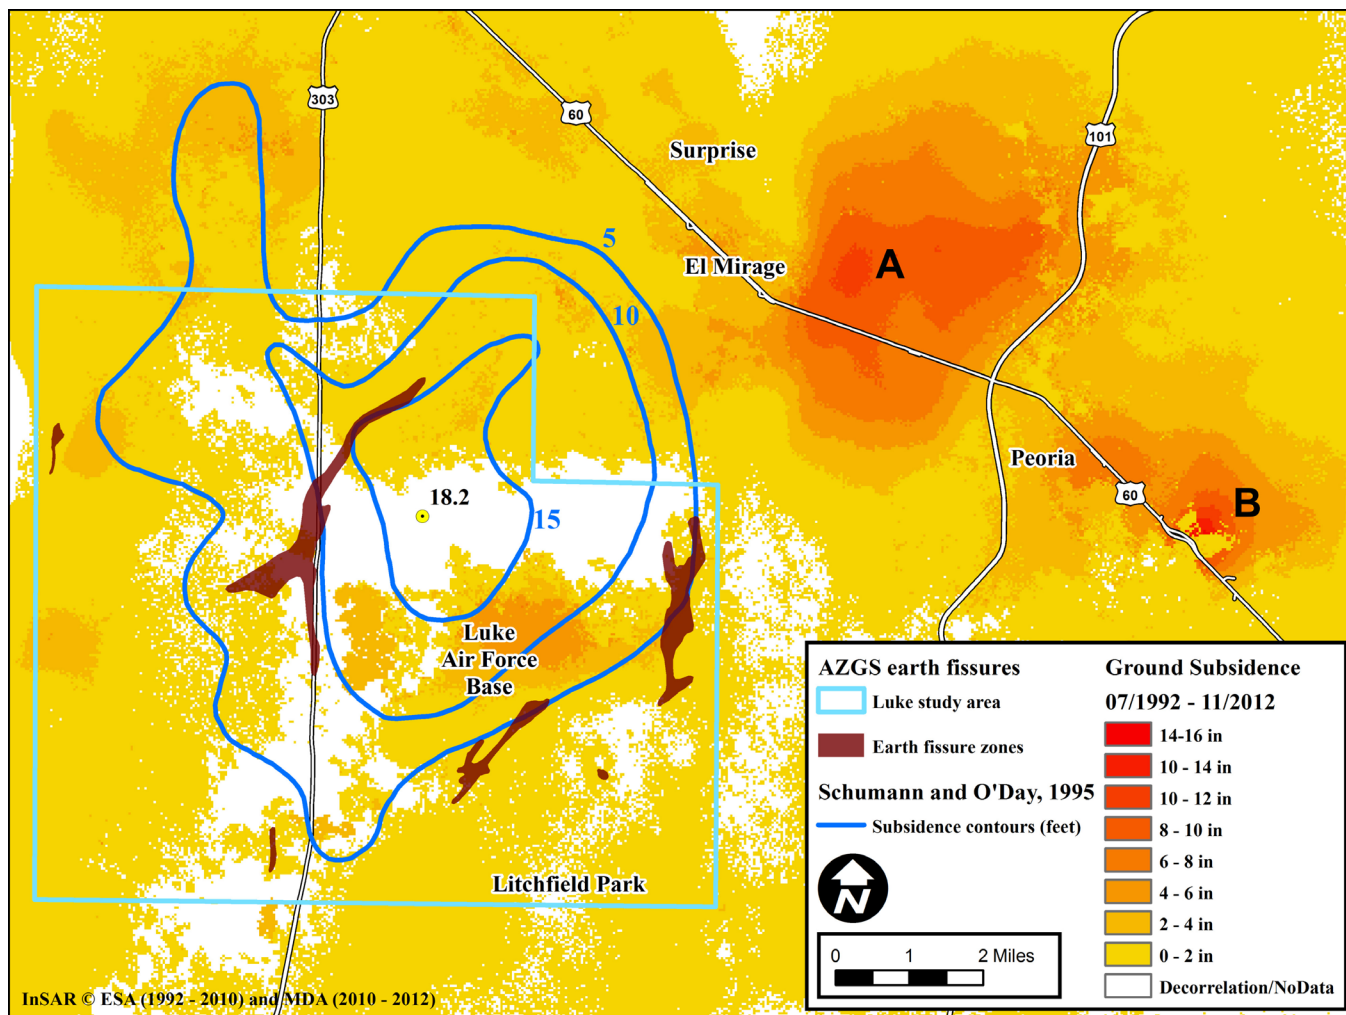
Figure 3. Land subsidence map of Luke Air Force Base and surrounding areas. Blue land subsidence contours are modified from Schumann and O'Day (1995). Note point of maximum subsidence (18.2 feet) measured in 1991. Subsequent land subsidence has been measured by InSAR and is represented by the color ramp. Because multiple land subsidence plots were used to create this figure, each individual plot varies in extent and area of decorrelation, and a data gap exists from 2000-2002, the land subsidence values shown here represent a minimum from 1992-2012. More dramatic land subsidence in the vicinity of El Mirage (A) and Peoria (B) is ongoing outside the Luke study area.

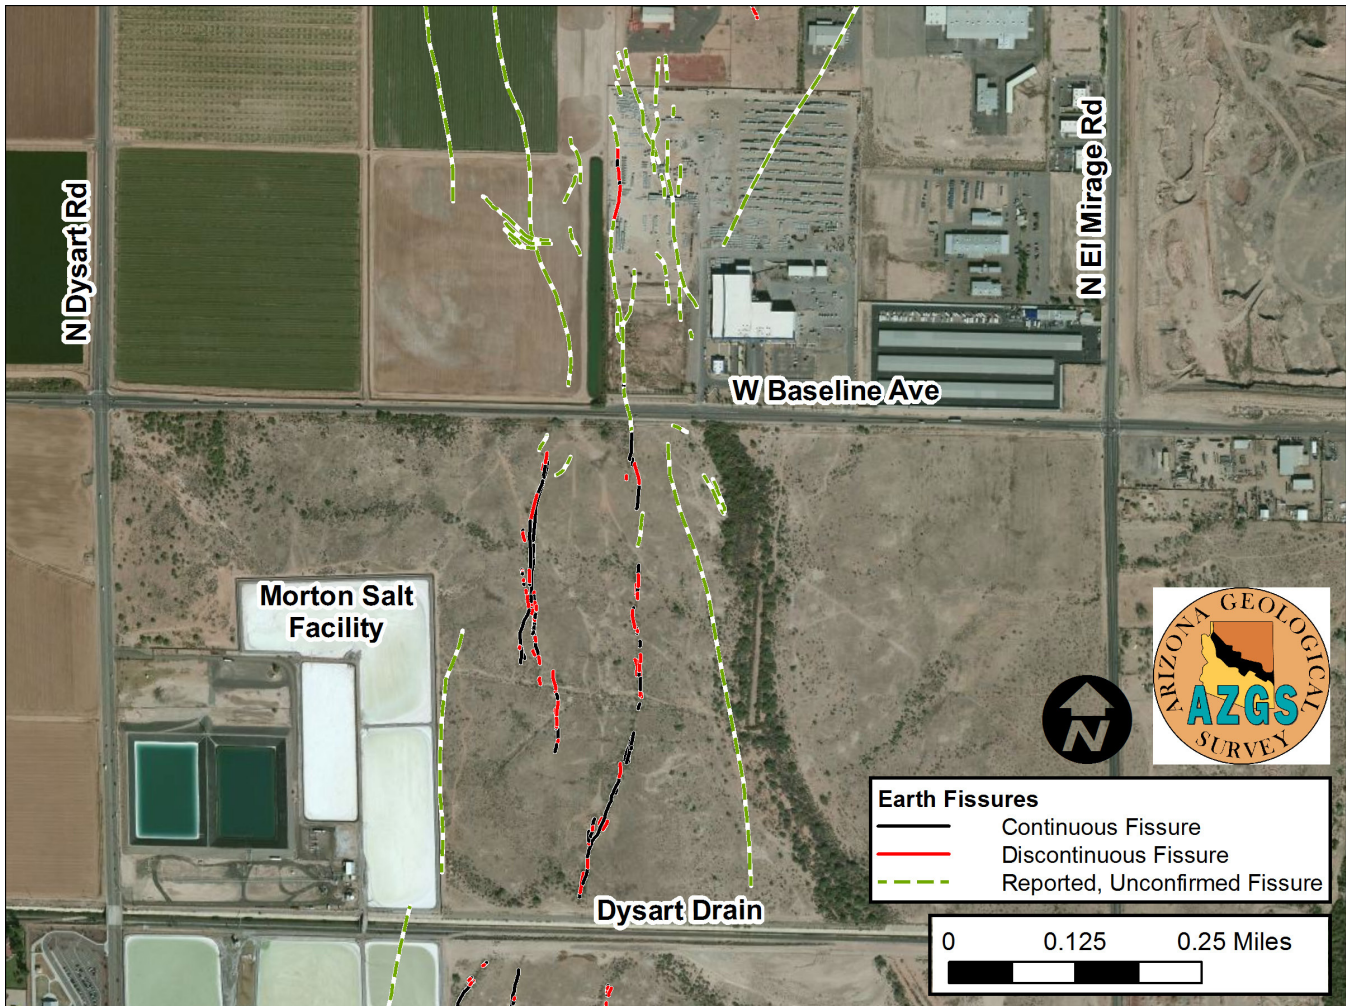
North-south trending fissure zones shown on the AZGS Luke earth fissure map south of Northern Avenue and immediately east of the Morton Salt evaporation ponds are still evident in the landscape (Fig. 4). The earth fissure zones consist of numerous parallel to

Figure 4. Location map of mapped earth fissures in the vicinity of West Northern Avenue between North Dysart and North El Mirage Road, Maricopa County, Arizona. Earth fissures shown here are the same as those depicted in the AZGS Earth Fissure Map of the Luke Study Area (AZGS DM-EF-8) overlain on 30 centimeter pixel 2010 Bing aerial imagery.

A short (less than 25 foot) earth fissure is mapped near the southwest corner of a drainage impoundment immediately north of a gravel-covered slope on the Hanson Pipe and Precast property (Figure 4). This crack does not show evidence of major collapse and consists only of shallow (less than 1 foot deep) cracks, depressions, potholes, and vegetation trends. The southern terminus of this mapped crack corresponds with a small offset in a cinder block wall at the top of the gravel-covered slope. The drainage impoundment area to the north is covered by thick stands of desert broom but some possibly anomalous depression trends

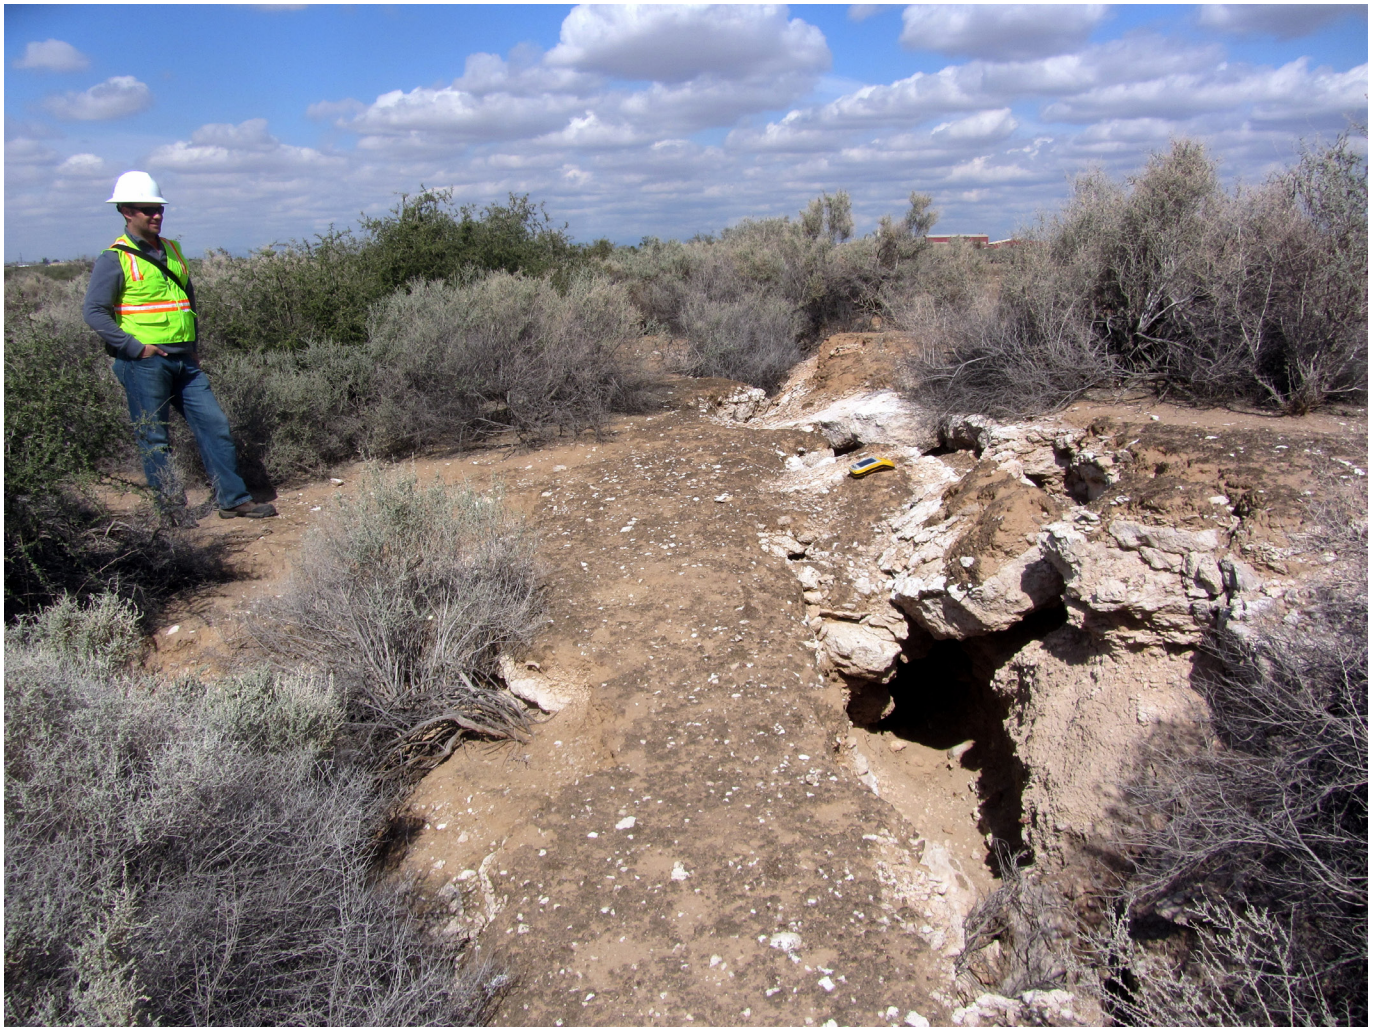
unconfirmed fissure traces during the site visit on February 21, 2013. Earth fissures mapped as continuous or discontinuous fissures in 2008 were still clearly evident in the landscape during the same inspection (Figure 5). Existing mapped fissure traces showed no evidence for extension and no new fissures were encountered. AZGS DM-EF-8 released in February 2009

gullies are typically wider, well-rounded, and include arroyo-like sections with flat, sandy bottoms. Some earth fissure trends are composed of disconnected potholes and collapse features. Some potholes are shallow (less than 1 foot deep) while others exceed 7-8 feet in depth and exhibit an open crack that tapers deeper underground and disappears into the subsurface. Strongly cemented calcium carbonate beds broken by earth fissures were exposed along some earth fissure traces and up to 3 feet of vertical offset (down to the west) was observed in several locations (Figure 5). The trend of the fissure zone exhibiting

Figure 5. View to north along western earth fissure zone approximately 900 feet south of West Northern Avenue. Here, strongly cemented carbonate beds are broken and draped across several feet of vertical offset (down to the west). Fissure depth in the vicinity of carbonate bed offset often exceeds 6 feet with a narrow open crack tapering deeper into the subsurface.
