WHY DID THE FISSURE CROSS THE ROAD? NEW AND OLD EARTH FISSURE ACTIVITY IN COCHISE COUNTY, ARIZONA

JOSEPH P. COOK, ARIZONA GEOLOGICAL SURVEY, TUCSON

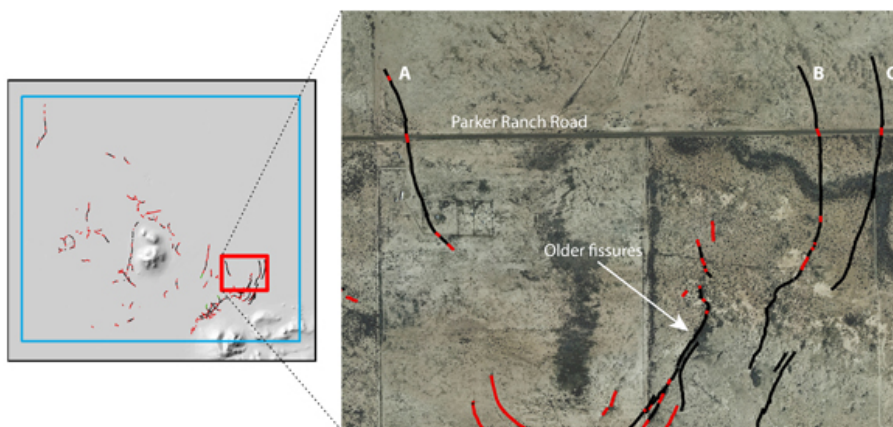
Figure 3. Section of the Three Sisters Buttes earth fissure study area containing the three new fissures cutting Parker Ranch Road. Fissures A, B, and C opened in summer 2010 while fissures to the south were evident in aerial photos from the late 1970s. Continuous fissures are indicated in black and discontinuous fissures are indicated in red.

The cumulative length of the open surface crack portions of the new fissures exceeds 1.3 miles (Fig. 3): it is possible, too, that hairline cracks and voids extend beyond the mapped fissure in the subsurface. Some sections of these fissures are narrow cracks less than six inches across or disconnected lineations of potholes. Other sections have experienced extensive surface collapse resulting in open surface cracks approximately 15 feet across (Fig. 4). The deepest measurable section of the earth fissure complex exceeds nine feet although numerous open cracks and collapse features visible in the base of the open portion of the fissures likely extend to much greater depths. The easternmost newly-opened earth fissure cuts across local drainages, affecting downstream vegetation and drainage patterns. Although the upstream channel is presently wide and unincised, future runoff will pour into the deeper earth fissure enhancing headward erosion along the drainage where there was little incision before. The downstream end of the channel is now abandoned and will no longer receive flow.

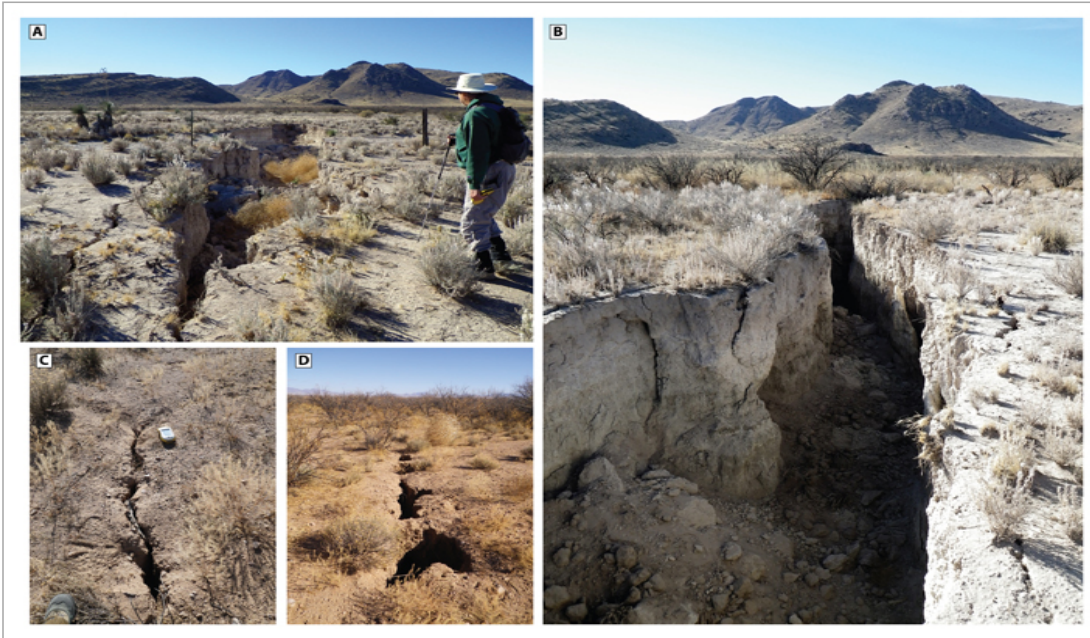
Figure 4. Field photos of newly opened earth fissures. A) A large open section of fissure C from figure 3, note fence stretched across open fissure. B) Deep, steep-sided section of the same fissure. C-D) Narrow surface cracks and aligned potholes representative of portions of earth fissures that have not yet opened completely. A subsurface void likely underlies these features and the overlying soil may one day collapse into it.

Once an earth fissure has breached the surface there is little that can be done to mitigate it, other than preventing water from entering and further eroding the sidewalls. Filling fissures with loose unconsolidated fill usually fails as surface flow eventually washes the fill laterally or down into the fissure. Authorities in Pinal County have filled the “Y-Crack” fissure near Chandler Heights several times, just to see the fissure reopen as monsoon rains and sheet flow erode and remobilize the fill.

Roads cut by fissures may require repeated repairs and continuous monitoring especially following intense rains. Because earth fissures form in response to overdrafting groundwater, the only guaranteed means of preventing their occurrence is to cease groundwater pumping in excess of recharge. But even if groundwater overdrafts were to cease today the compaction of valley filling sediments would likely continue for some time, perhaps years, as the compaction process lags behind decades of falling groundwater levels.

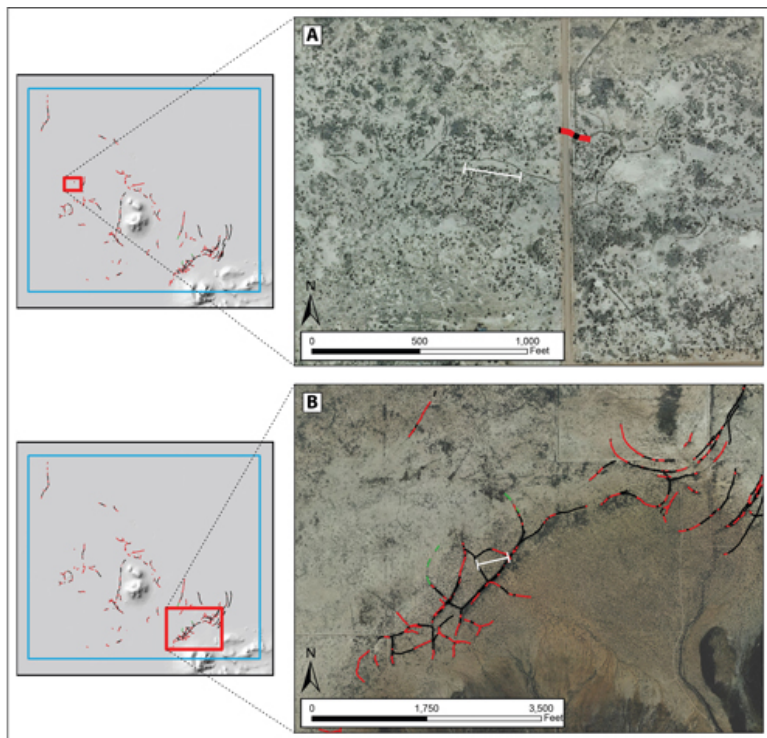
Figure 5. A) Giant desiccation crack field in the Three Sisters Buttes study area. These GDCs have disrupted the surface of Fern Ct (N-S dirt road), which required repair. The distance across the white line in the GDC polygon is 250 feet. B) Polygonal crack network near known earth fissures. These polygonal cracks were previously identified as combination earth fissure-giant desiccation cracks. In the Three Sisters map they are shown as earth fissures. The polygon here measures 425 feet across. Continuous fissures are indicated in black and discontinuous fissures are indicated in red.

Not all large surface cracks in Cochise County are earth fissures. Giant desiccation cracks (GDCs) are abundant around the present and former margins of Willcox Playa, on the distal toes of alluvial fans, and along the valley axis of fine grained alluvial basins. GDCs form in fine grained, clay-rich soils in response to prolonged drought or repeated wetting and drying (Neal et al., 1968, Harris, 2004). GDCs form polygonal networks reminiscent of mudcracks except GDC polygons can be hundreds of feet across (figure 6). Much like earth fissures, surface cracks forming GDC networks may start out as hairline cracks but evolve into large collapse features due to subsurface piping and erosion. Unlike earth fissures, GDCs are strictly surface features extending mere feet into the subsurface. Older GDC networks may become nearly or partially filled due to wall collapse. Vegetation may preferentially grow in or along GDCs because of loose soil fill and a greater affinity for capturing and storing water. Over time vegetation may help completely fill the surface crack through the capture of windblown sediment resulting in a vegetated mound along the former GDC trace.

While earth fissures form as a result of the overpumping of groundwater, GDCs can form naturally in response to soil characteristics and climate patterns. In some cases, earth fissures have formed across preexisting GDC networks, as observed in aerial photos as far back as 1935 (Harris, 2004). Where GDCs and earth fissures form in close proximity, it can be difficult to discriminate between them. It is possible the introduction of a deep earth fissure in the vicinity of preexisting GDCs may enhance or renew the formation of GDCs through increased desiccation of near surface soils, base level lowering and subsequent downcutting, or a combination of both. In the Three Sisters Buttes earth fissure study area, some features previously identified as combination earth fissure-giant desiccation cracks were mapped as earth fissures based on similar appearance, morphology, and crack geometry to nearby fissures. Other more shallow polygonal features in the study area were interpreted as GDCs and were not depicted on the map.

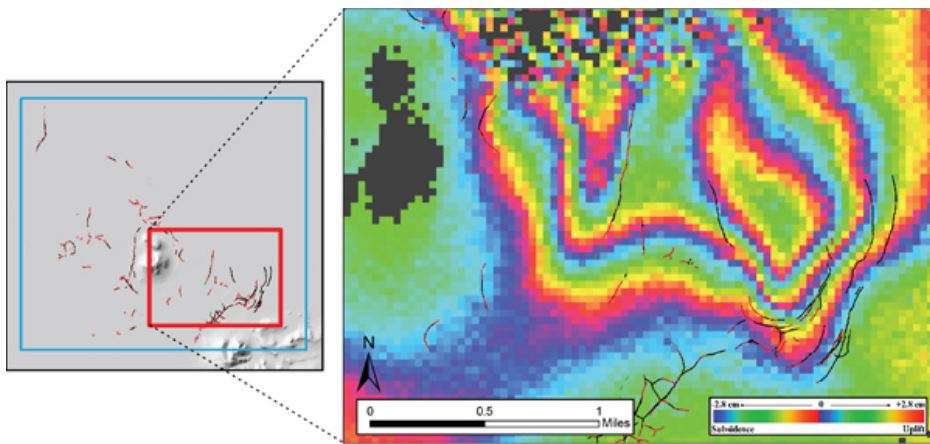
InSAR interferograms are proving a useful predictive tool for pinpointing new fissure formation. As Figure 5 shows, the new fissures in the Three Sisters Buttes study area correspond closely with high differential subsidence areas portrayed on InSAR interferograms. We have had some success, too, using InSAR images to guide us to unmapped earth fissures. The ability to accurately quantify subsidence trends and outline fissure-prone areas is a valuable tool for civil authorities, developers, landowners, and the general public.

Figure 6. InSAR interferogram spanning May 2008 through May 2010. Each repetition of the color ramp represents 2.8 centimeters (just over an inch) of subsidence. In the past two years, more than 3 inches of ground subsidence occurred. Note close agreement between areas of pronounced differential compaction and earth fissure formation. And note, too, areas of strong differential compaction that lack earth fissures. Are these areas where we can expect fissures to occur in the future? Continuous fissures are indicated in black and discontinuous fissures are indicated in red.
