## GEOTECHNICAL CHARACTERIZATION AND MAPPING OF TWO EARTH FISSURES APPEARED IN THE GUADALENTIN VALLEY AFTER THE SEPTEMBER 28TH, 2012 FLOODING

**J.L. Pastor, J. Mulas, R. Tomás, G. Herrera, J. A. Fernández-Merodo, M. Béjar, L. Jordá, J. C. García López Davalillo, R. Aragón, R. M. Mateos**

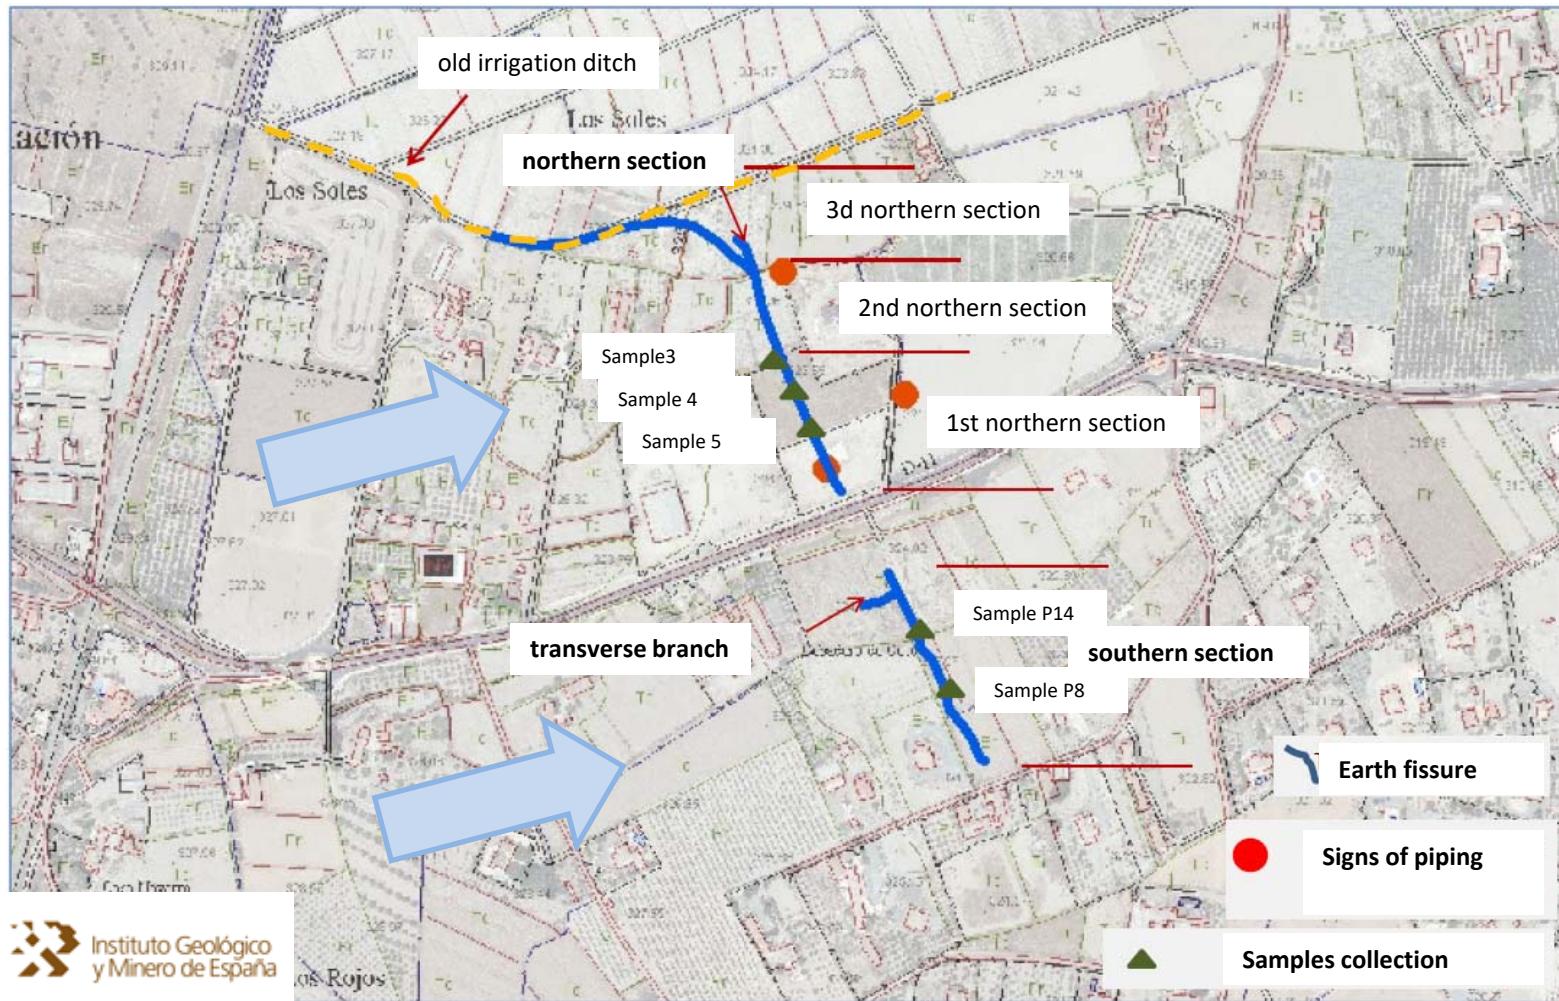
- A 400 m long earth fissured appeared

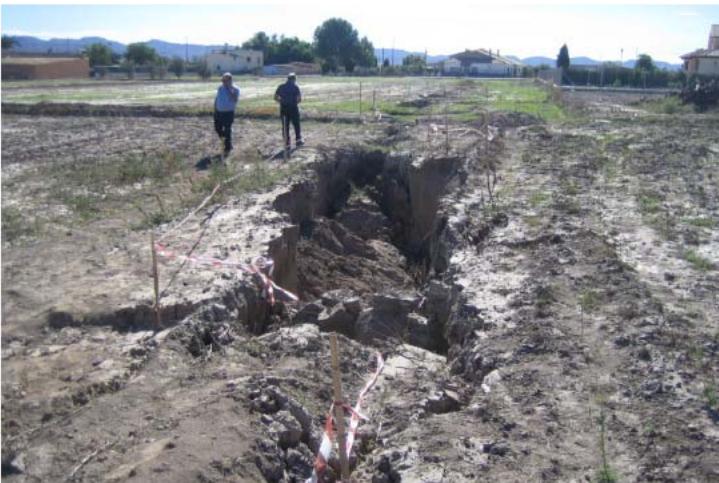
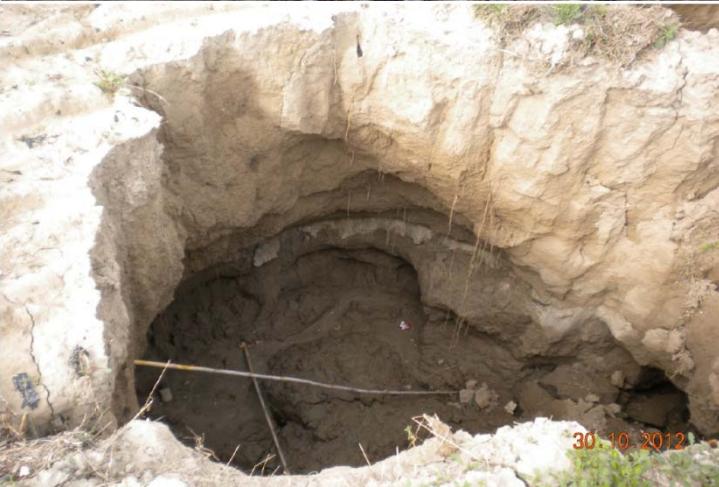
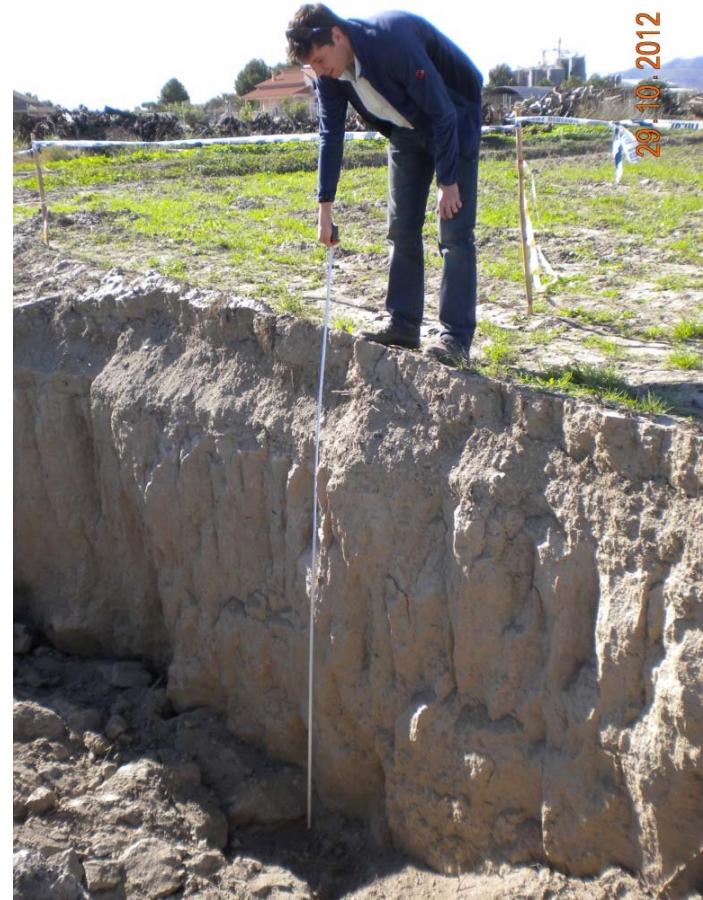
- Piping processes observed

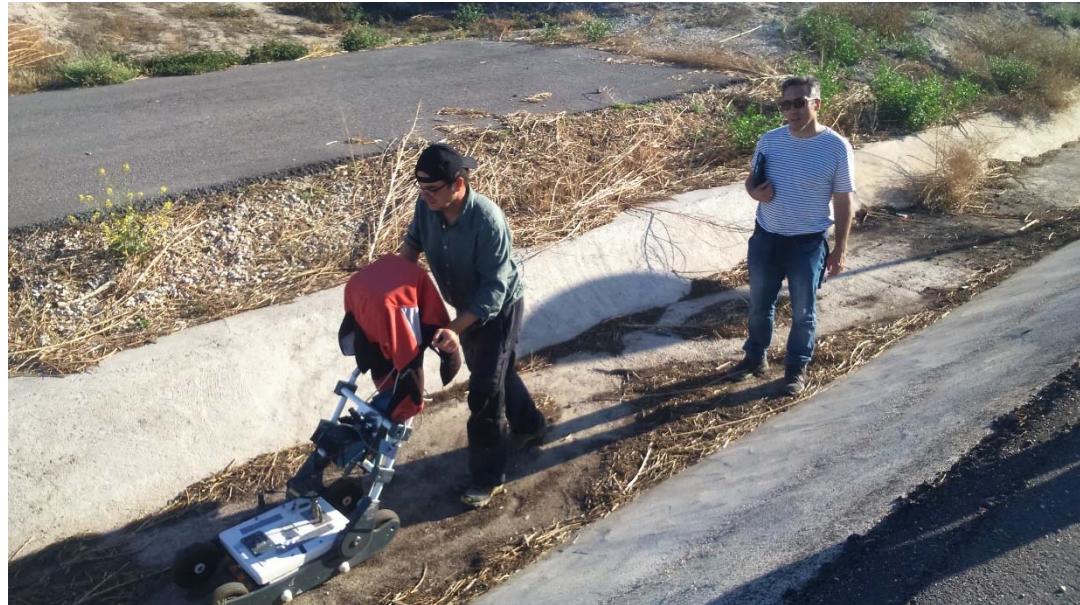
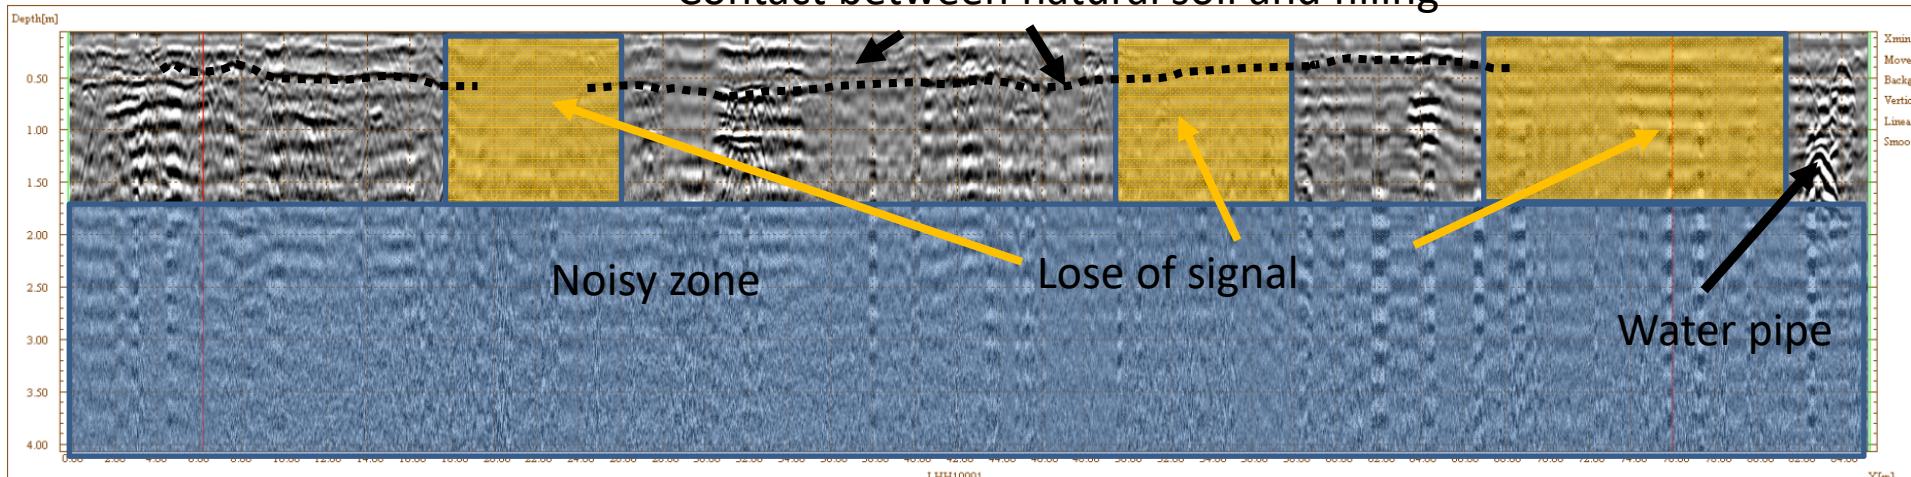
- GPR  
(Ground Penetrating Radar)

Contact between natural soil and filling

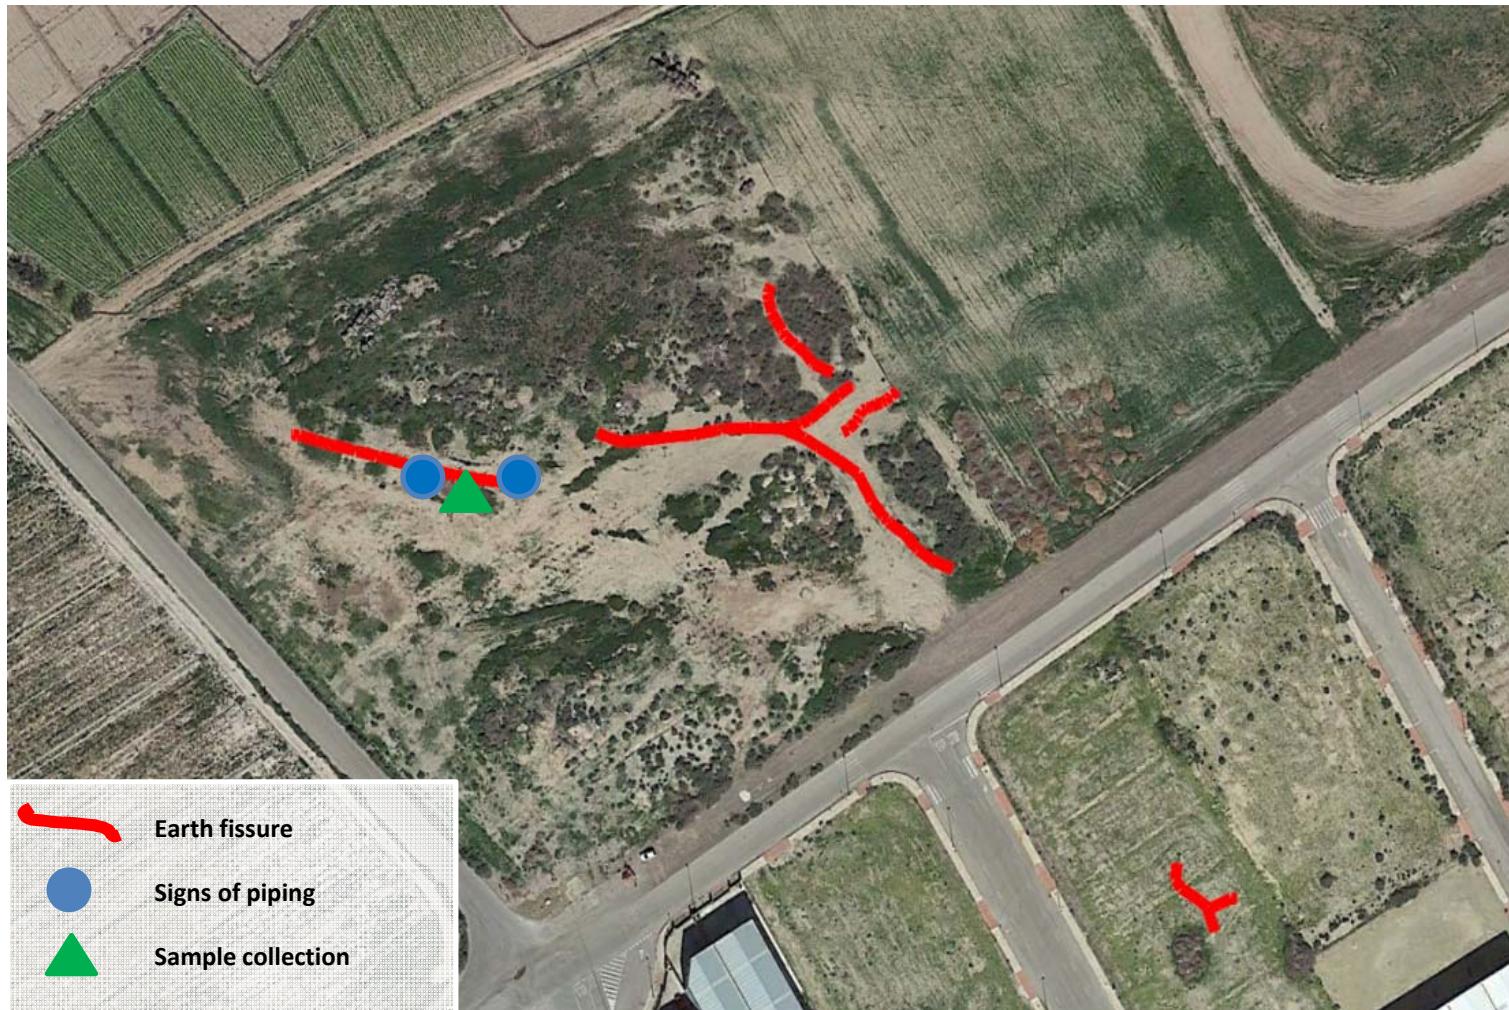
- About 200 m long earth fissure appeared

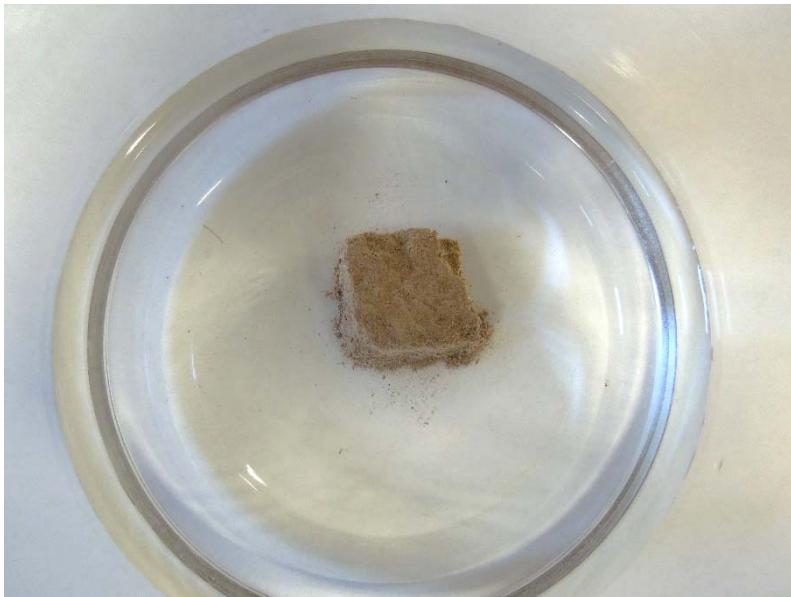
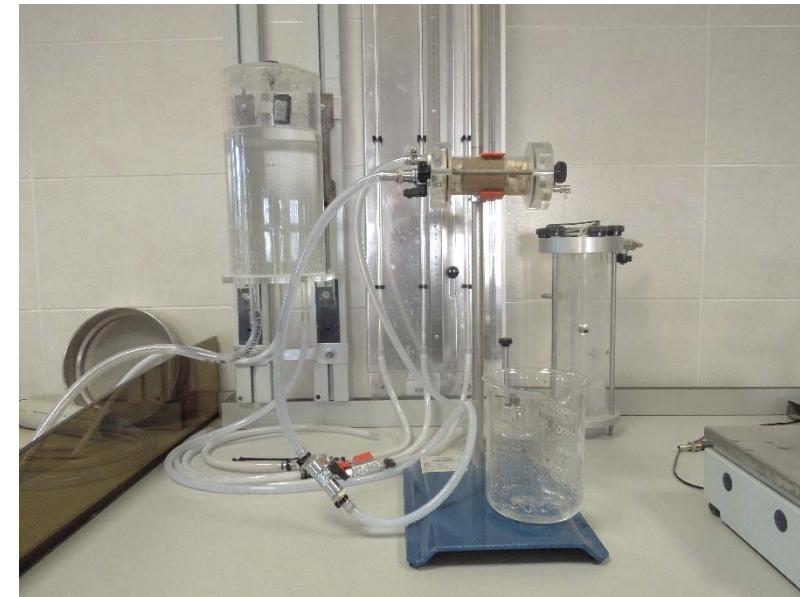
- 1 soil sample collected
- Silt 53%, clay 22%, sand 25%)
- LL = 31.8 PI= 8.3
- ML according to USCS
- Non dispersive (Crumb, D.H. and Pinhole test)
