Geometrical and geotechnical characterization of the earth fissures appeared in the Guadalentín Valley (southeastern Spain) after the September 2012 flooding

Abstract. Two earth fissures appeared in Murcia province (southeastern Spain) after the flood occurred because of a heavy downpour on 28 September 2012. In this area, located within the Guadalentín Valley, up to 212 L m^{-2} was reported that day. More than 200 agricultural exploitations were destroyed by the flooding, with a devastating effect on many infrastructures, such as a main A-7 highway bridge that collapsed in this event. The earth fissures appeared after this flooding in the towns of Puerto Lumbreras and Totana. The first fissure showed a straight-line direction approximately parallel to the main geological structures of the Guadalentín Valley. The total length of the fissure was 400 m and was 2 to 3 m in depth. The soil in the fissure is classified as a low-plasticity silt with some sand and clay, ML, according to the Unified Soil Classification System. From the sieve and hydrometer tests, the percentage of silt in these samples was between 48 % and 68 %, the clay content between 12 % and 30 % and the sand content

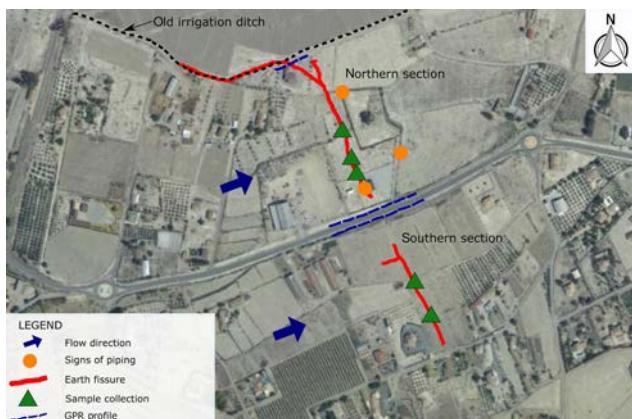
Figure 1. Location of the Puerto Lumbres earth fissure and the locations of signs of piping and sample collection (modified from Mulas, 2013). Orthophoto from PNOA 2019 CC-BY scne.es.

The mapping of the Puerto Lumbres earth fissure is shown in Fig. 1, modified from Mulas (2013). This figure shows the distribution of the fissure that appeared when waters receded on a very flat land. The main crack was about 400 m long and was perpendicular to the main flow of the flood, except for the northern section of the crack where it was nearly parallel to the flow. The crack presented a main NW–SE orientation (N150E) that changes to E–W in the northern section.

It is important to point out that the continuity of the earth fissure was disrupted by the road located at the center of the figure, which presents a lower elevation. The orange points in Fig. 1 indicate those locations in which signs of piping were recognized in the field (Fig. 2), and the green triangles indicate the locations from which soil samples were collected to be tested later in the laboratory.

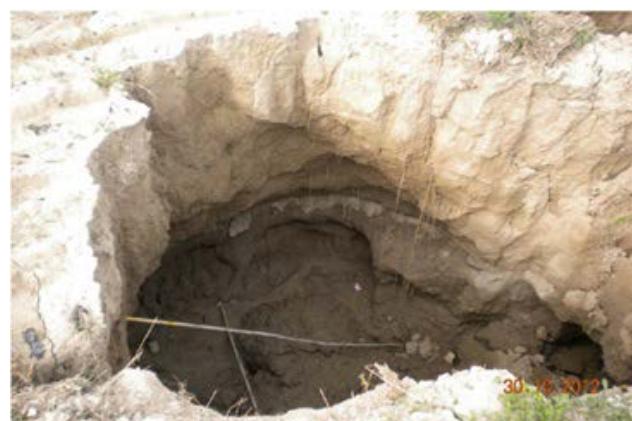
Figure 2. Signs of piping along the fissure. Soil erosion caused by water beneath the surface of the ground creating an underground tunnel.

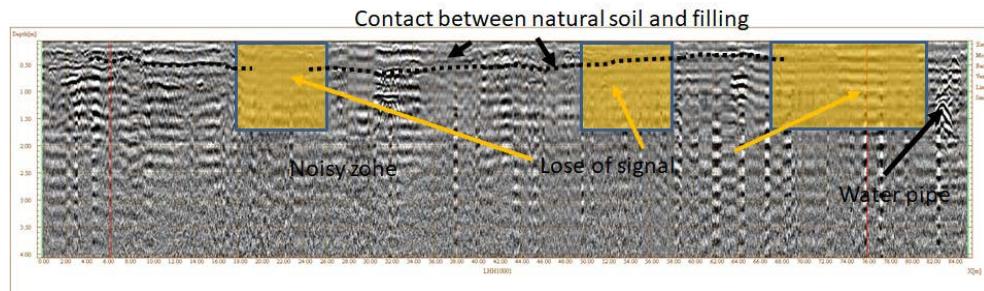
Figure 3. Ground-penetrating radar along the ditch beside the road.

During the field inspection, a damaged ditch was observed beside the aforementioned road after the flooding. This road was approximately parallel to the main flow of the flood and some erosion was clearly observed below the ditch.

A GPR was used along the ditch beside the road to analyze what was beneath the concrete (Fig. 3). The contact between the natural soil and the filling is observed in this figure. A water pipe was also detected, as well as some loss of signal that can be due to soil erosion. However, no good information was obtained below 1.5 to 2.0 m, probably due to the silty clay composition of the soil. Figure 4 shows an aerial view of the northern section of the crack and the runoff flow direction. Note how the fissure intersects and surrounds the building. Figure 5 shows the location in which the direction of the fissure changed from NE–SW to E–W. The aperture of the fissure can be seen in this figure. The fissure showed rough and vertical sides with a maximum depth of 3.7 m and a maximum aperture of 2.7 m.

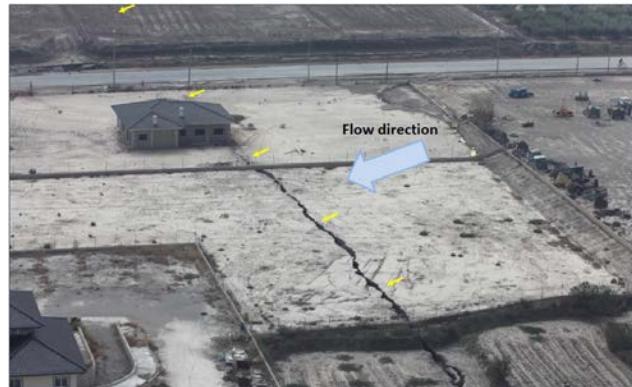
Figure 4. Aerial view of the northern section of the crack (courtesy of Puerto Lumbreras City Council). The yellow arrows indicate the location of the earth fissure (modified from Mulas, 2013).

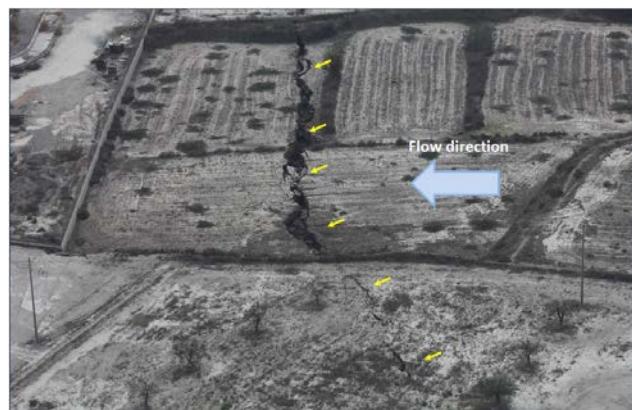
Figure 5. Aerial view of the third and second northern sections of the crack (courtesy of Puerto Lumbreras City Council). The yellow arrows indicate the location of the earth fissure (modified from Mulas, 2013).

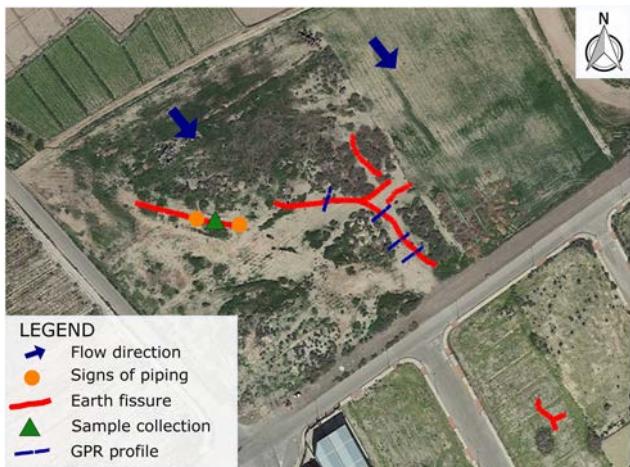
Figure 6. Location of the Totana earth fissure and the locations of signs of piping and sample collection. Orthophoto from PNOA 2019 CC-BY scne.es.

Regarding the Totana earth fissure, the location and distribution of the fissure observed when water receded can be seen in Fig. 6. Figure 7 shows a view of the fissured that appeared in Totana. The fissure appeared on a flat land and was discontinuous and ramified. Both soils, in Totana and Puerto Lumbreras, have a similar origin and a distal alluvial fan, although the age of the soils in Totana is older than in Puerto Lumbreras, Late or Upper Pleistocene (more than 10 000 years ago) in Totana and Holocene (less than 10 000 years ago) in Puerto Lumbreras. Some signs of piping were also observed in this fissure and one sample was collected at the site to test it later in the laboratory. The results of the tests show sand, silt and clay of 25 %, 53 % and 22 %, respectively. The liquid limit was 31.8 and the plasticity index 8.3. Therefore, the soil was classified as a low-plasticity silt (ML) according to the USCS. The results to assess the soil dispersion (crumb, double hydrometer and pinhole tests) showed a non-dispersive soil.

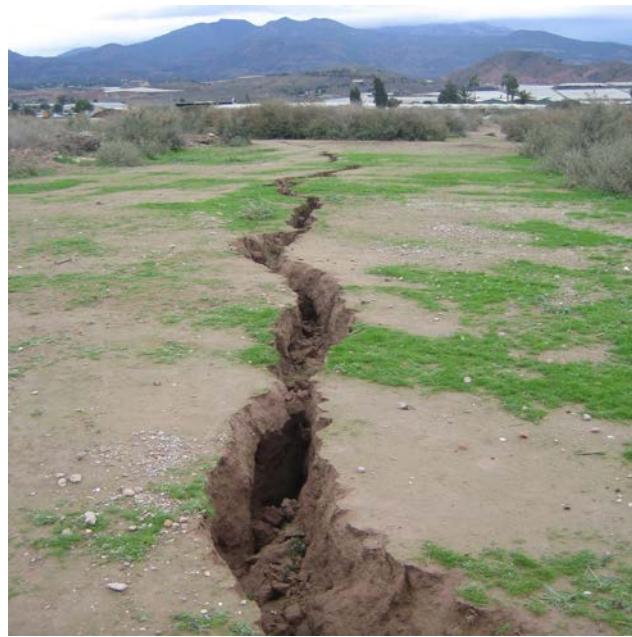
Figure 7. Image of the fissure that appeared in Totana.

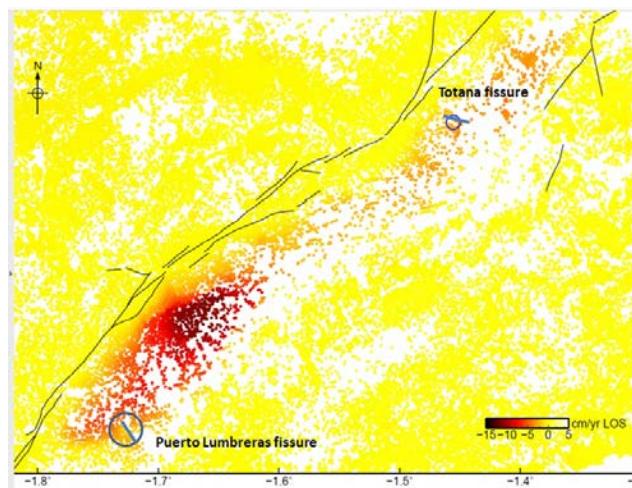
Figure 8. Locations of both fissures on the SAR interferometry deformation map of the Guadalentín Valley from Envisat 2003–2010. Continuous black lines represent surficial faults.

an Envisat dataset covering the period 2003–2010, where the location and main direction of the fissures have been drawn. As can be seen, both fissures are located near the edge of the subsidence bowl. It is worth pointing out that this valley presents the highest subsidence rate due to groundwater extraction in Europe, with accumulated settlements up to 2.5 m from 1992 to 2012 (Boní et al., 2015).

The direction of one of the main geological structures of the Guadalentín Valley can be seen in Fig. 8. The other main direction is perpendicular to the first one (Cerón, 1997). Therefore, the directions of both fissures are approximately

parallel to one of the directions of these main geological structures or faults in this area.
