# Triggering of ground subsidence related fault motion in Mexico City by the Mw8.2 Chiapas and the Mw7.1 Puebla, September 2017 earthquakes.

D. Solano-Rojas<sup>1</sup>, E. Havazli<sup>1</sup>, E. Cabral-Cano<sup>2</sup>, S. Wdowinski<sup>3</sup>

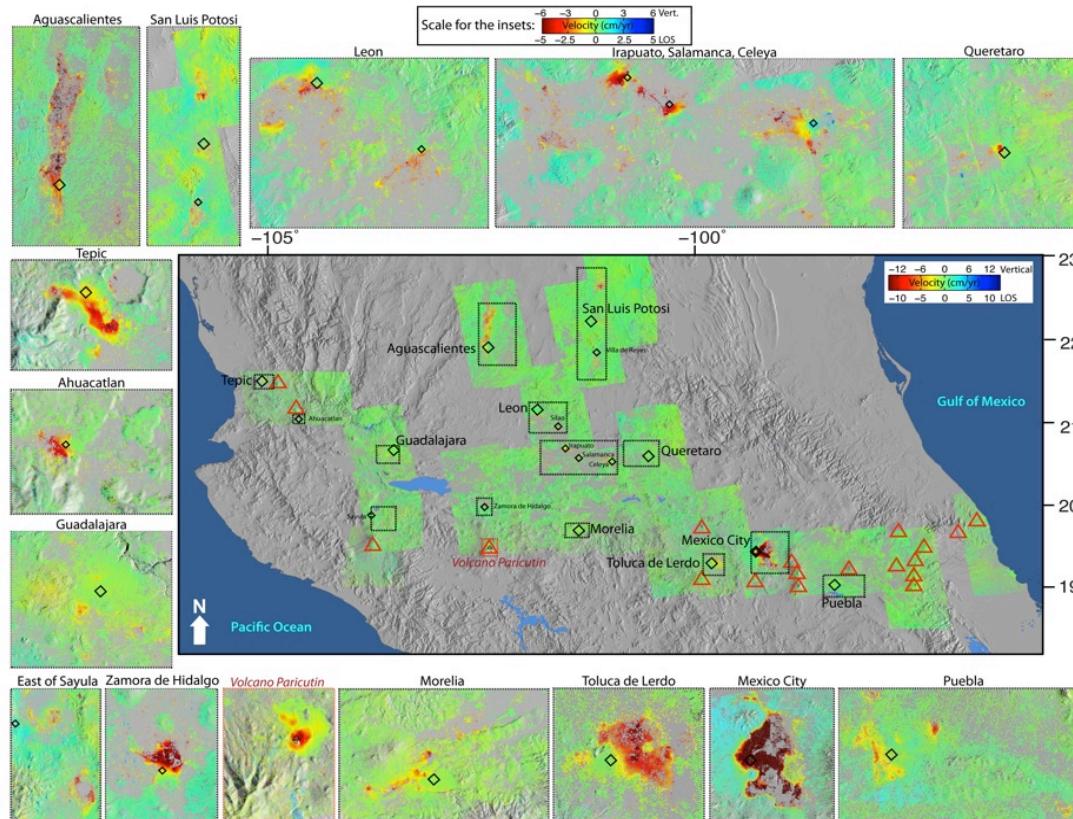
Chaussard et al., 2014

# 15 cities in central Mexico undergo rapid subsidence

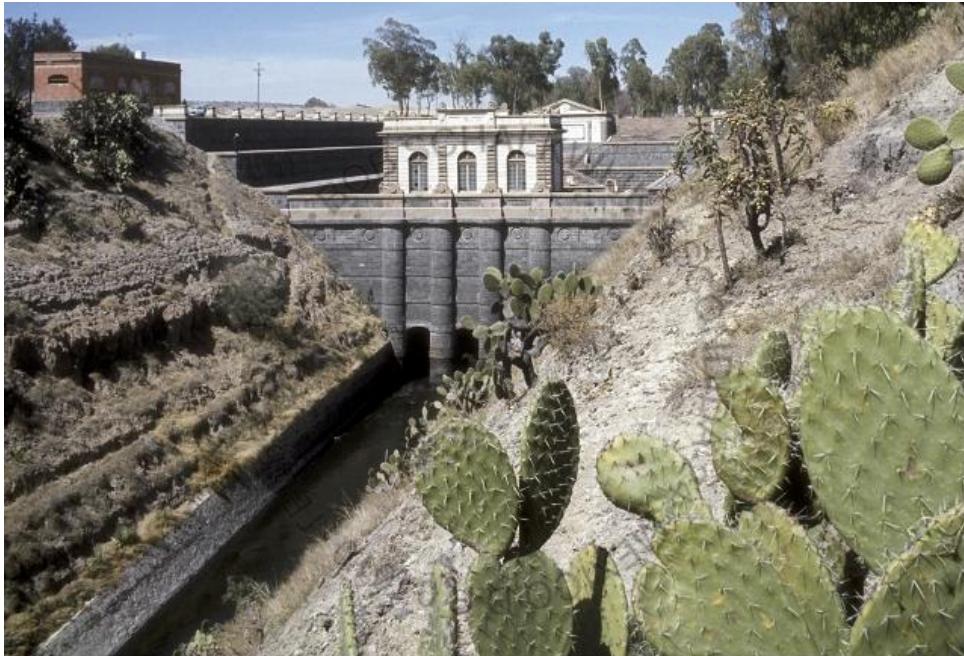
### **Nochistongo Canal**

Artificially opened the basin and took over 100 yrs. to finish

Started operations	1788
Initial design	90 m <sup>3</sup> /s
Current capacity	40 m <sup>3</sup> /s

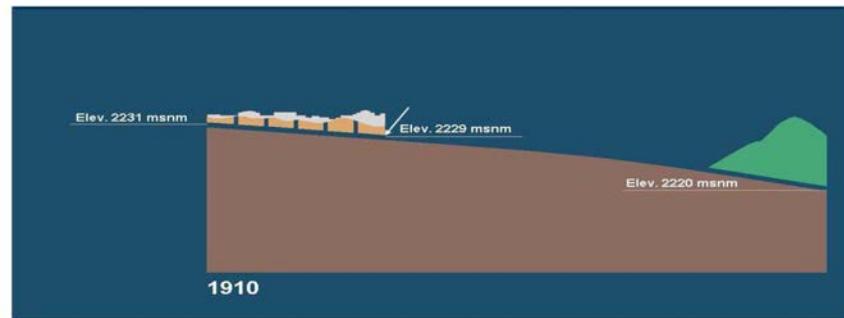
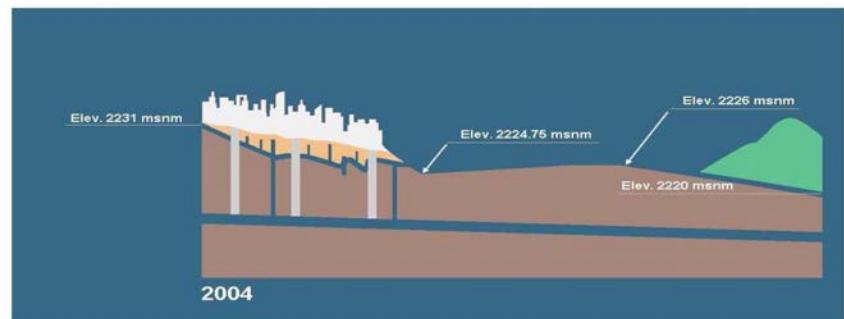
## Grand Canal

Started operations	1910
Initial design	80 m <sup>3</sup> /s
Current capacity	15 m <sup>3</sup> /s

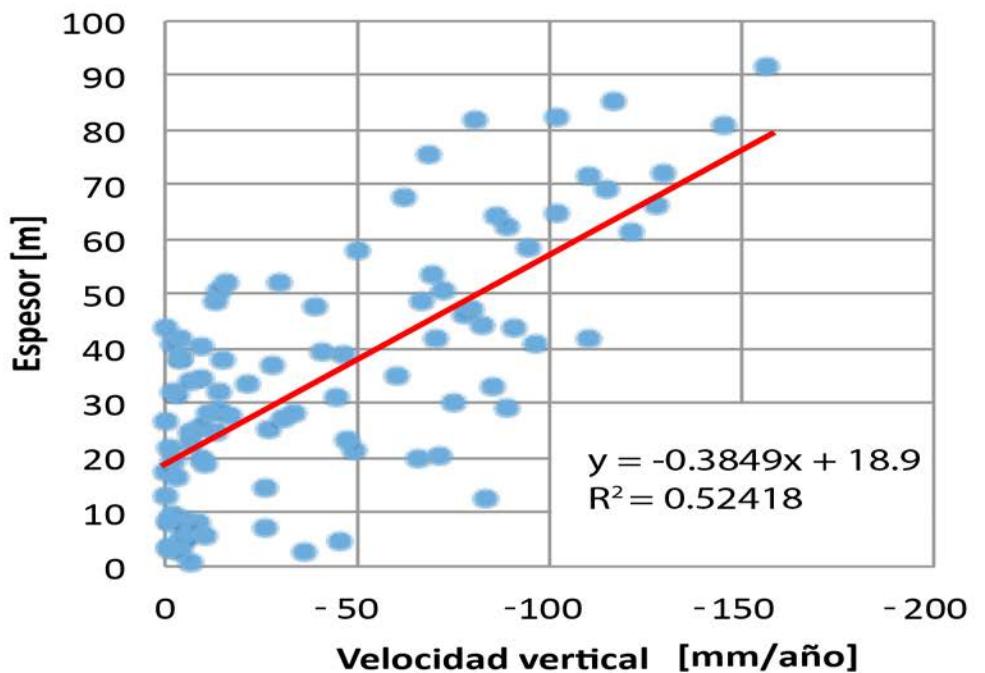
*Solano-Rojas et. al. 2015.*

In high subsiding areas, water well static level drawdown is well correlated to the aquifer thickness.

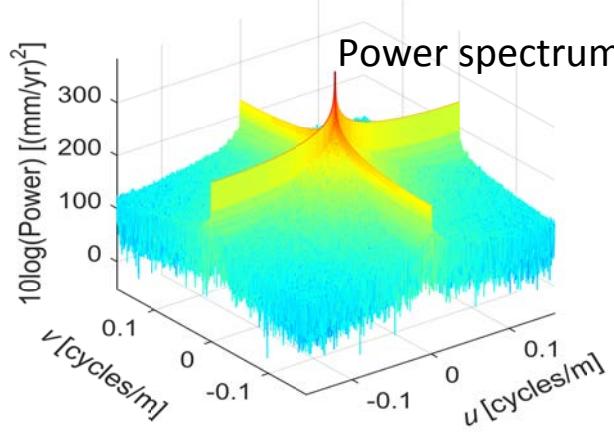
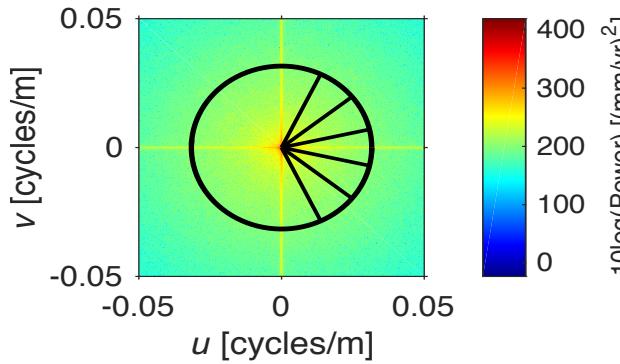
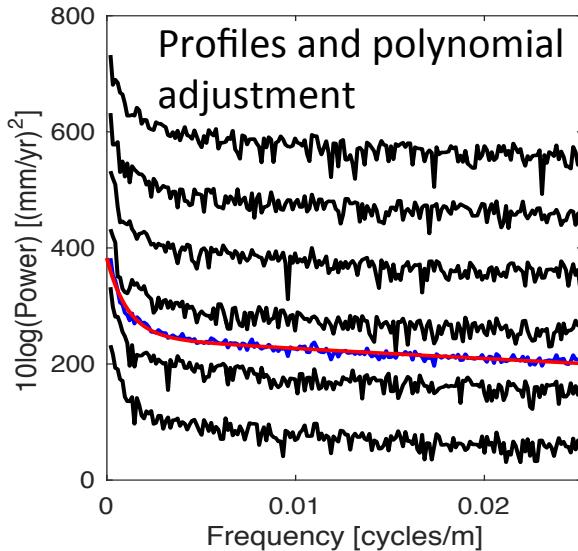
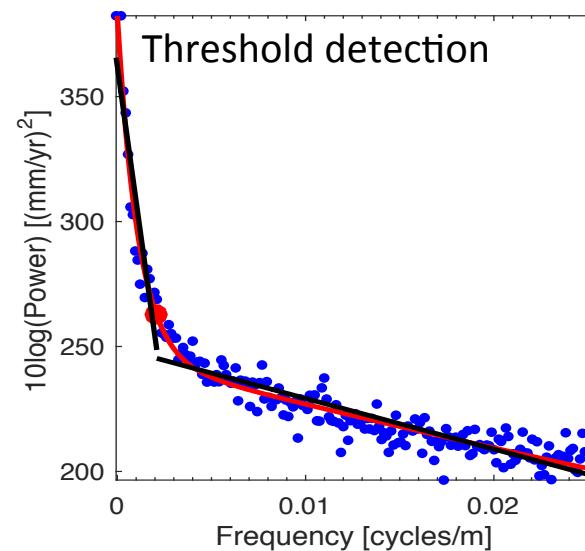
Analysis of spatial frequencies of the subsidence signal

Definition of wavelength thresholds that best describe the velocity subsidence.

This spatial frequency FFT filtering technique is capable of detecting new, subtle details that correspond to faults and anomalous structural behaviour (apparent emersion).

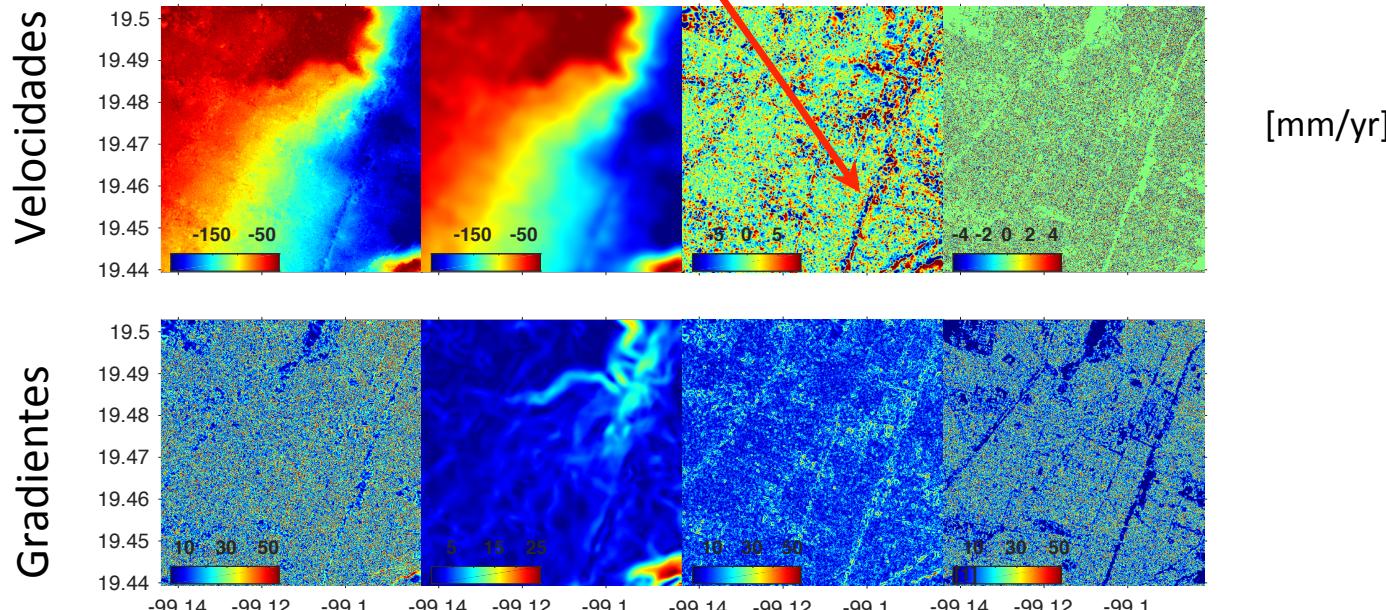
Detection of apparent emerion of large structures, such as large sewage works, overpasses and Metro lines

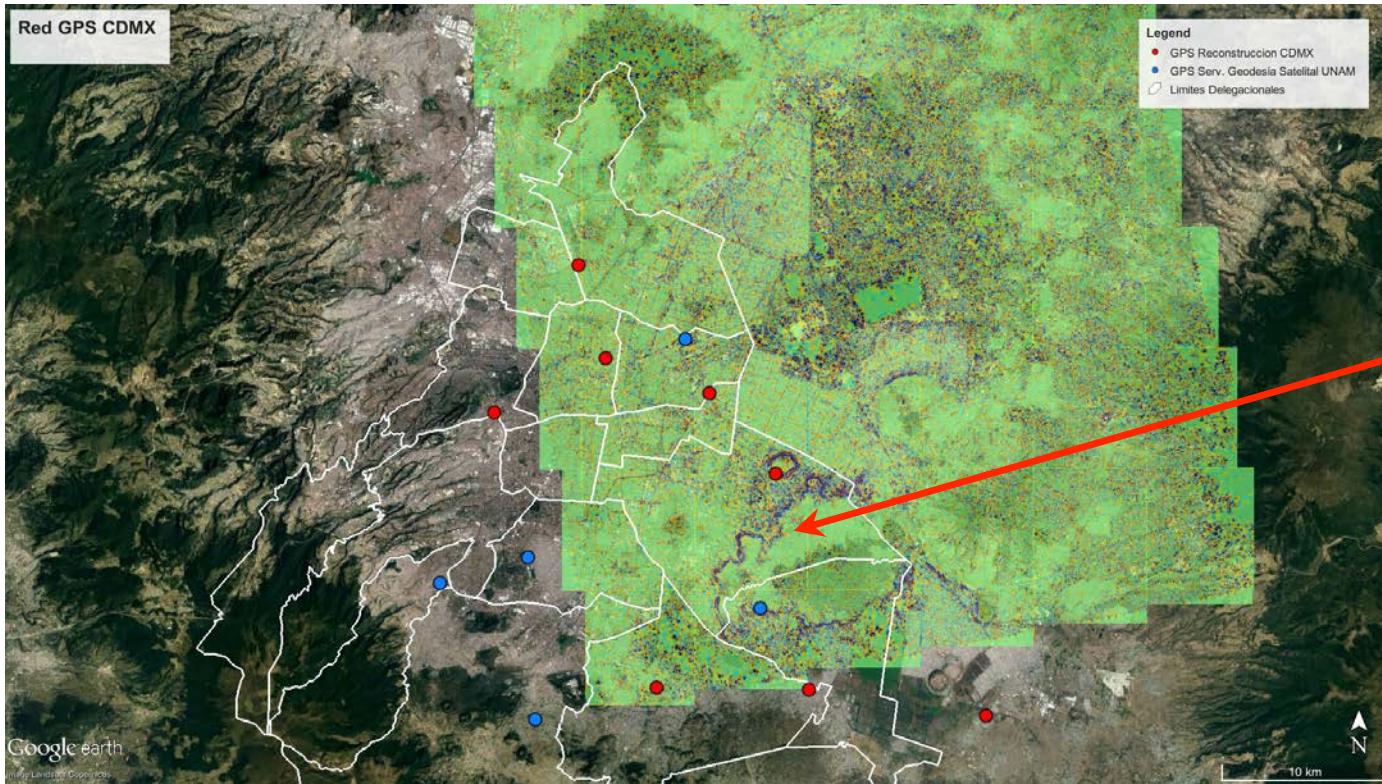
Detection of  
faults in the N,  
W and S slopes  
of Sierra Santa  
Catarina

High fault density areas using this technique can be used to update and refine construction code and land use zoning.

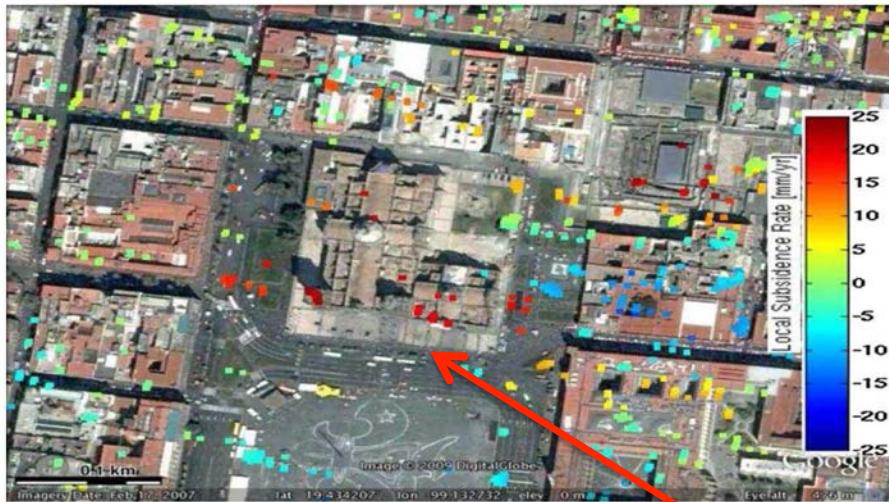
*Osmanoglu et al., 2011*

Large structures undergo apparent emersion if its foundations are overcompensated.

They can be old colonial-era structures that have been reinforced with modern foundations such as the National Cathedral in Historic downtown, Mexico City

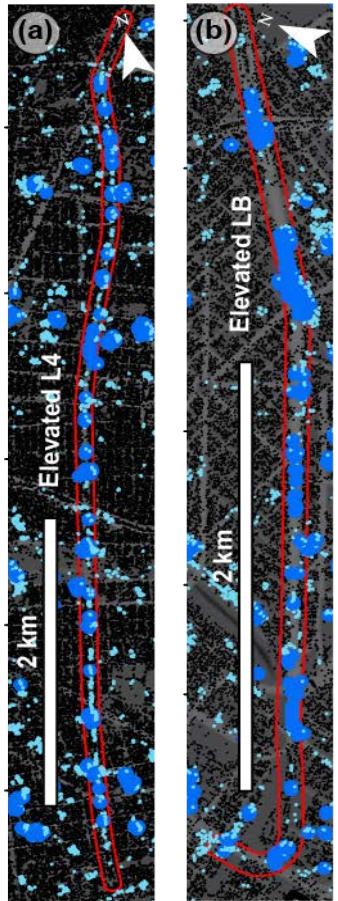
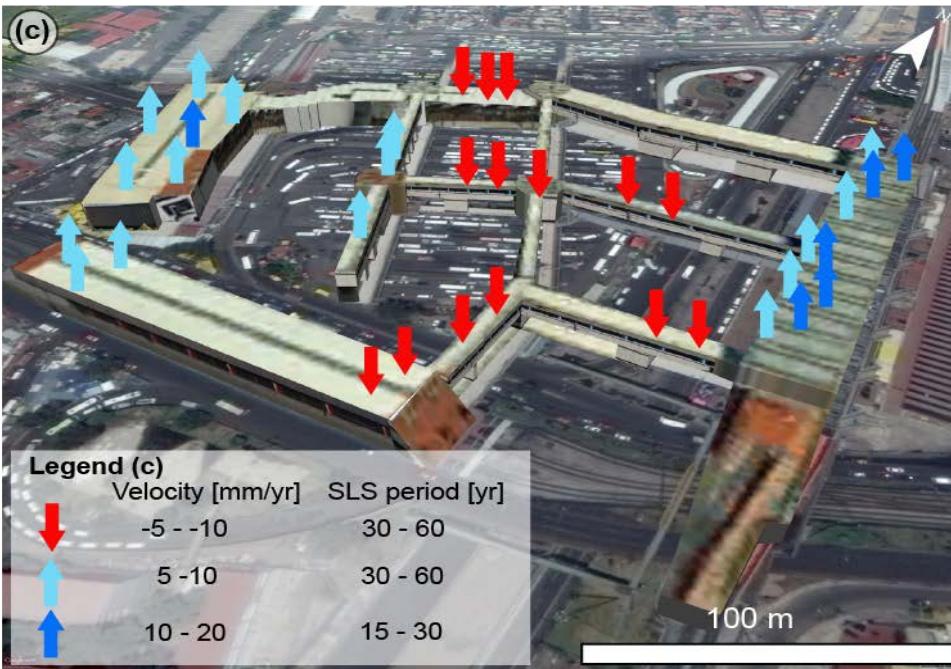
Modern structures such as Metro Lines 4, B and the Pantitlán station show apparent emersion

A Limit State estimation of the structure incicates reduction to  $\frac{1}{2}$  or  $\frac{1}{4}$  of its serviceability life span.

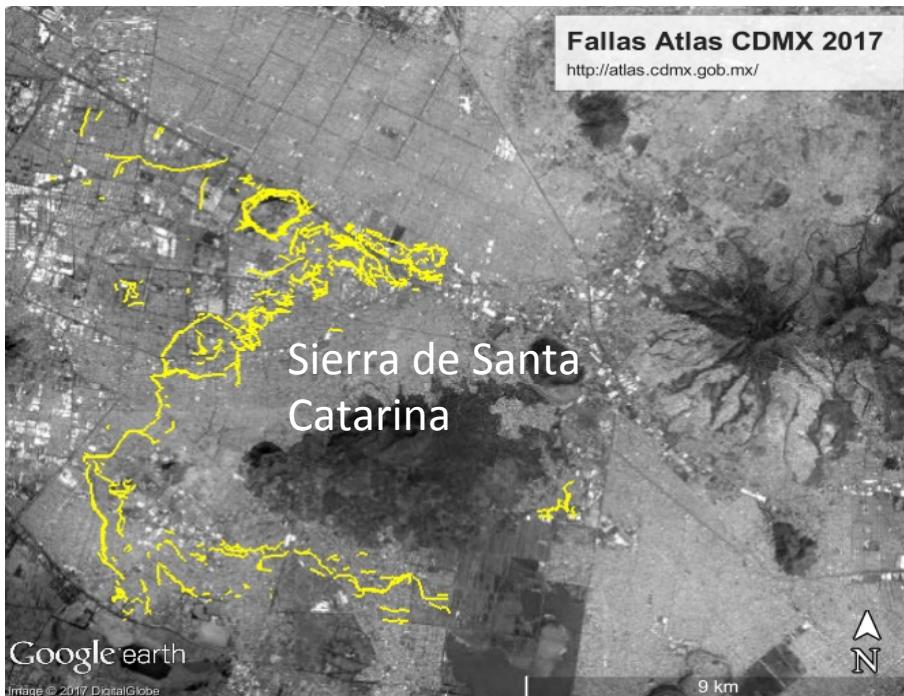
Field mapped faults (Atlas CDMX, 2017)

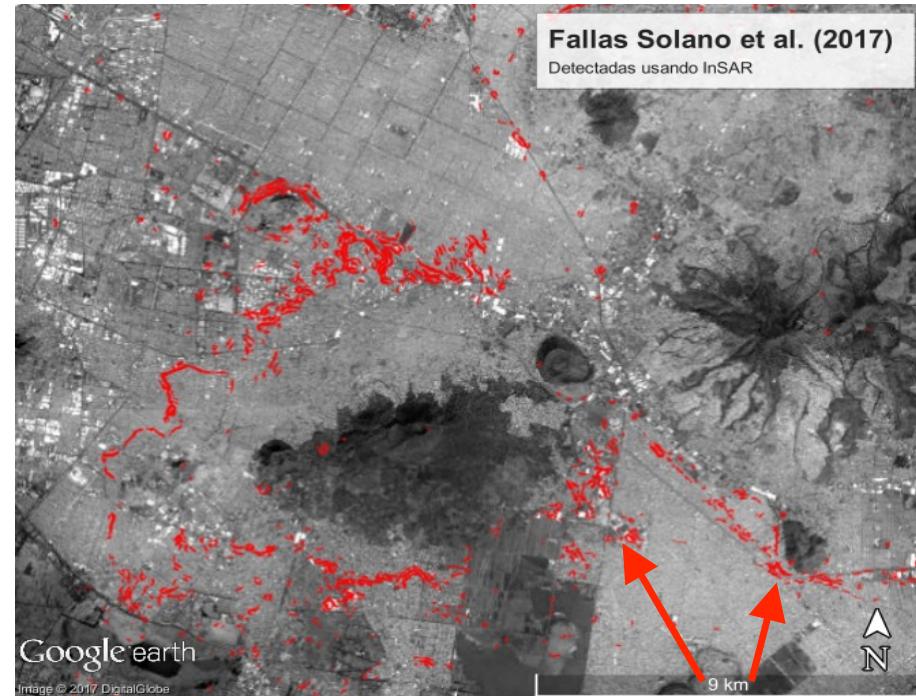
Fault detection using a spatial frequency filtering FFT technique

This same method has proven very effective to detect subsidence-related faults

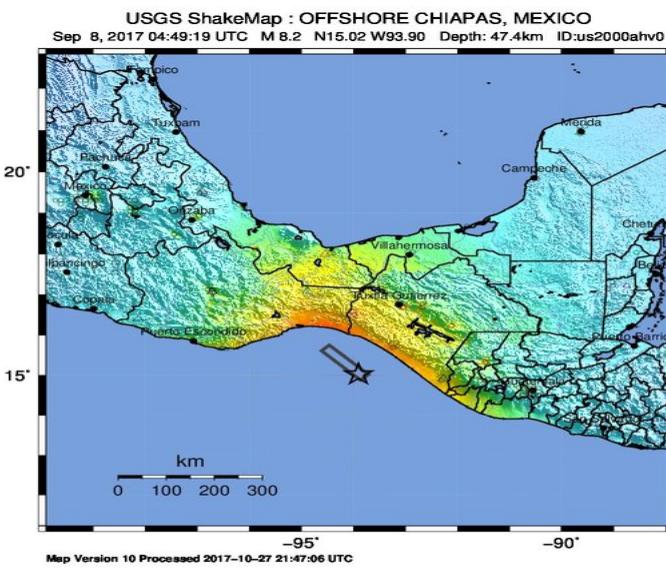
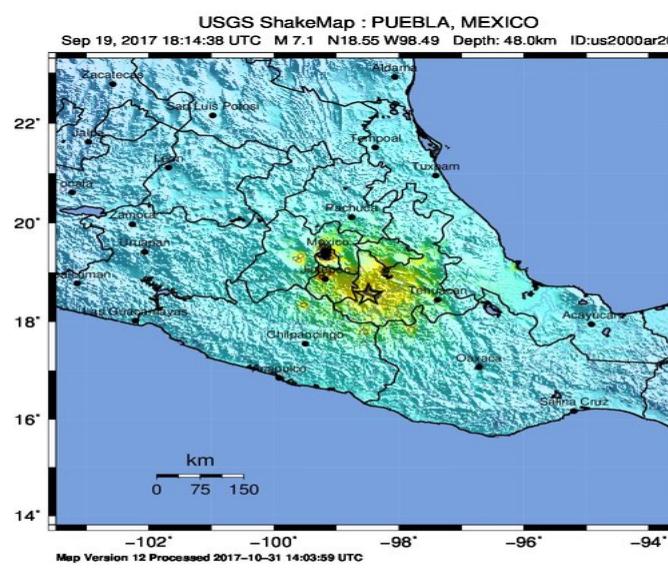
Shake Maps from September 7 and 19, 2017 earthquakes in Mexico. USGS

Mexico City recently experienced two large earthquakes only 11 days apart: the Mw8.2 September 8<sup>th</sup>, 2017 with its epicenter offshore Chiapas, and the Mw7.1 September 19<sup>th</sup>, 2017 with its epicenter in Puebla.

The Mw8.2 earthquake was located over 700 km away from Mexico City and its effects in the city were not significant. However, the Mw7.1 earthquake occurred only ~100 km away and produced severe damages.

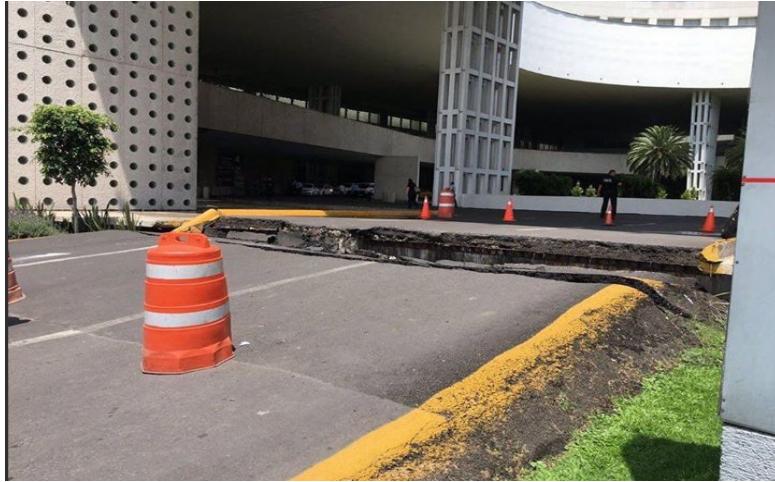
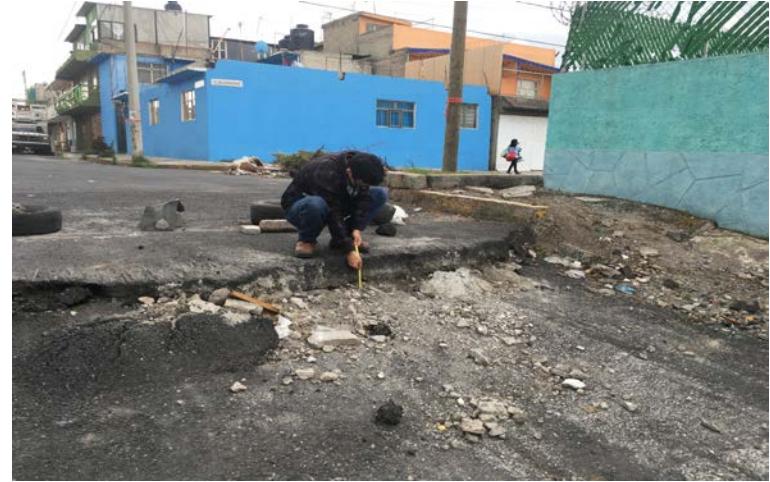
*T2 terminal, Mexico City International Airport*

Photos of coseismic faulting taken after the Sept 19, 2017 central Mexico earthquake.

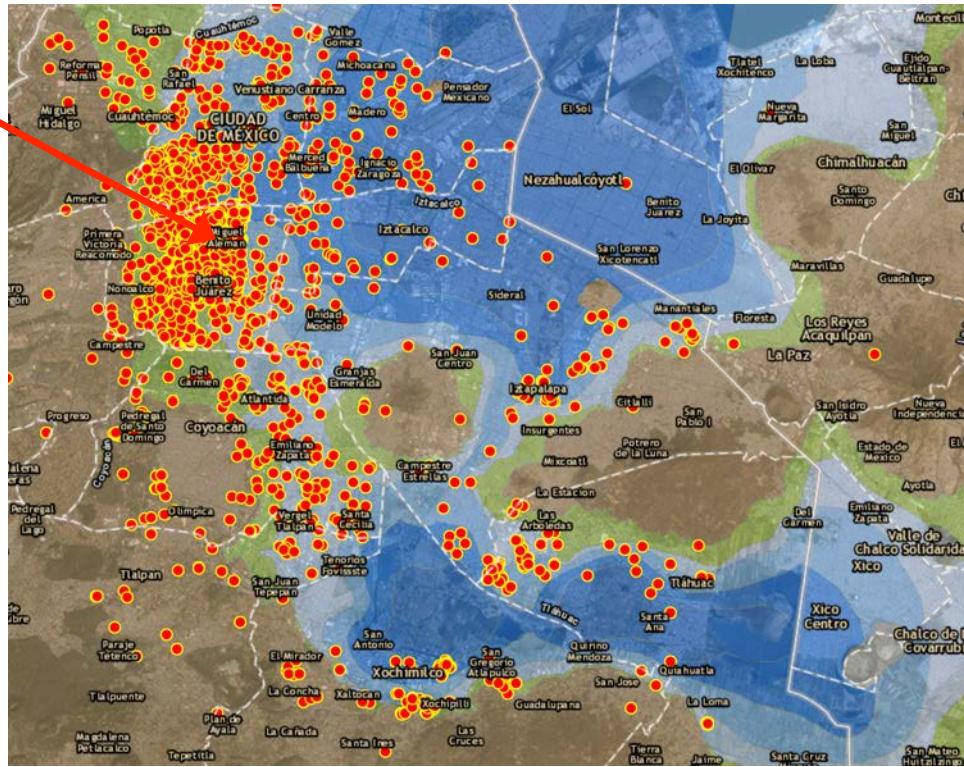
Greater seismic acceleration (site effect) affects buildings 6-10 floors high.  
This explains damage in the western sector of the city.

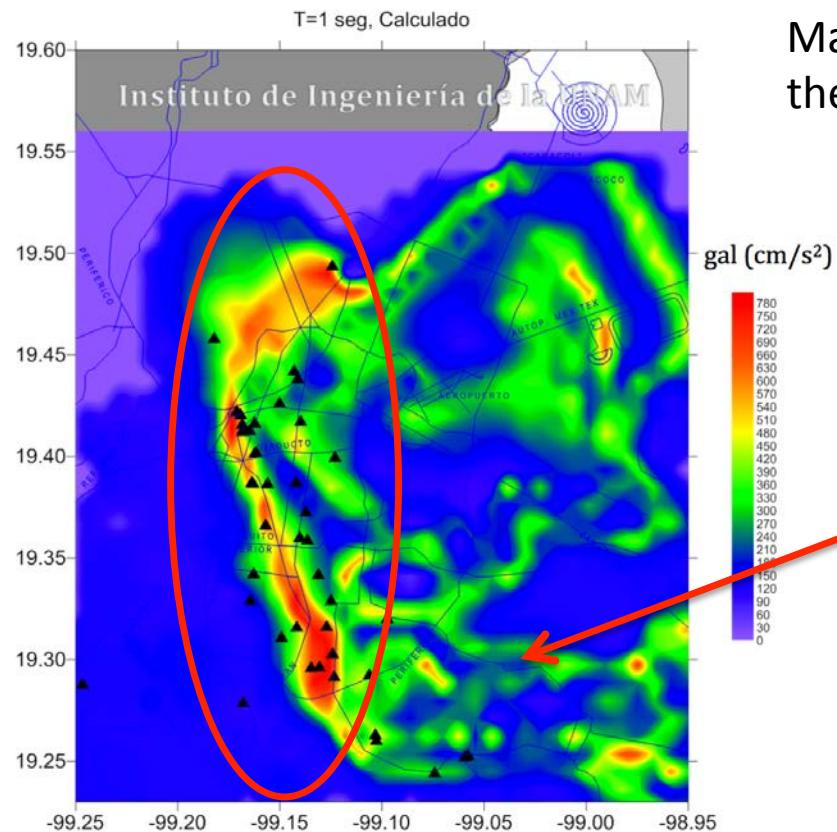
Maximum ground Acceleration during the Sept 19, 2017 earthquake.

But it doesn't explain much of the damage in the SE sector

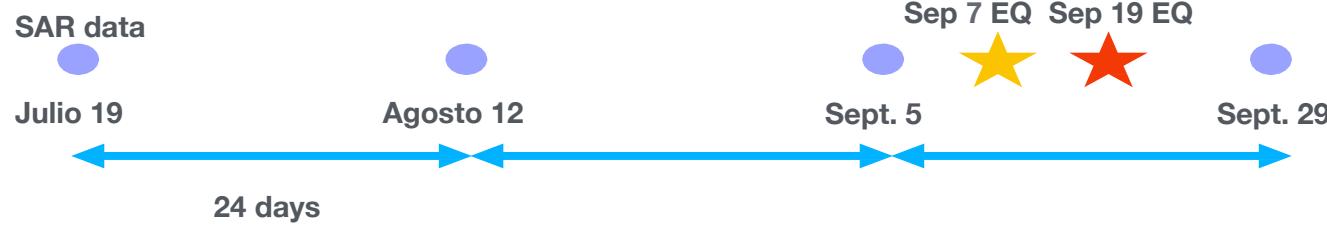
### Velocity Difference [Sept.5 - Sept.29]-[Aug.12 - Sept.5]

Unwrapping interferograms and subtracting the 24 day velocity field prior to the 2 earthquakes interferogram defines areas of subsidence acceleration due to the earthquakes

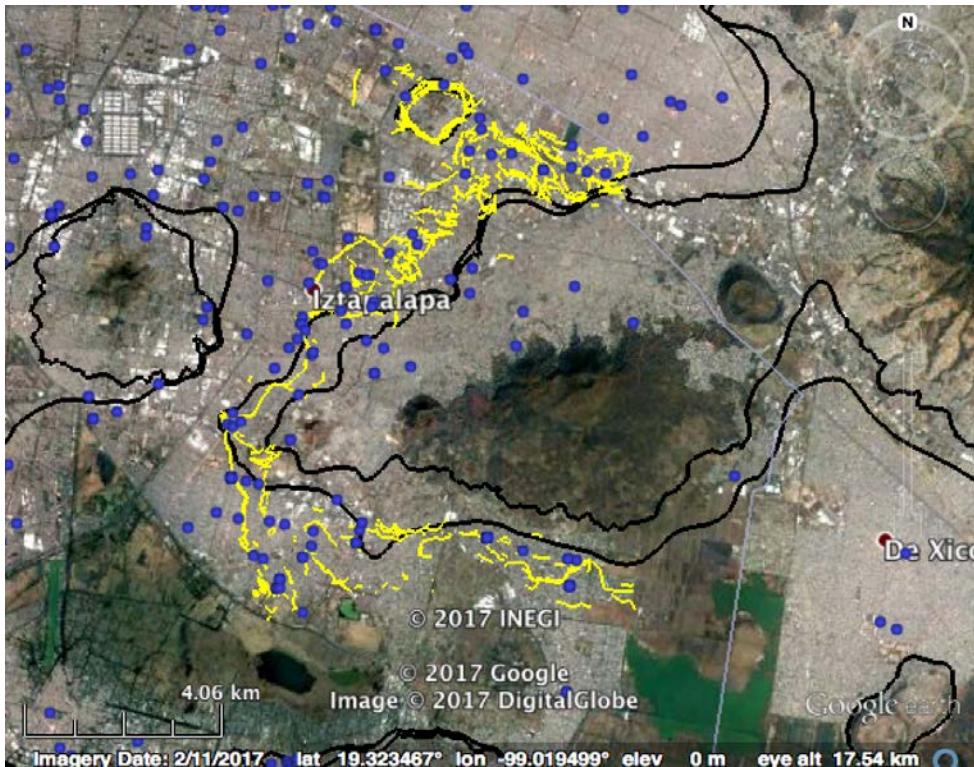
Reported structural damage (blue dots), and subsidence related faulting (yellow lines) coincide with these regions

A large portion of the reported damage in the southern sector of the city clearly correlates with the presence of pre-existent, subsidence-related faults that have been identified using spatial frequency FFT filtering (Solano-Rojas et. al, 2017).
