# Discovery of a large earth fissure in the Southern Picacho Basin, Pinal County, Arizona

Joseph P. Cook  
Arizona Geological Survey

**OPEN-FILE REPORT OFR-17-01**

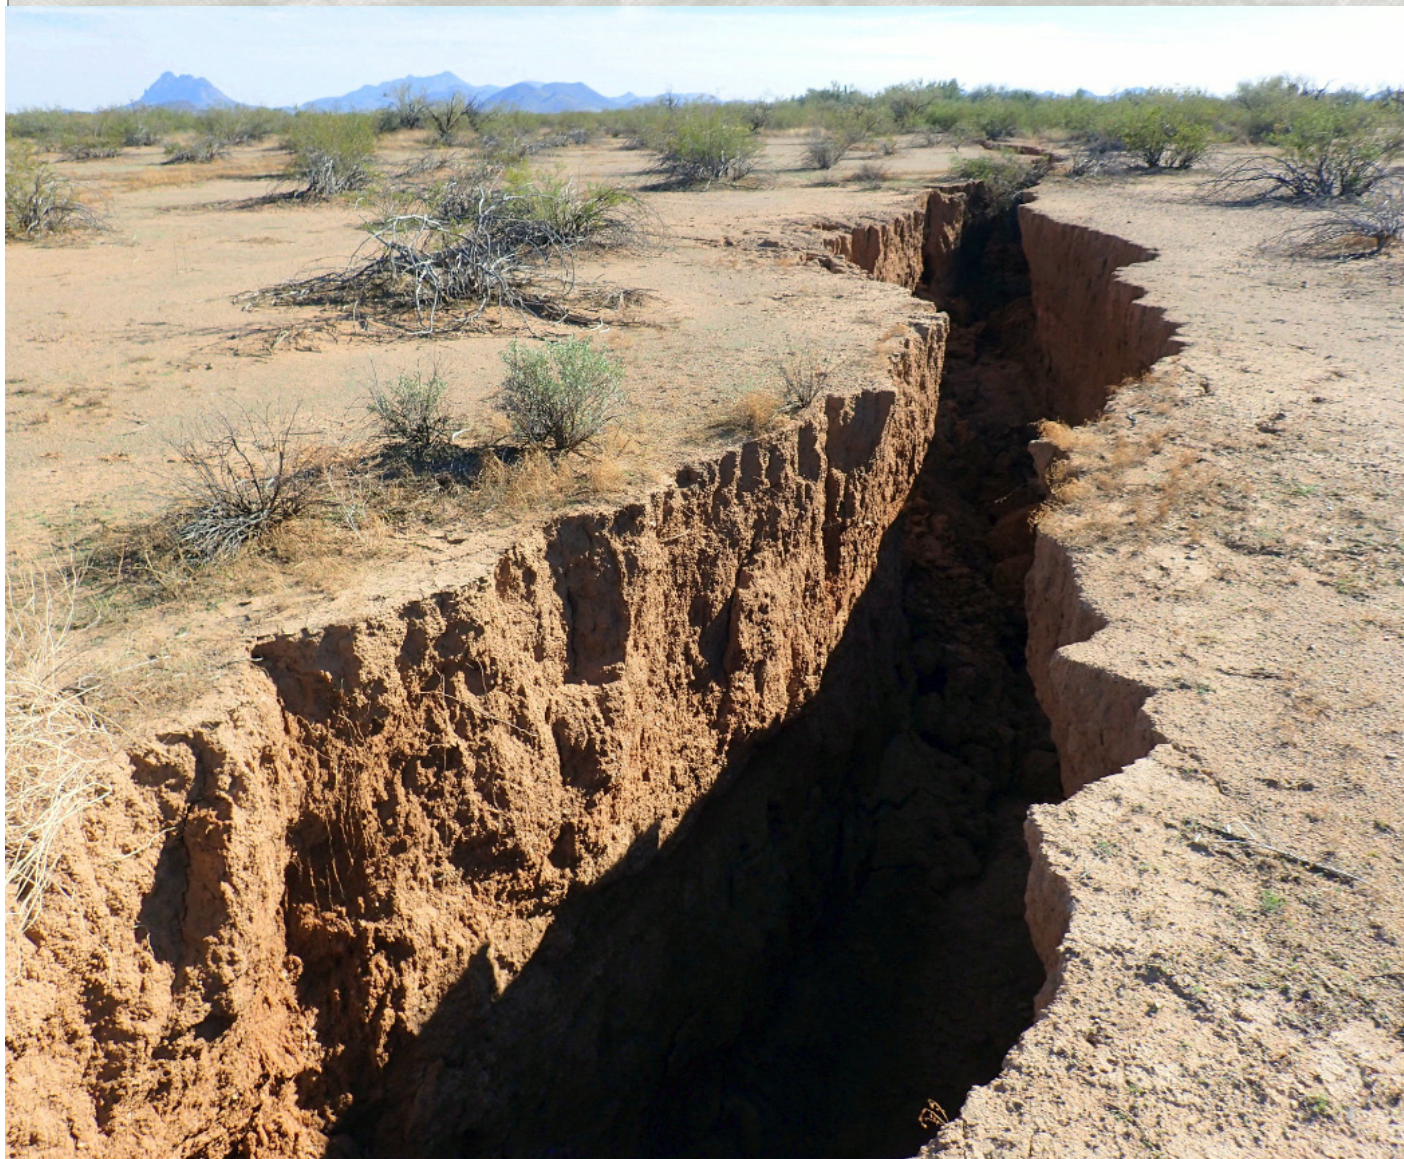
Fresh earth fissure exposed in southern Pinal County.

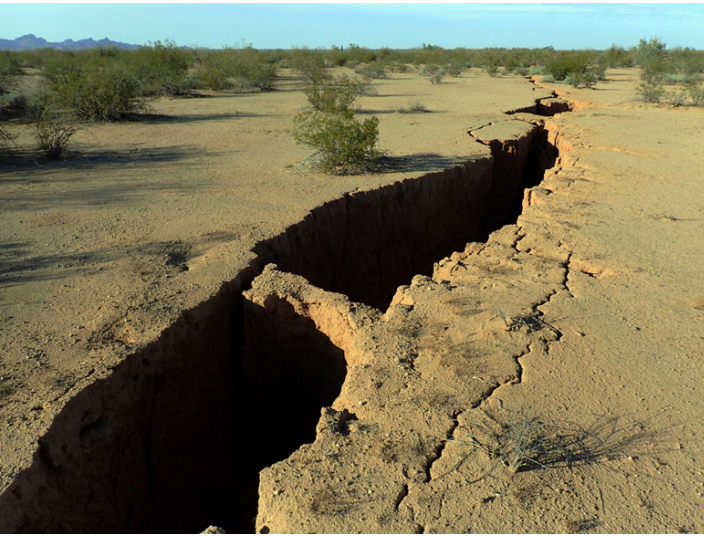
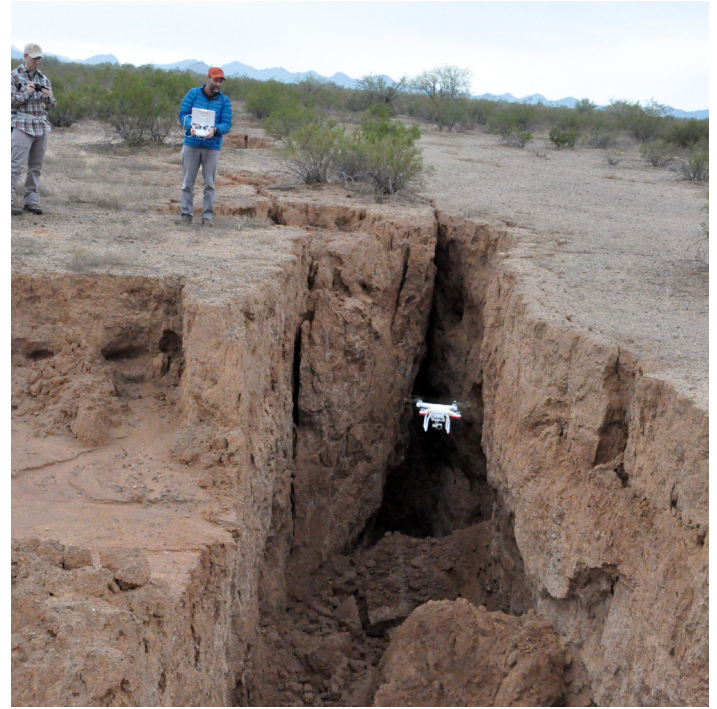
AZGS geologists employed drone/UAV technology to provide a more comprehensive aerial view of the new Tator Hills fissure. These photos and video are the only aerial photo documentation of the new fissure that we are aware of at this time. Low altitude aerial photos captured in this manner provide a better sense of scale for the fissure in the landscape than possible with ground-based photos. Overlapping aerial photo frames and structure-from-motion software were used to generate a digital elevation model of the fissure and surrounding area. Extensive erosion through headcutting on the upstream side of channels cut by the fissure is commonly observed following fissure formation (Figure 6b). Repeat drone flights and data collection can be used to compare landscape changes and calculate the volume of sediment entering the fissure from captured drainages. Changes along the northern mile of the fissure are already apparent when comparing December 2014 and March 2016 Google Earth imagery. High resolution handheld GPS points were collected along the length of the fissure and can be referred to in future visits by AZGS geologists to determine how much extension, if any, has occurred.

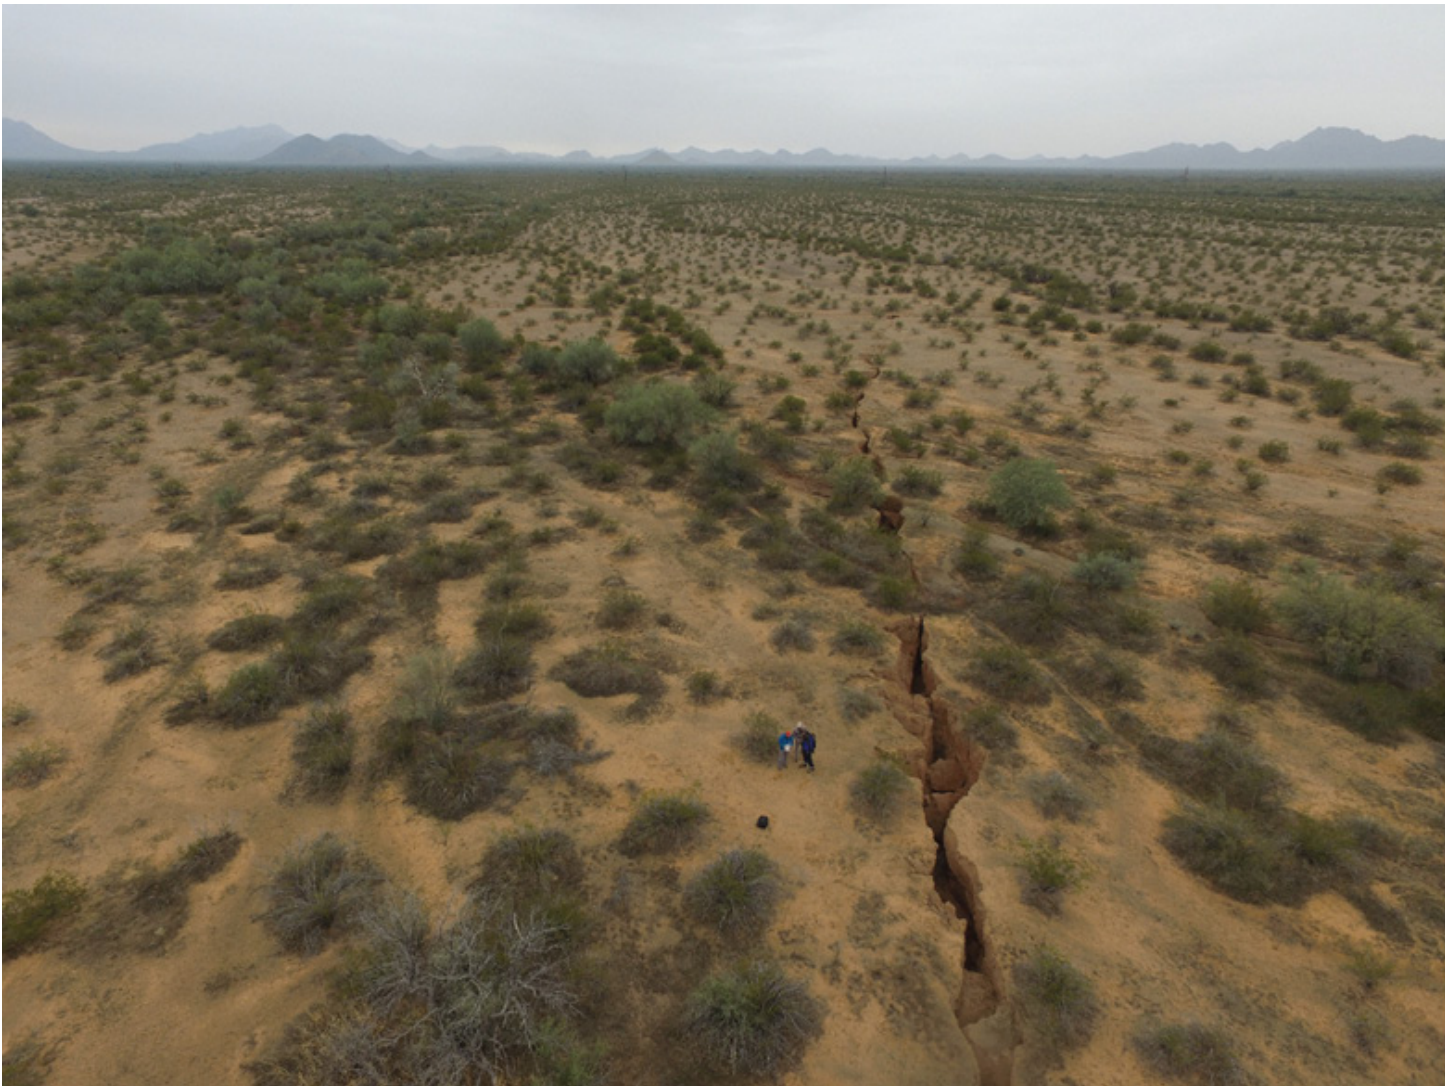
Figure 4. Low-altitude oblique aerial view of new Tator Hills fissure on January 19, 2017. View to the south with Silver Bell Mountains in the background. Photo captured by Brian Gootee via drone. AZGS and ADWR personnel for scale.

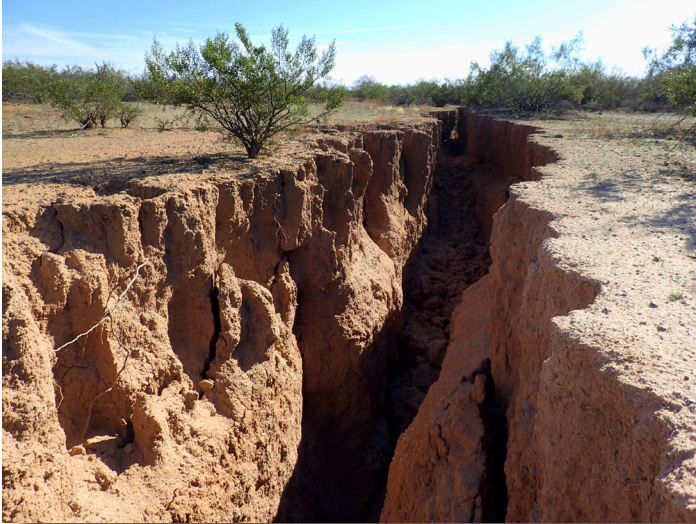
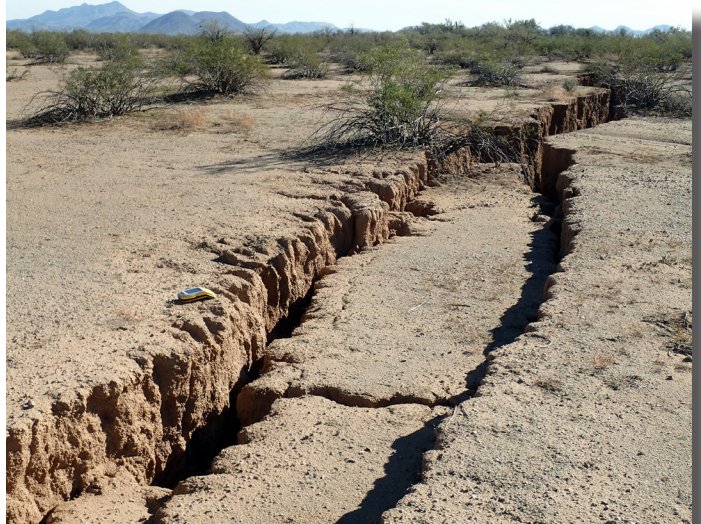
Deeply incised fissure segments near the southern terminus; to the right, central down-dropped block. Photos by Joe Cook.

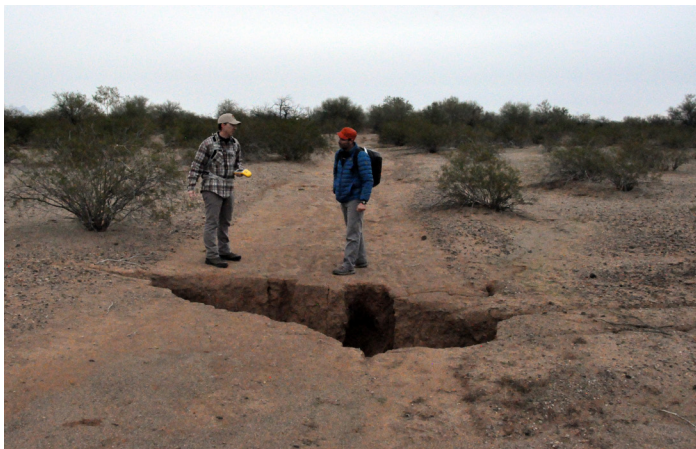
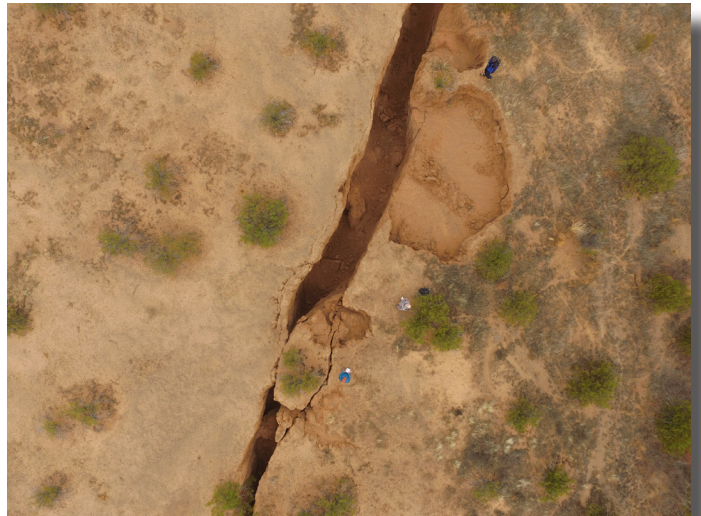
Drone images of the southern end of the earth fissure. Note people for scale in both photos. Left photo by Brian Conway, right photo by Brian Gootee.

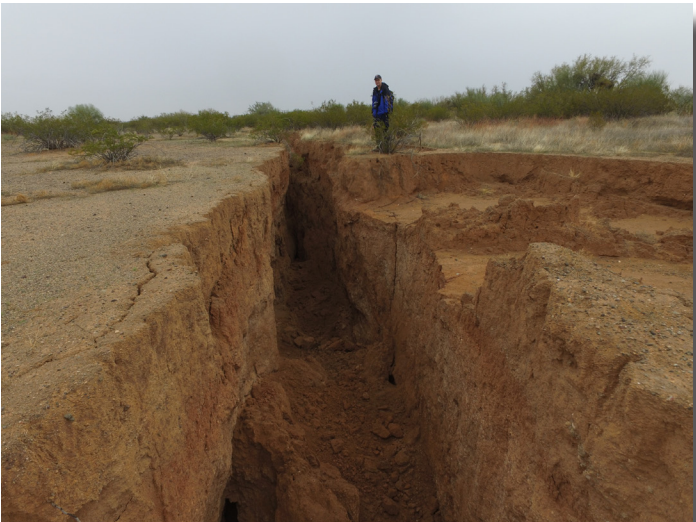
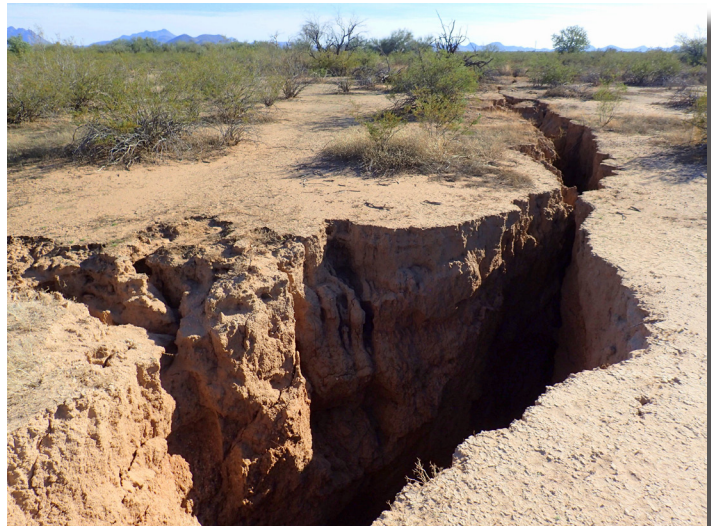
Drone photo with Brian Conway of AZ Dept. of Water Resources. Ground photo showing fissure scar - photo by Joe Cook.
