A NEW EARTH FISSURE
NEAR WINTERSBURG,
MARICOPA COUNTY, ARIZONA

Arizona Geological Survey
Open-File Report 01-10

Raymond C. Harris
Arizona Geological Survey

November 2001

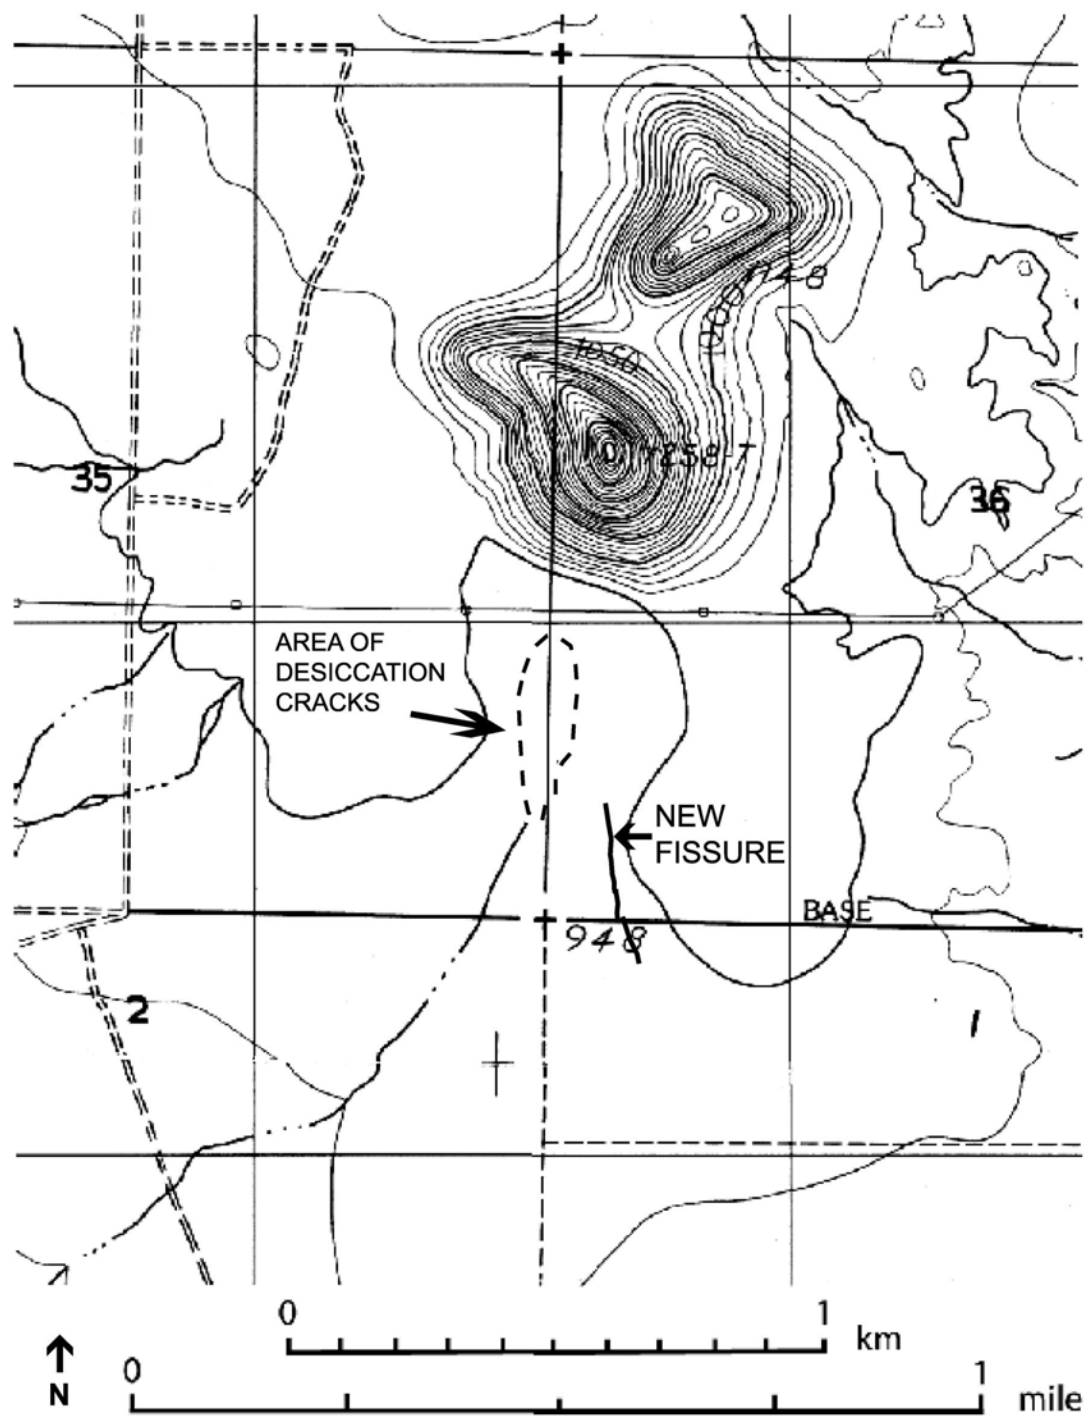
Figure 2. Topographic map showing location of new earth fissure and area of Desiccation cracks. Hill at top of map is 3 miles southeast of Wintersburg. (Base from Wintersburg and Arlington 7.5-minute quadrangles)

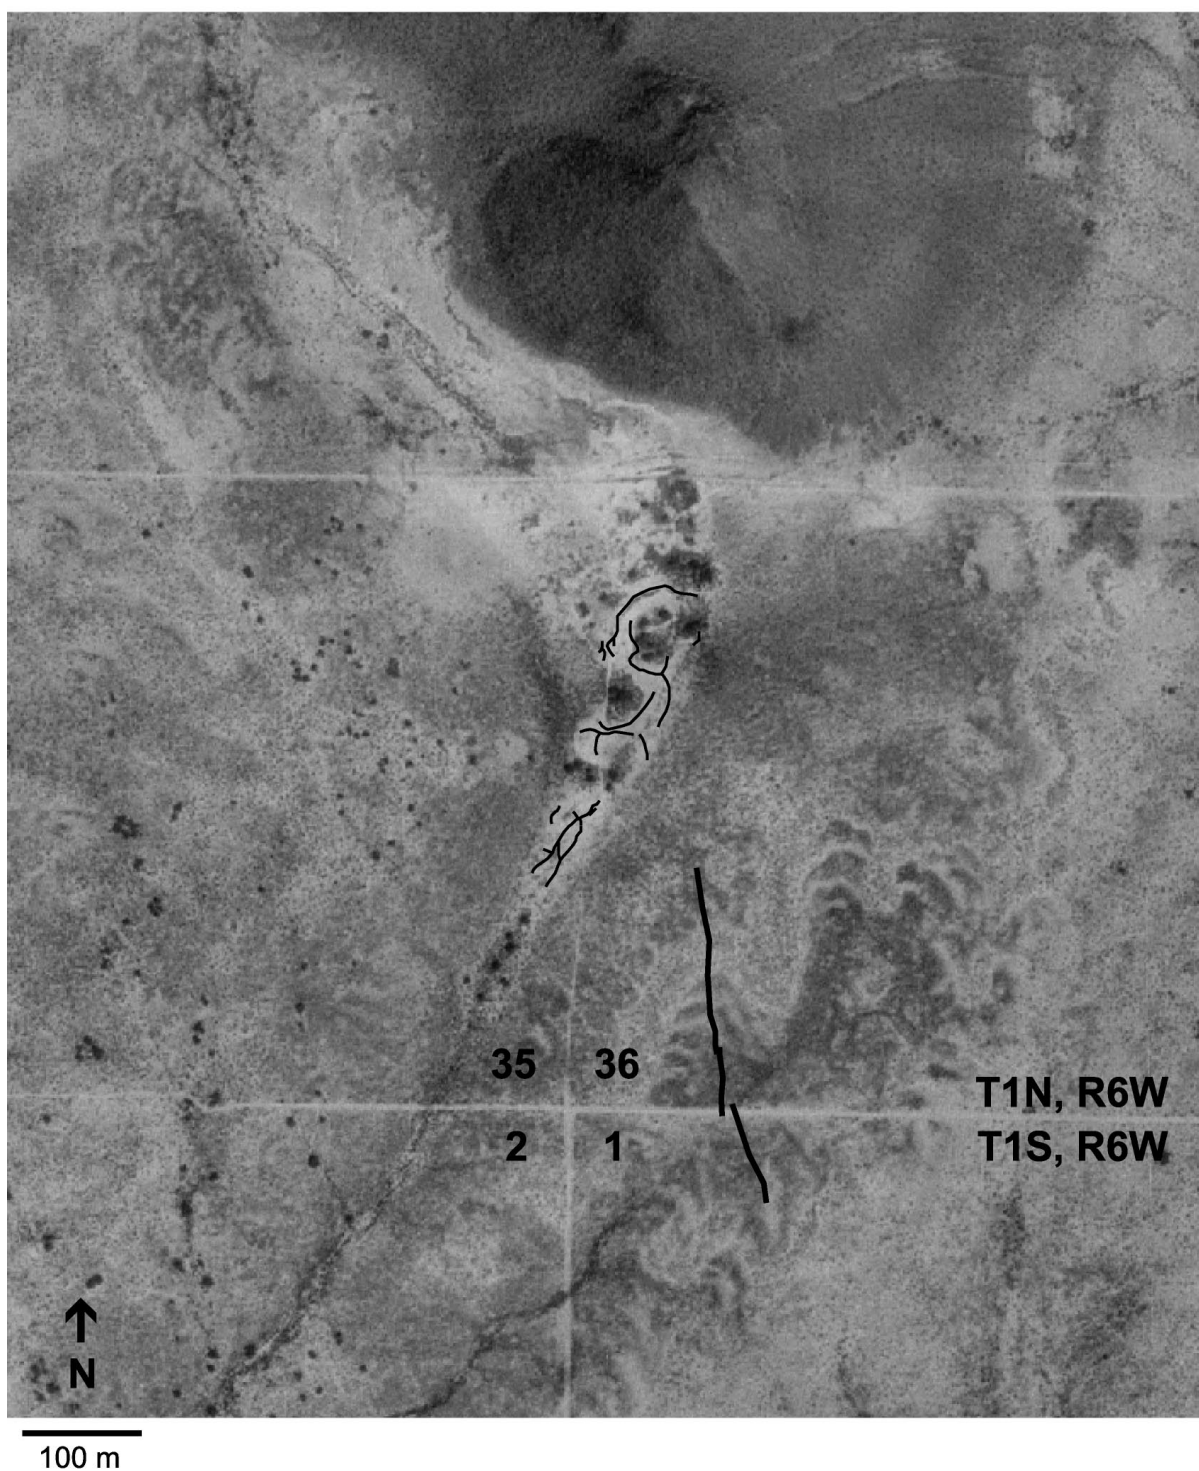
Figure 3. Aerial photo showing location of earth fissure and desiccation cracks.

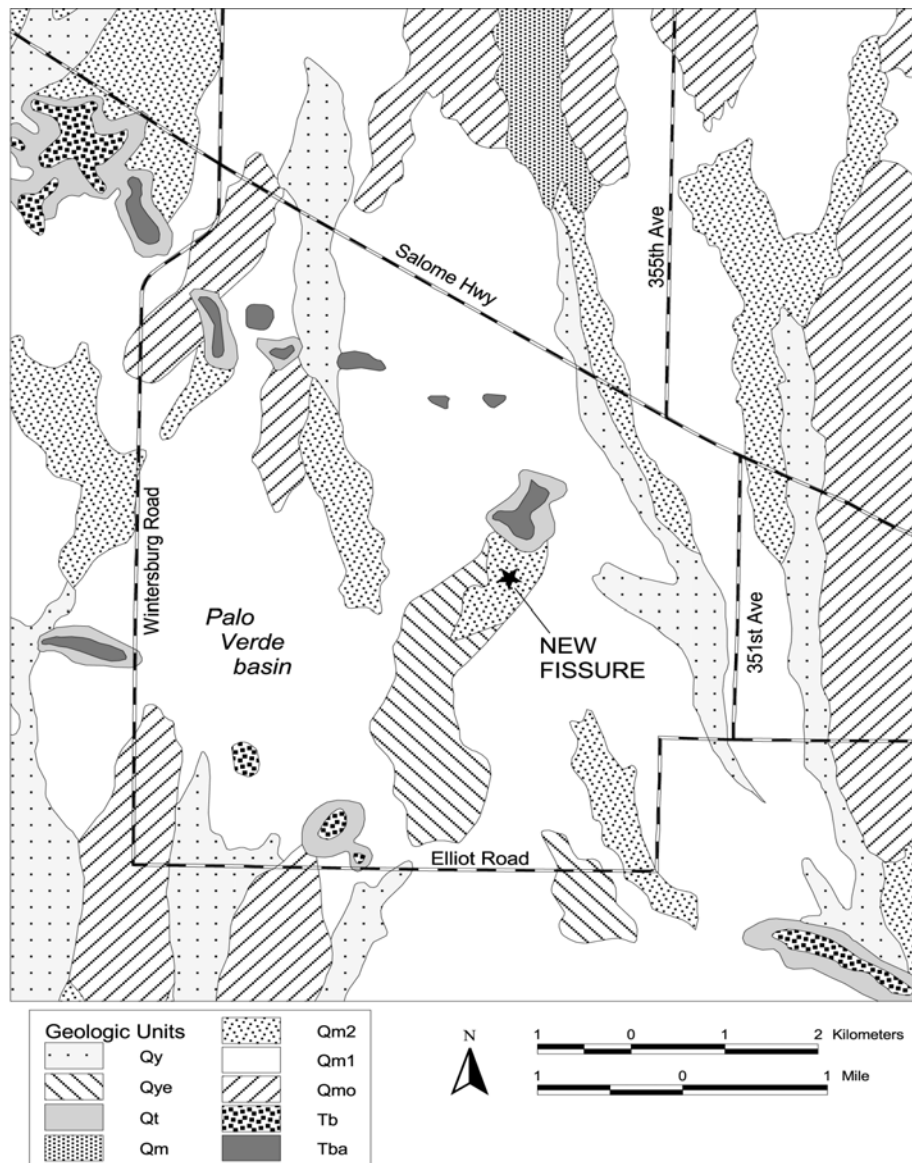
The site of the new fissure is immediately south of a small hill three miles southeast of Wintersburg. A ring of similar small hills defines the tiny Palo Verde basin, with the new fissure near its eastern margin. Figure 17 is a generalized geologic map of the Wintersburg area, based on the mapping of Demsey (1989) and Reynolds and Skotnicki (1993). Geologic units are described in Tables 1 and 2.

Figure 17. Geologic map of the Wintersburg area. Units described in Tables 1 and 2.

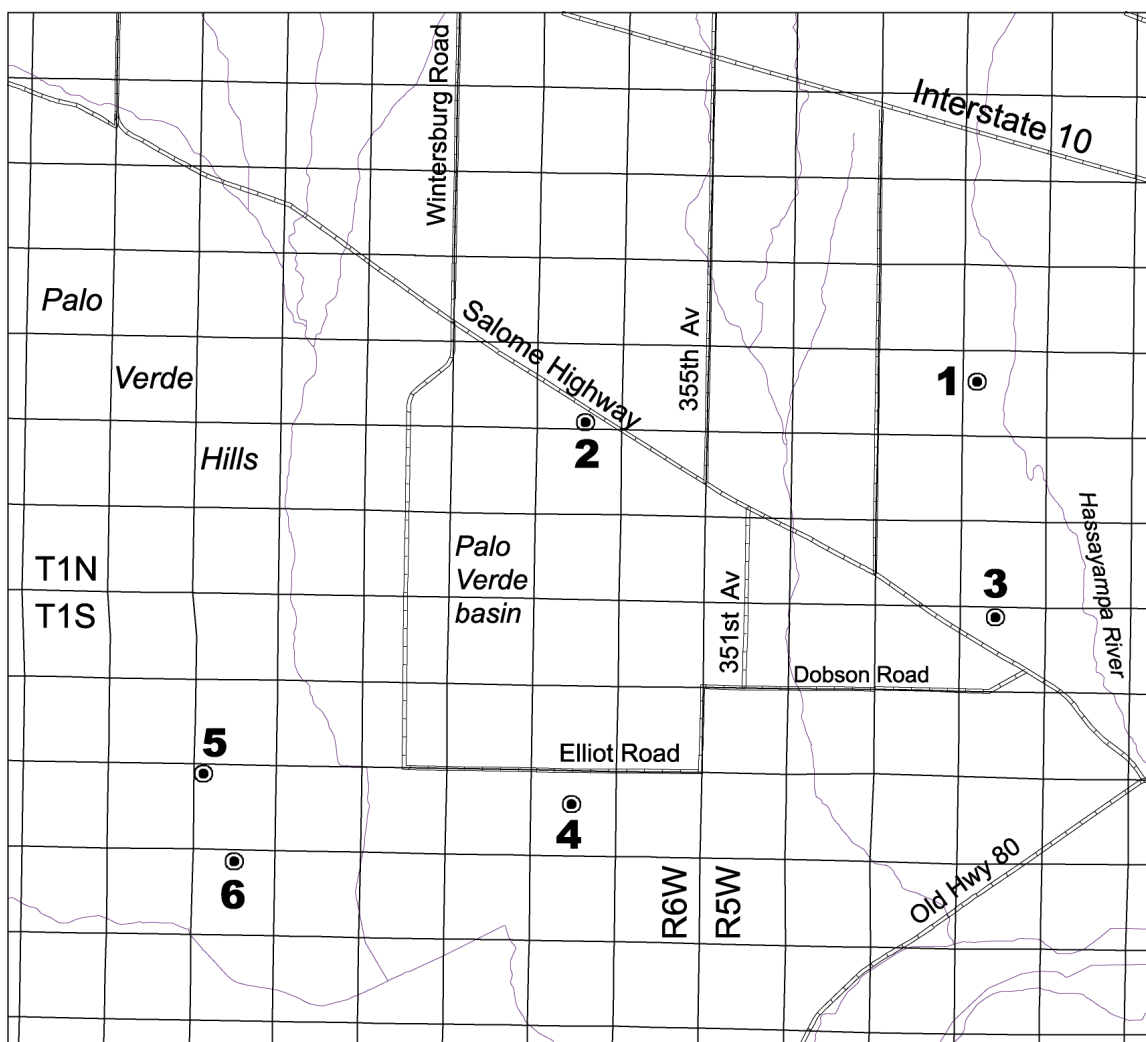
Groundwater levels in the vicinity of the fissure have been measured for many years. Long-term records for six wells in the region were obtained from the Arizona Department of Water Resources. Well locations are plotted in Figure 18. Water levels seem to be fairly steady in the area immediately surrounding the fissure. Plots of water levels over several decades in three wells (Figure 19, a-c) north and east of the fissure show little sign of groundwater decline. Three wells (Figure 19, d-e) southwest of the Palo Verde Hills do record groundwater decline trends on the order of 100 feet (neglecting the lowest “outlier” points on the plots) from the 1950s to about 1980. Groundwater declines of similar magnitude have been responsible for subsidence and earth fissures in other Arizona basins. Since 1980, however, groundwater levels in these three wells have recovered to almost the 1950s levels.

Figure 18. Location of wells with long-term water level measurements.

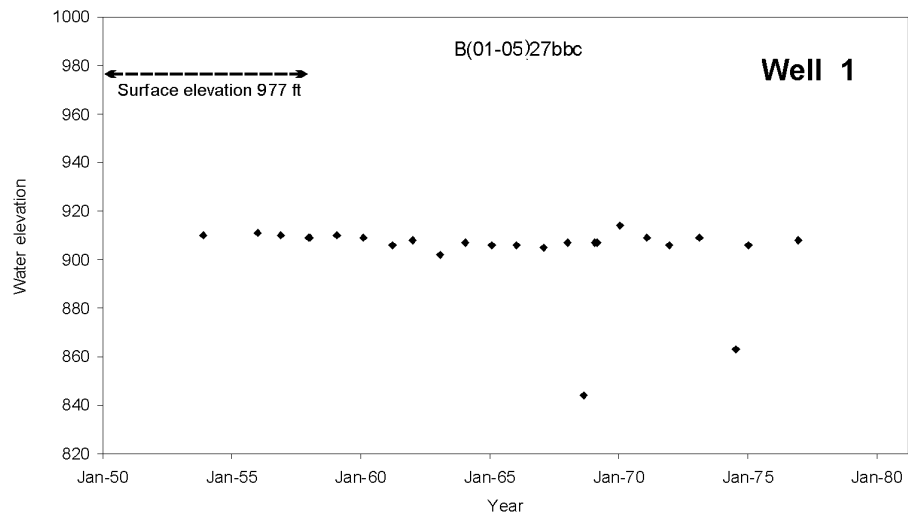
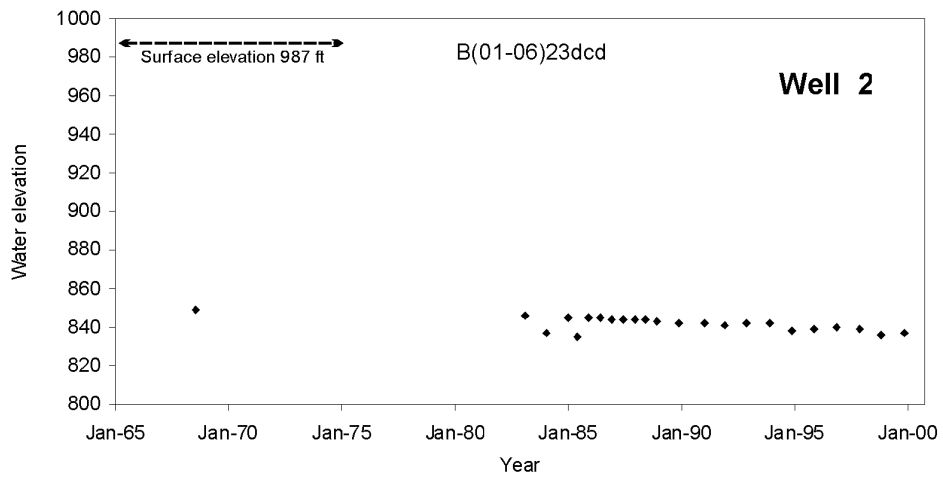
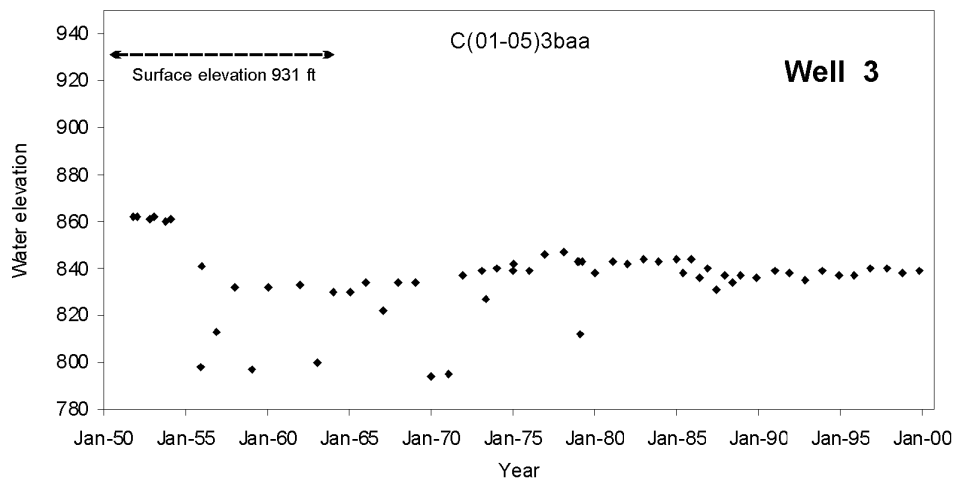
Figure 19. Water level measurements in selected wells near the Palo Verde basin.

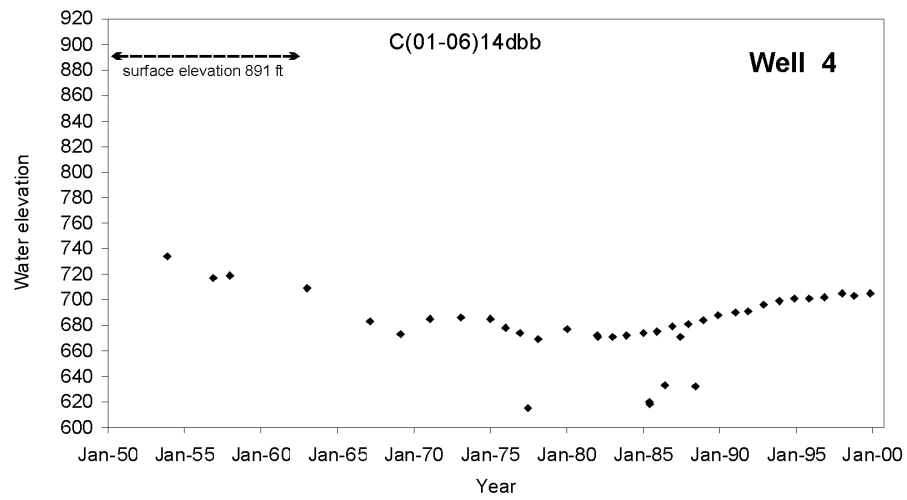
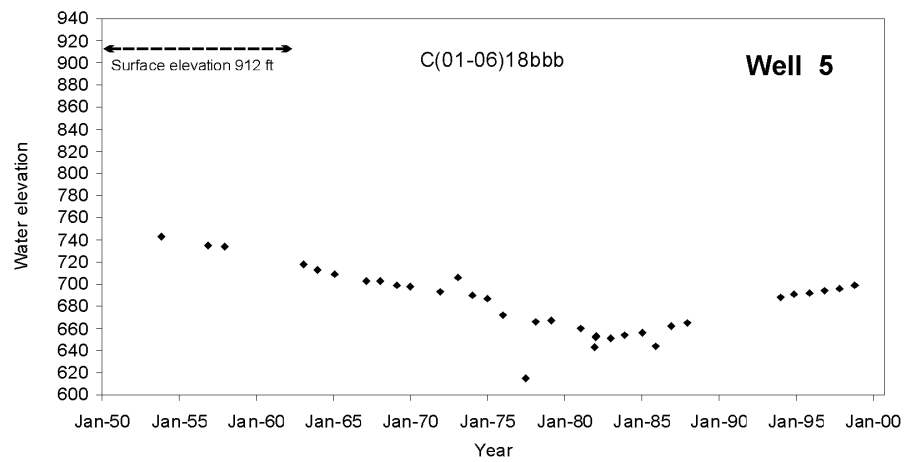
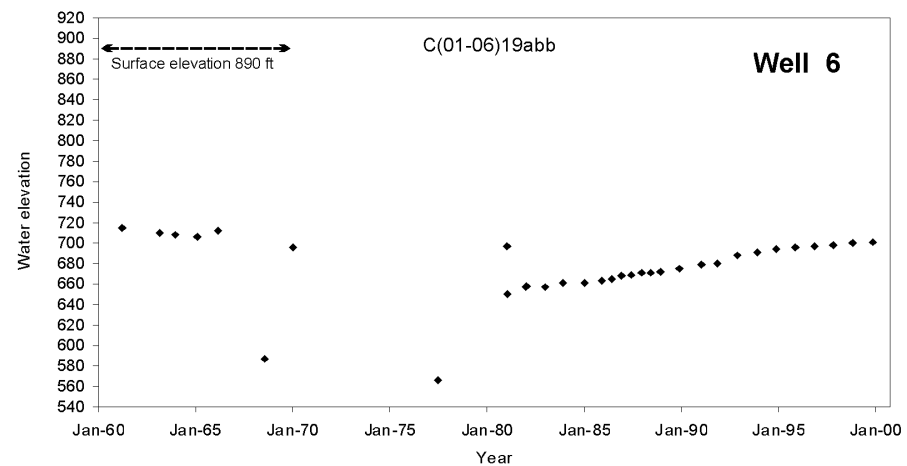
Figure 19 (continued). Water level measurements in selected wells near the Palo Verde basin.
