WHY DID THE FISSURE CROSS THE ROAD? NEW AND OLD EARTH FISSURE ACTIVITY IN COCHISE COUNTY, ARIZONA

JOSEPH P. COOK, ARIZONA GEOLOGICAL SURVEY, TUCSON

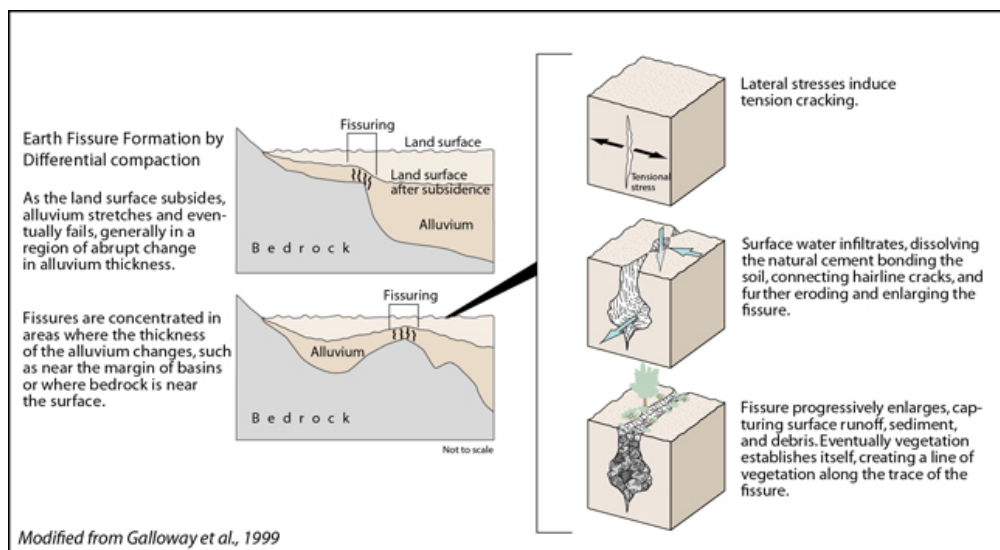
Figure 2. Schematic diagram of earth fissure formation by differential compaction, tensional cracking, and subsurface erosion.

The initial appearance of incipient earth fissures is a hairline surface crack, often crossing or perpendicular to local drainage patterns. Rainwater and overland flow are able to infiltrate the crack and percolate into the subsurface leading to piping erosion that eventually forms an open underground void aligned with the still narrow surface crack. When the void becomes large enough the undermined surface soil may abruptly collapse into the open part of the fissure below.
