Earth Fissures and Surface Faults Accompanying Aquifer-System Compaction and Land Subsidence in the USA

**DEVIN L. GALLOWAY
U.S. GEOLOGICAL SURVEY**

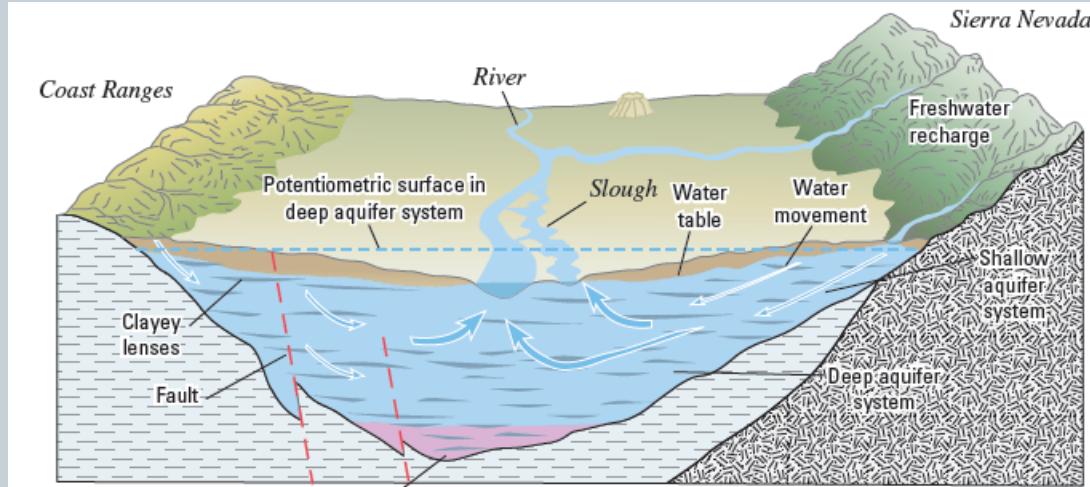
Hydrogeologic Framework—Conceptual Model

Pre-development

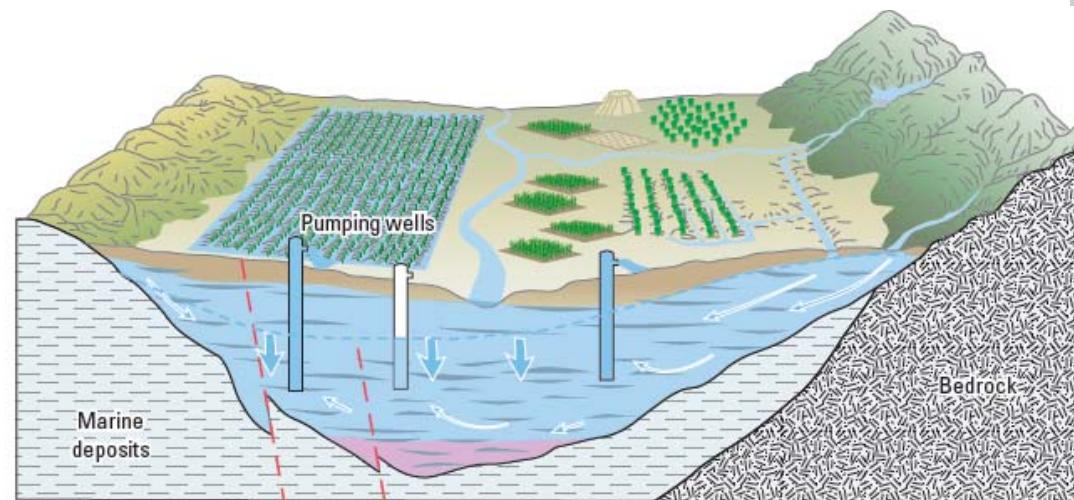
Post-development

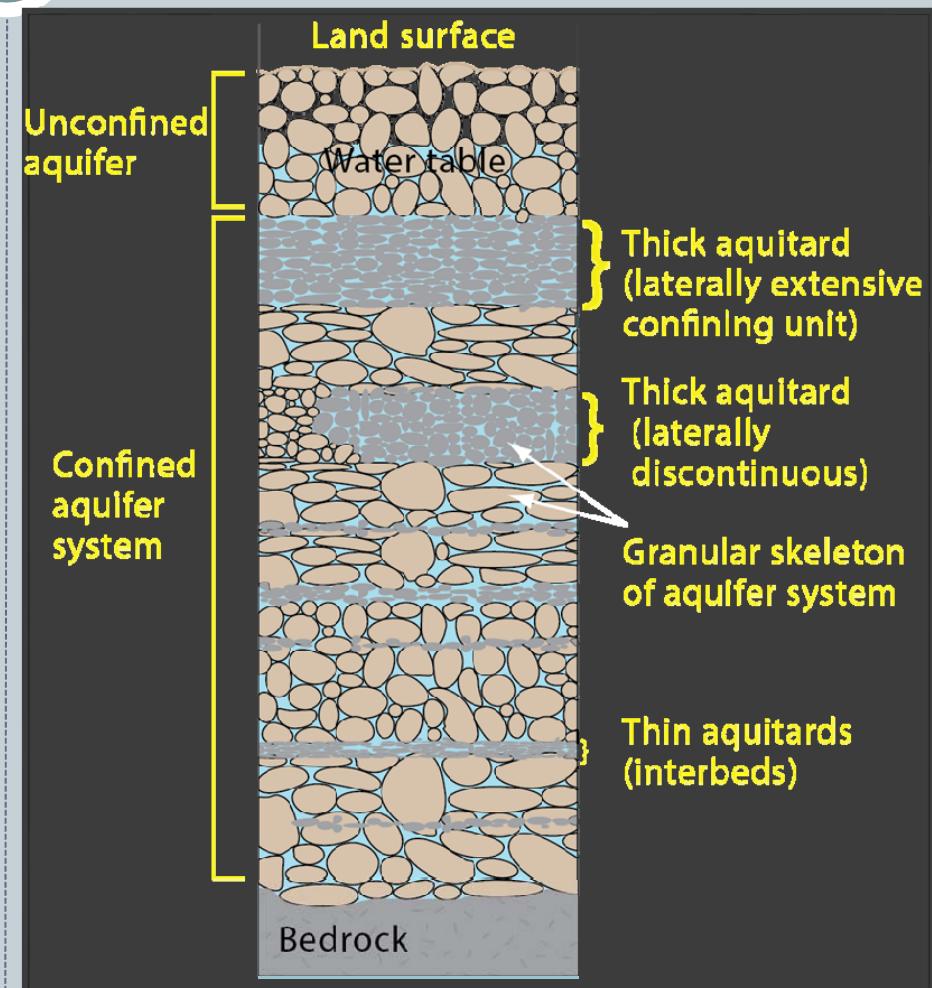
- Susceptible Hydrogeologic Settings
 - Land Subsidence/Aquifer-System Compaction
 - Almost all the permanent subsidence occurs due to the irreversible compression or consolidation of aquitards (interbeds and confining units) during the typically slow process of aquitard drainage (Tolman and Poland, 1940).

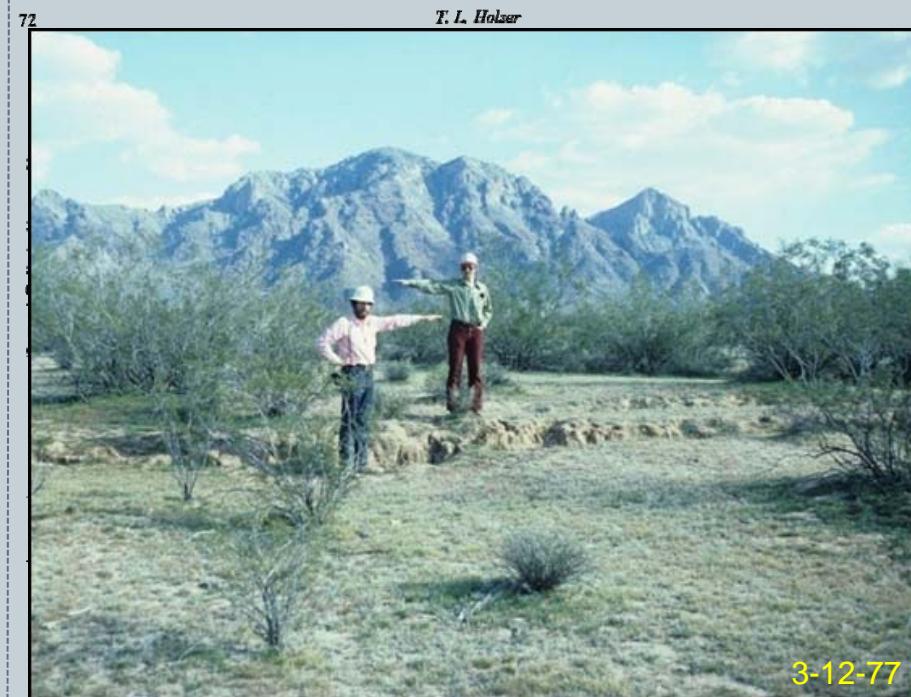
Picacho Fault, AZ

Figure 4. Ground fissure areas in the western United States.

- Typically associated with pre-existing faults and land subsidence in at least 5 areas in the western United States (in AZ, CA, TX, NV). The density of faults varies greatly from area to area, but is highest in the greater Houston, Texas subsidence areas.

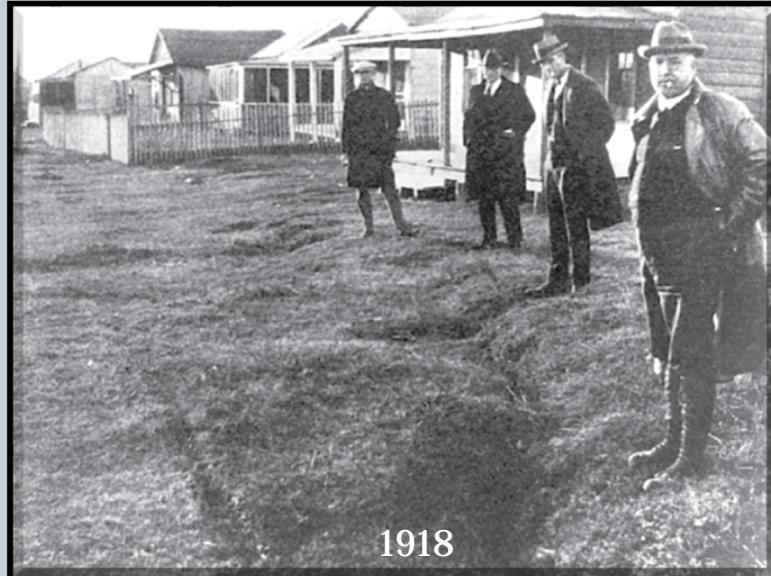
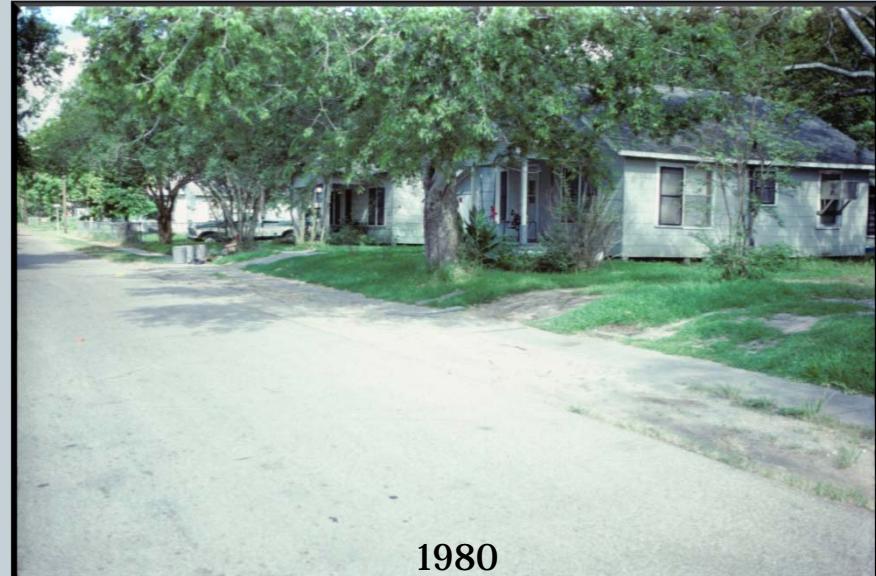
1980

Pelley Fault, Goose Creek Oil Field, Houston, TX

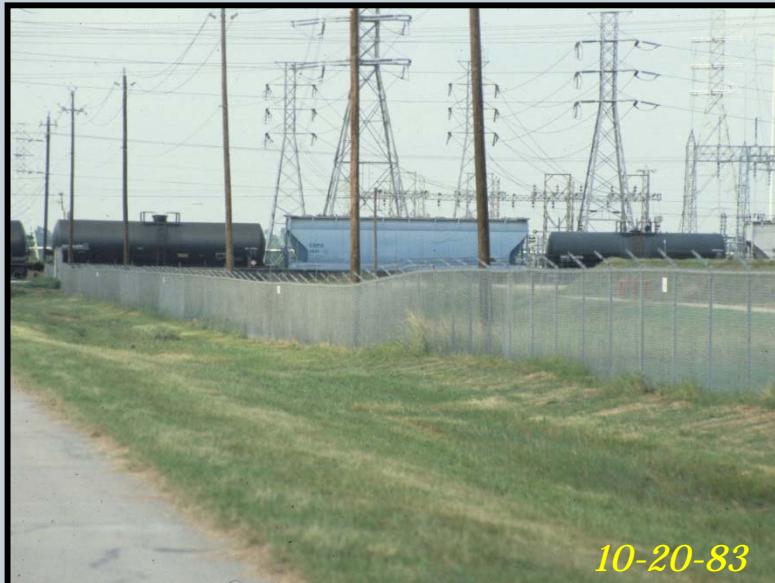
Ethyl Fault, Houston, TX

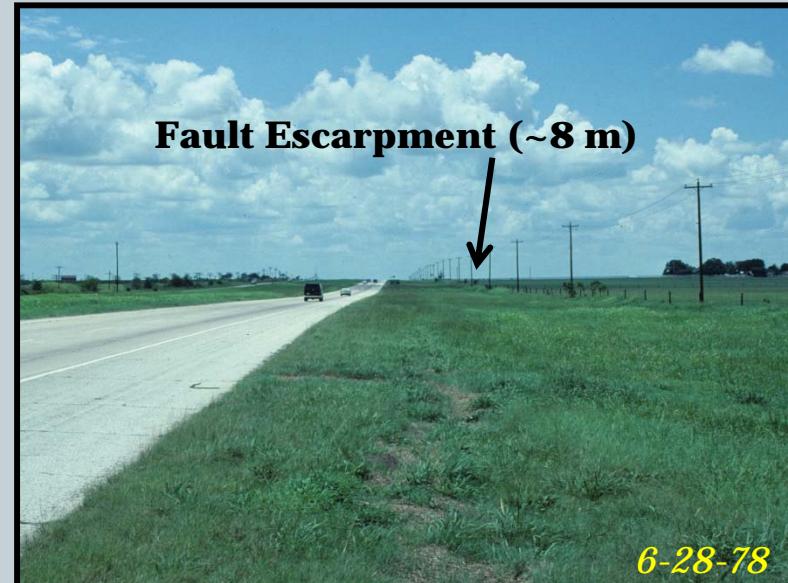
Hockley Fault, Houston, TX

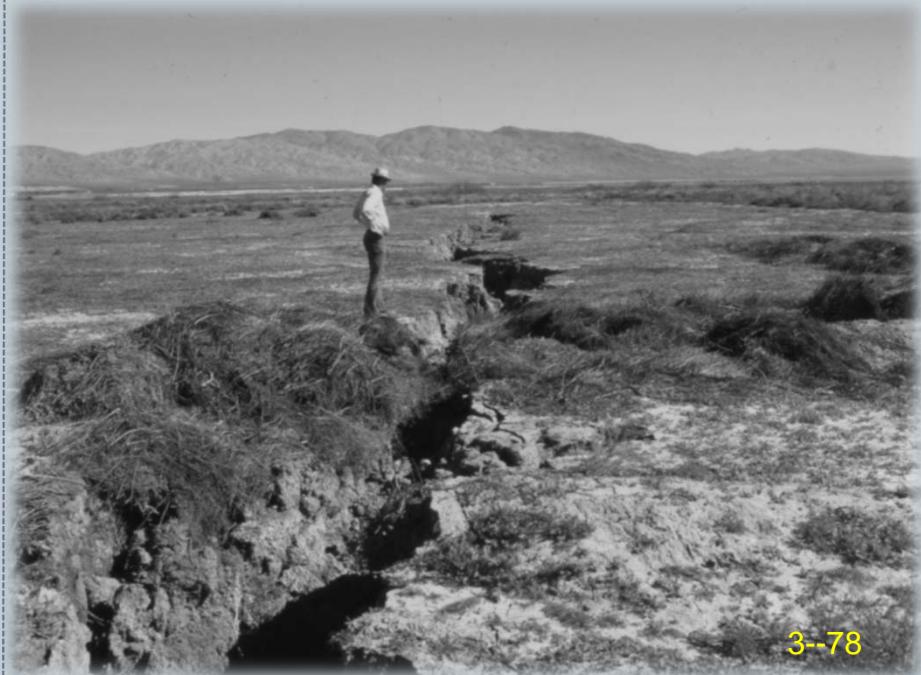
- ✖ Large tension cracks—are commonly associated with aquifer-system compaction and subsidence caused by groundwater withdrawal. Occur in many areas in the United States.

Eroded Earth Fissure, Fremont Valley, CA

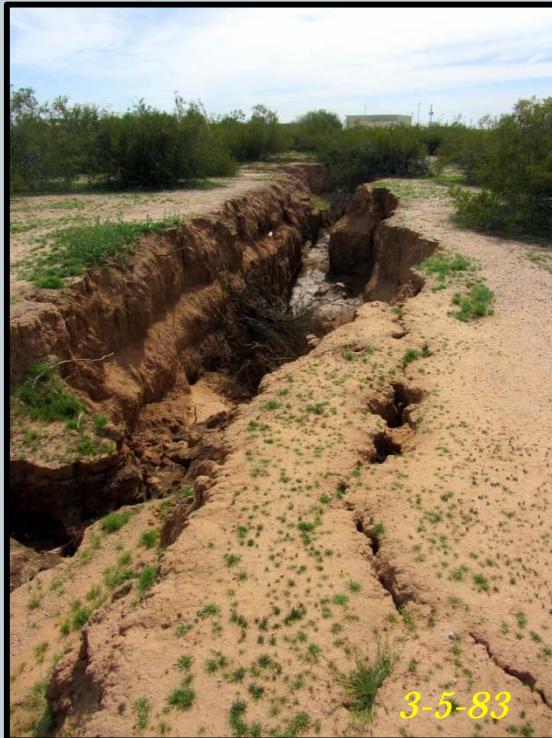
Apache Junction Fissure, AZ

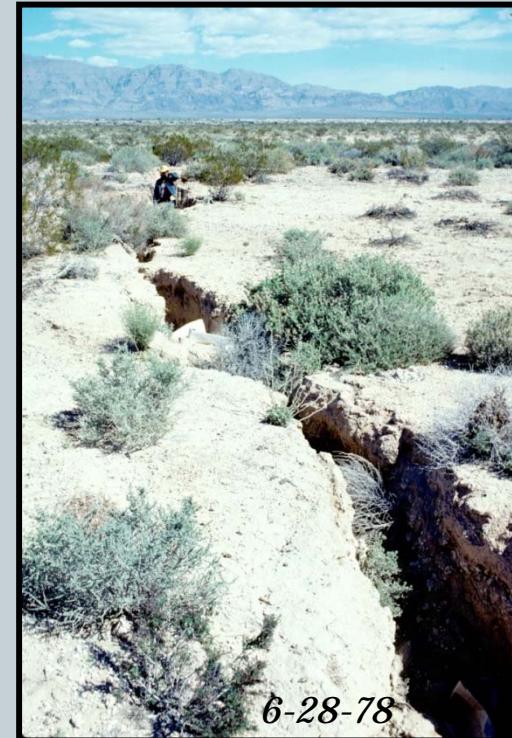
Earth Fissure, Las Vegas, NV

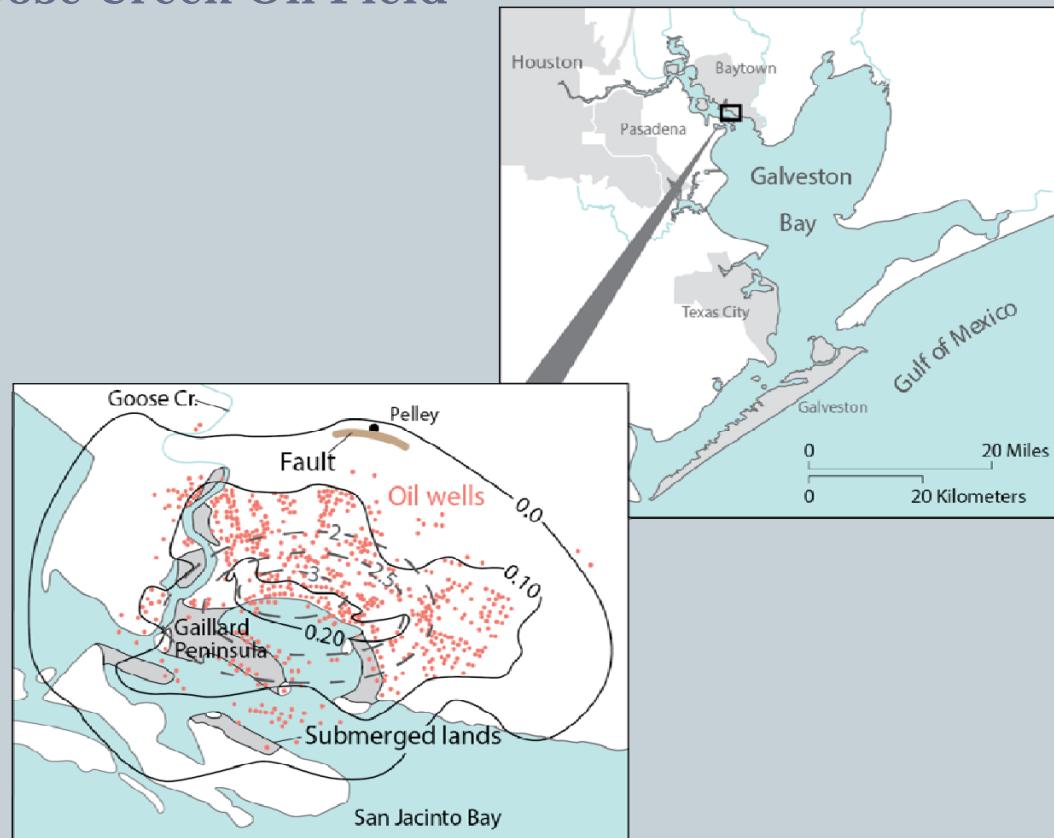
- Relation to Subsidence/Subsurface Fluid Extraction
 - Pelley Fault, Goose Creek Oil Field

Subsidence contours: for 8-yr period (grey dash), and for 1-yr period (black) in feet, during 1918-1935.

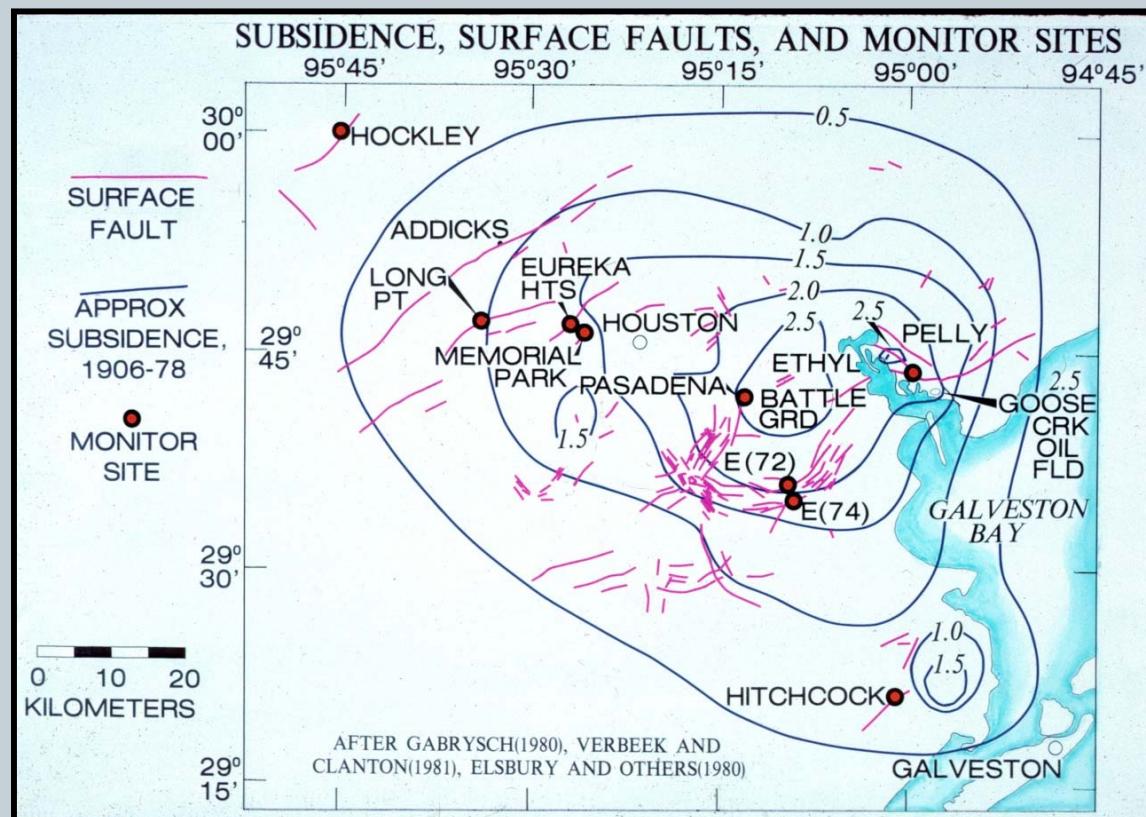
- Relation to Subsidence/Subsurface Fluid Extraction
 - Surface Faults, Houston Area, TX (Groundwater/Oil and Gas)

Subsidence contours:
1943-73 in meters.

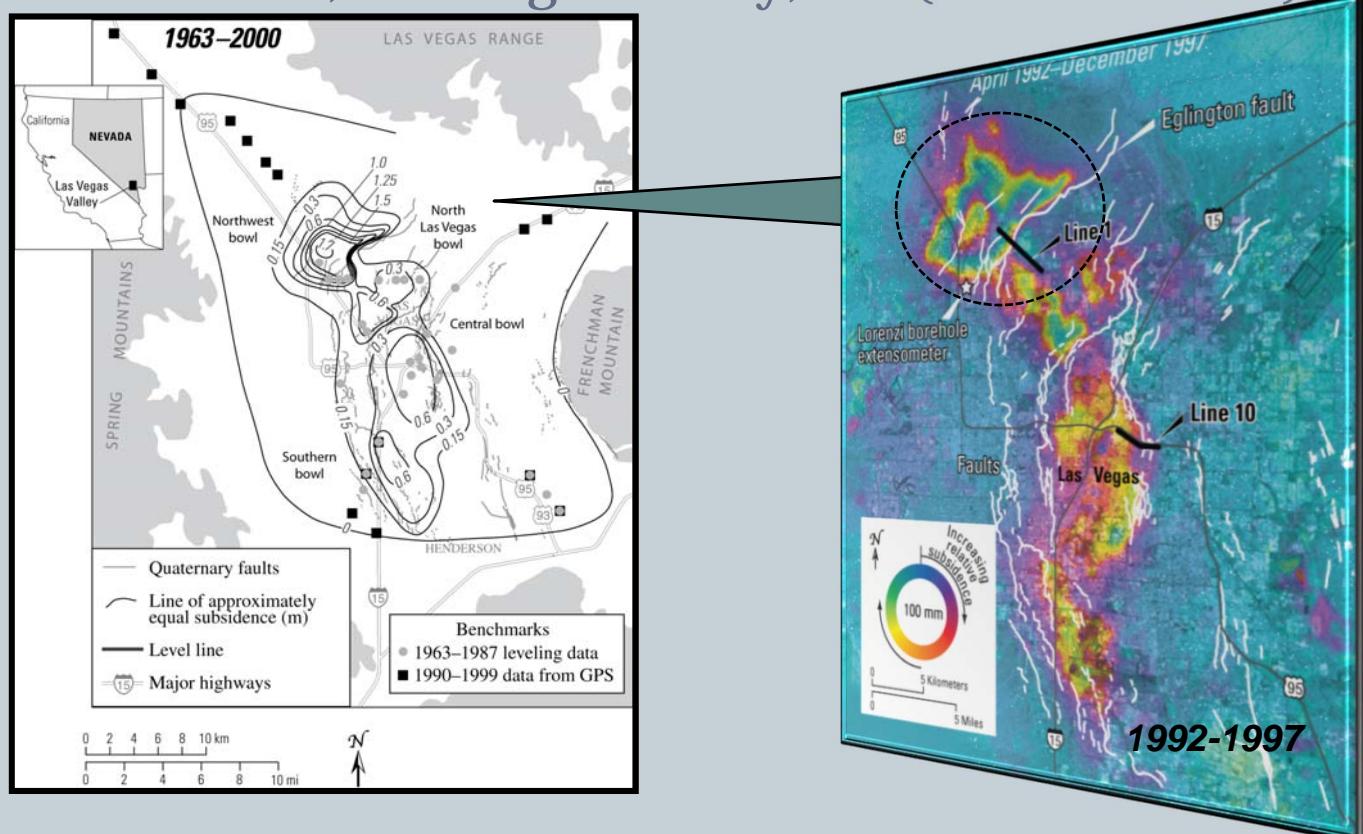
- Relation to Subsidence/Subsurface Fluid Extraction
 - Surface Faults, Las Vegas Valley, NV (Groundwater)

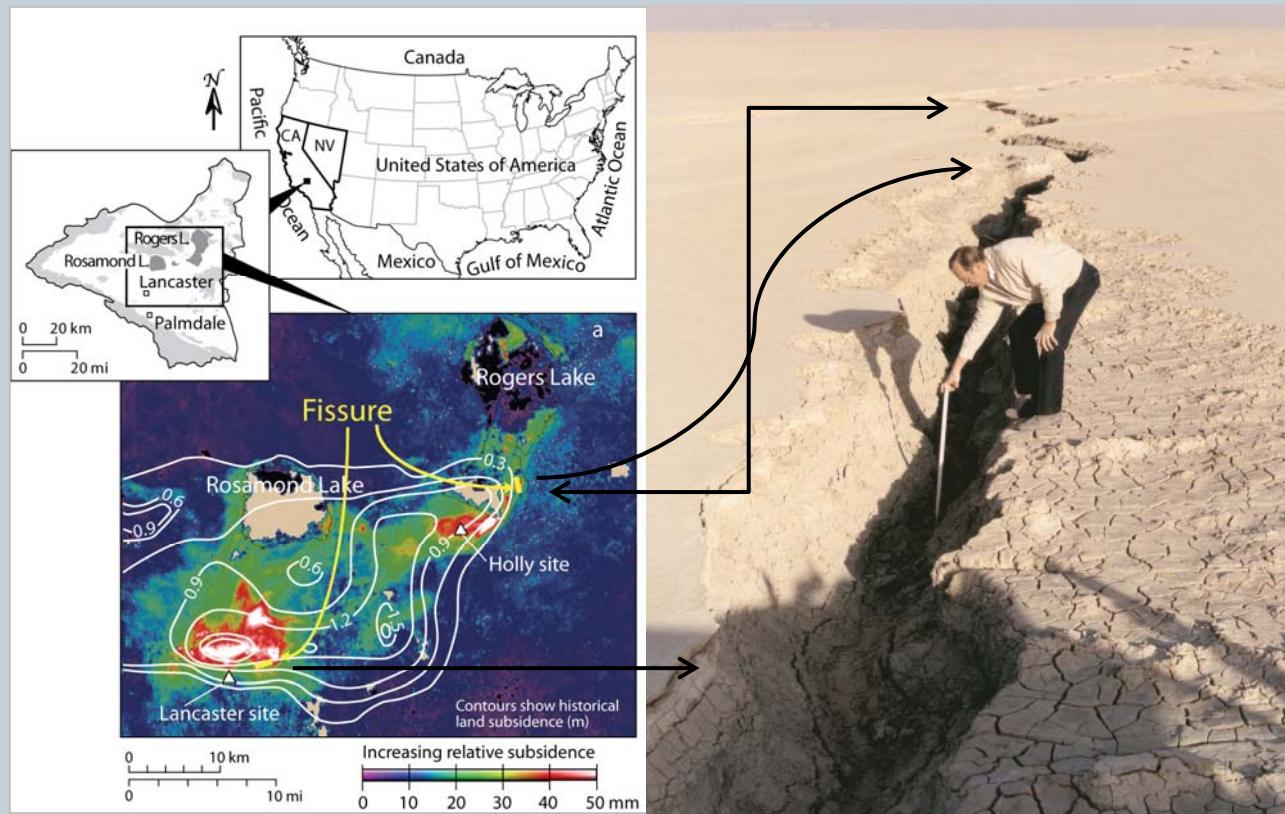
- Relation to Subsidence/Subsurface Fluid Extraction
 - Earth Fissures, Antelope Valley, CA (Groundwater)

Subsidence mapped using GPS surveys (1935-1992) and InSAR (Oct. 1992-Dec. 1995). Fissure appeared in Jan 1991.

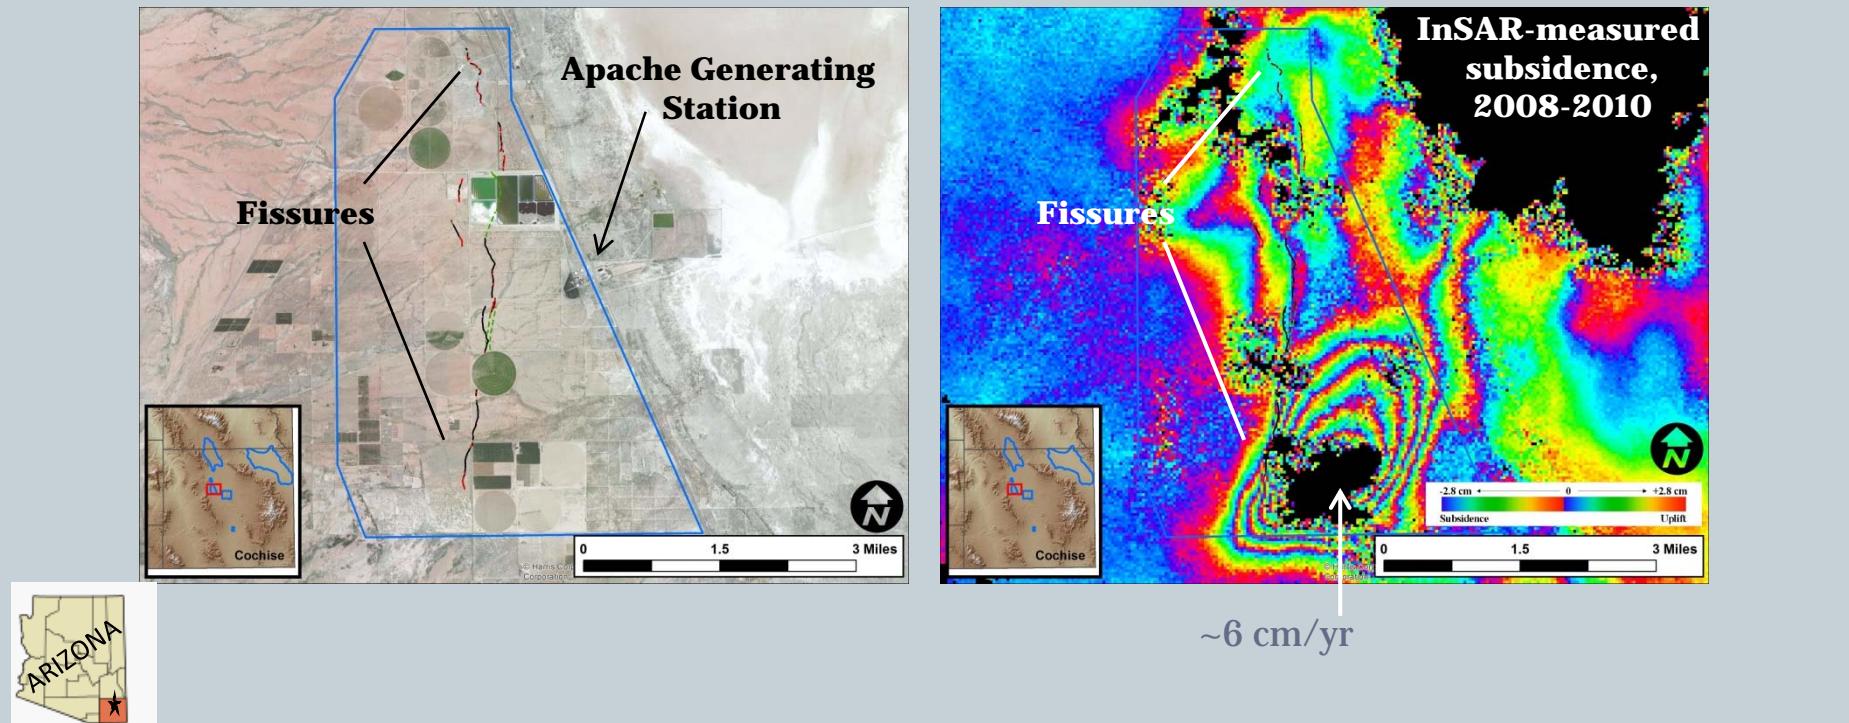
- Relation to Subsidence/Subsurface Fluid Extraction
 - Earth Fissures, Dragoon Rd., Cochise County, AZ (Groundwater)

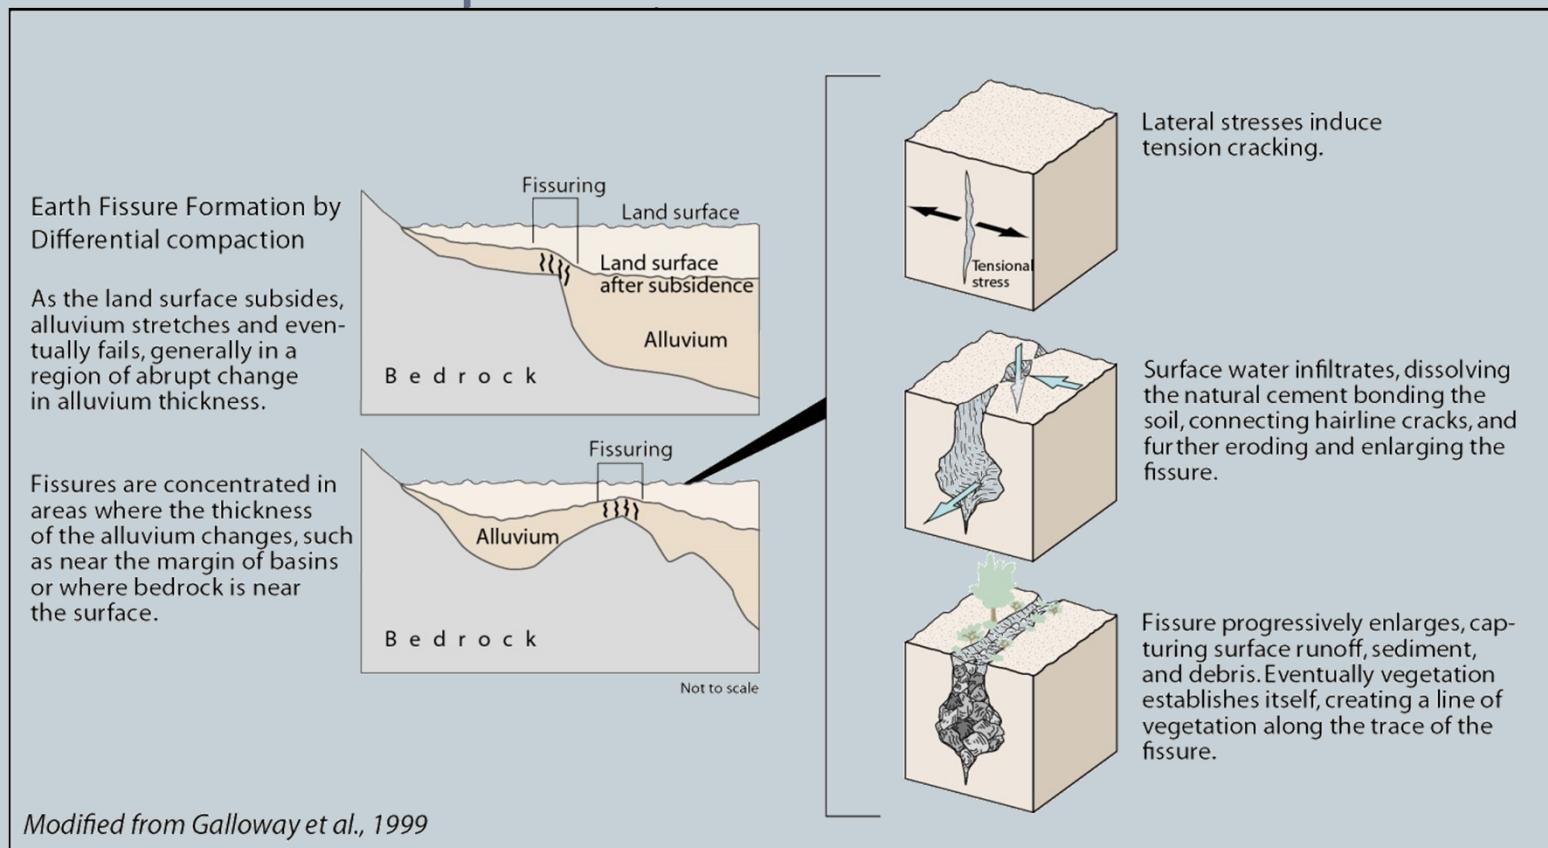
- Relation to Subsidence/Subsurface Fluid Extraction
 - Differential Compaction/Subsidence

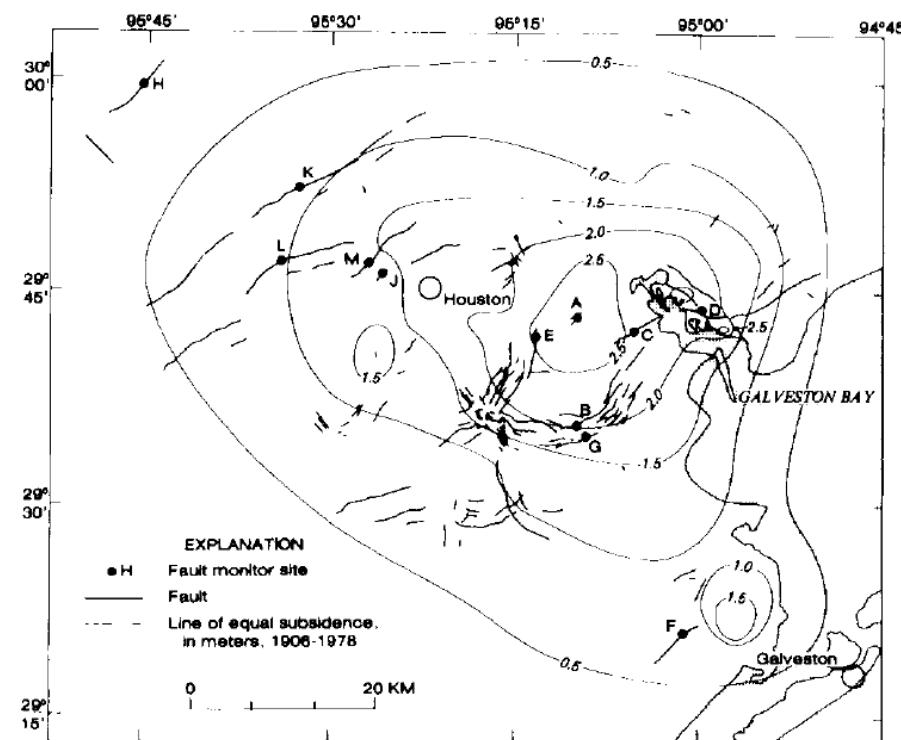
- Houston Area, TX
Subsidence 1906-78

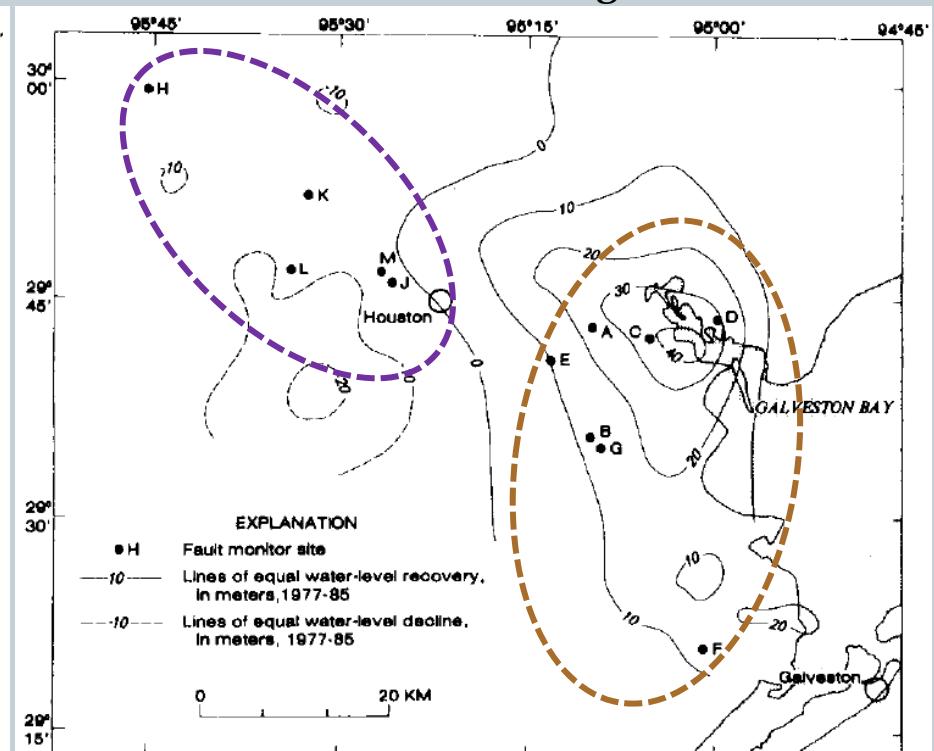
- Groundwater Level Change 1977-85

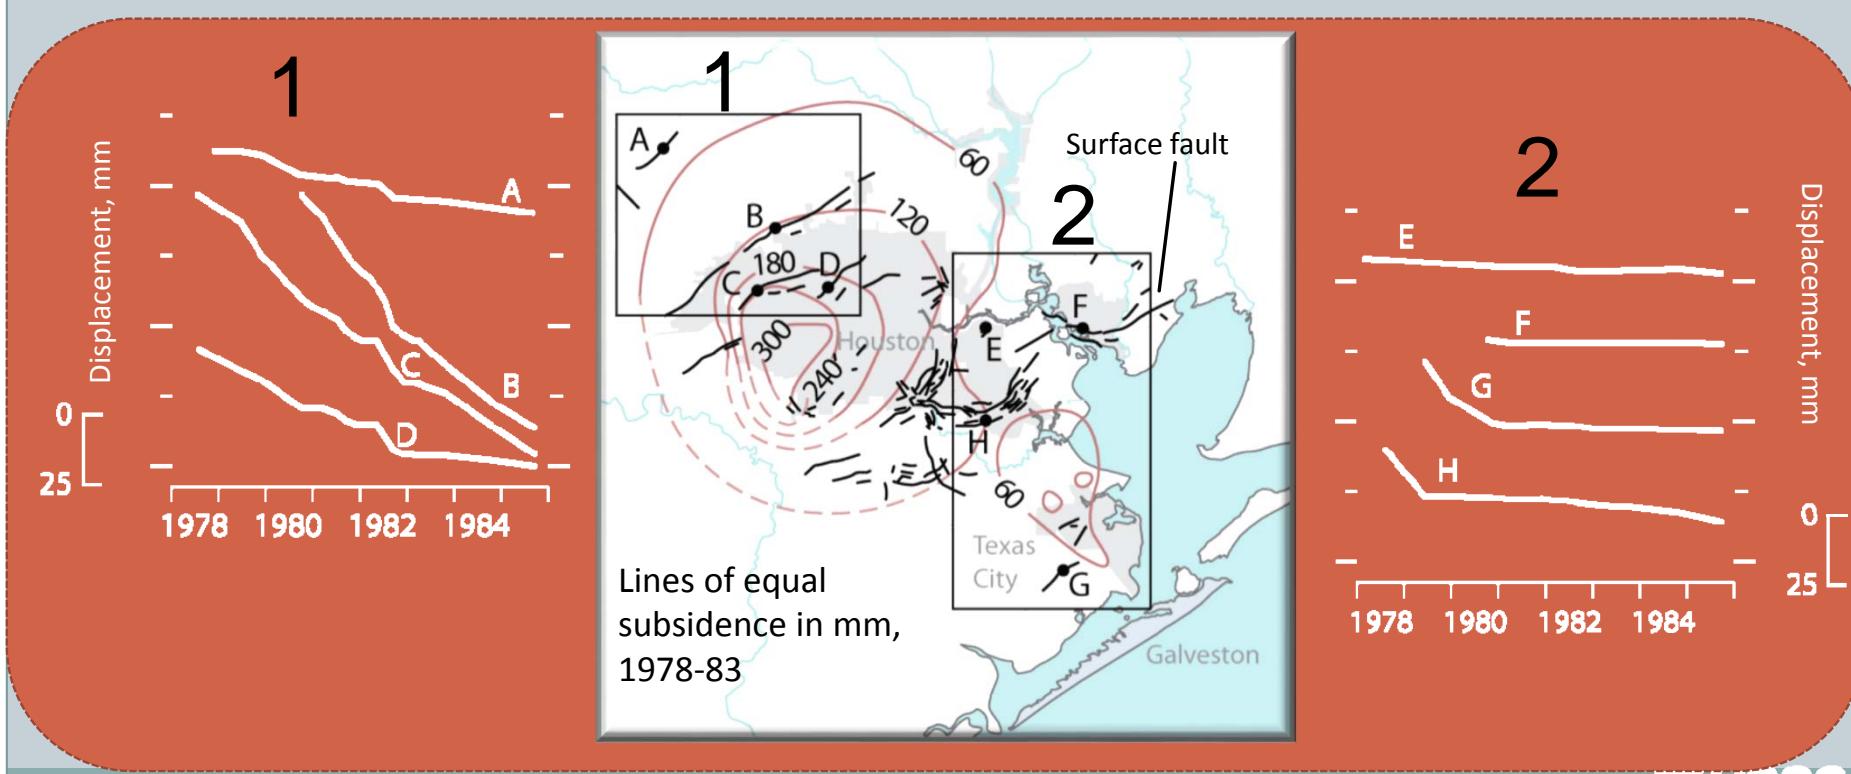
- Surface Faults
 - Houston Area, TX
 - ✖ Vertical displacements on fault scarps greater in areas of groundwater-level decline and subsidence, less in areas of groundwater-level recovery and reduced subsidence

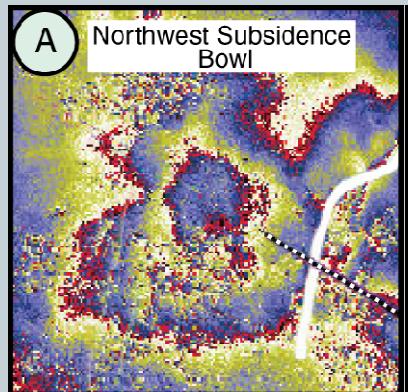
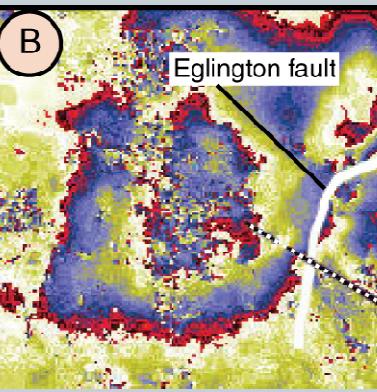
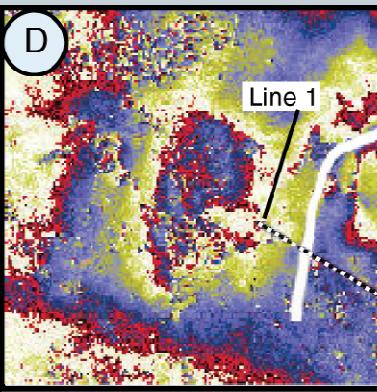
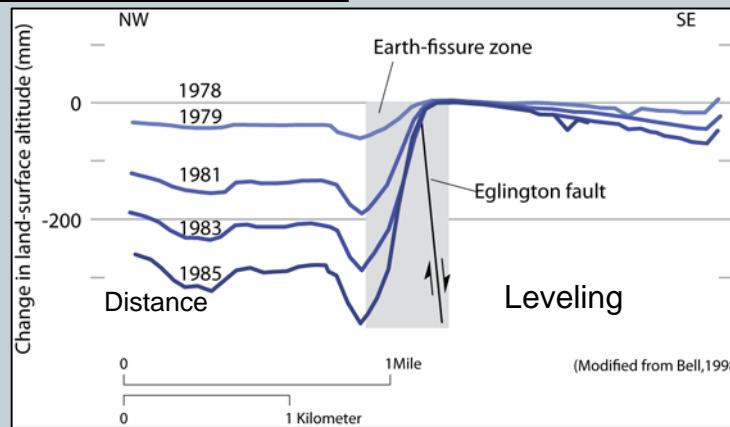
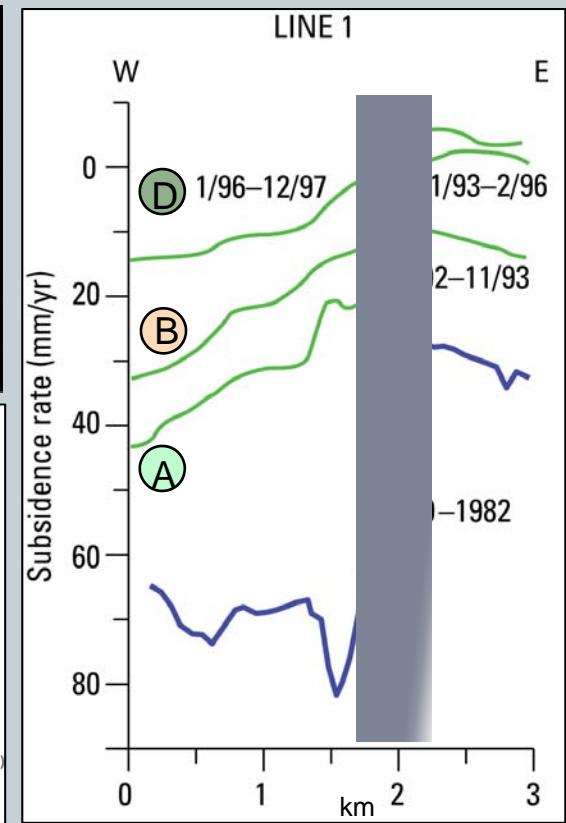
- Surface Faults
 - Las Vegas Valley, NV

InSAR reveals a decreasing rate of differential subsidence across the Eglinton fault during 1992 – 97, attributed to groundwater-level recovery.

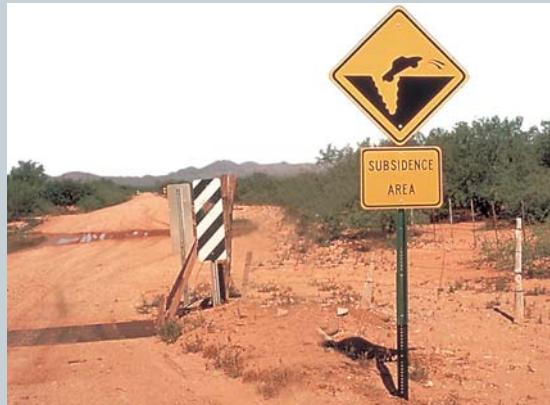
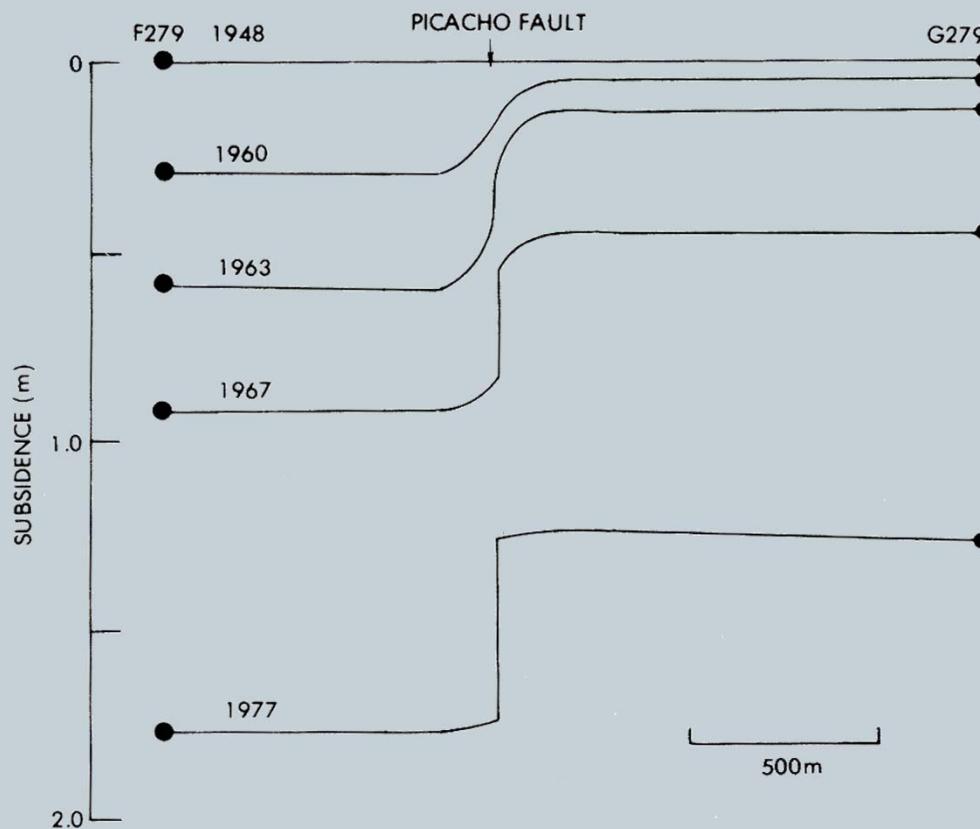
- Surface Faults
 - Picacho Fault, AZ
 - Reconstruction of deformation from leveling surveys

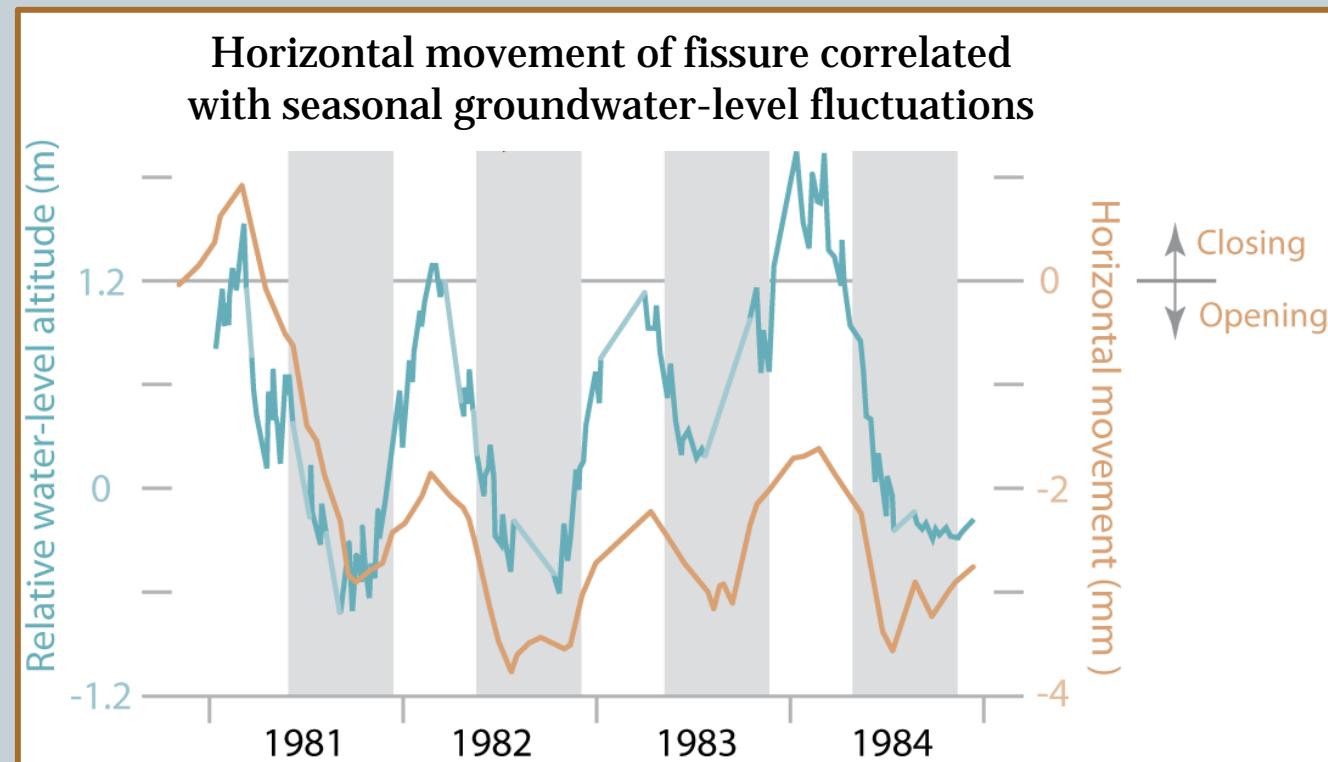
- Earth Fissures
 - Picacho Basin, South-Central AZ

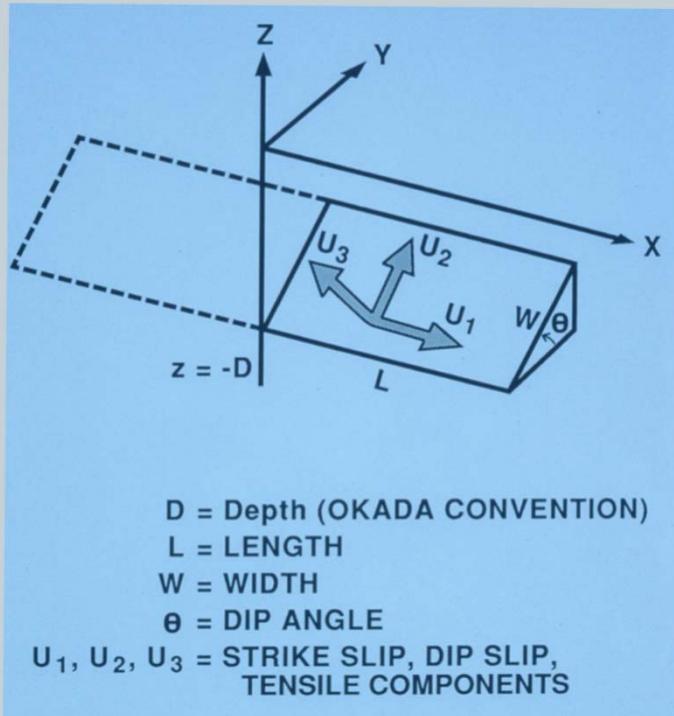
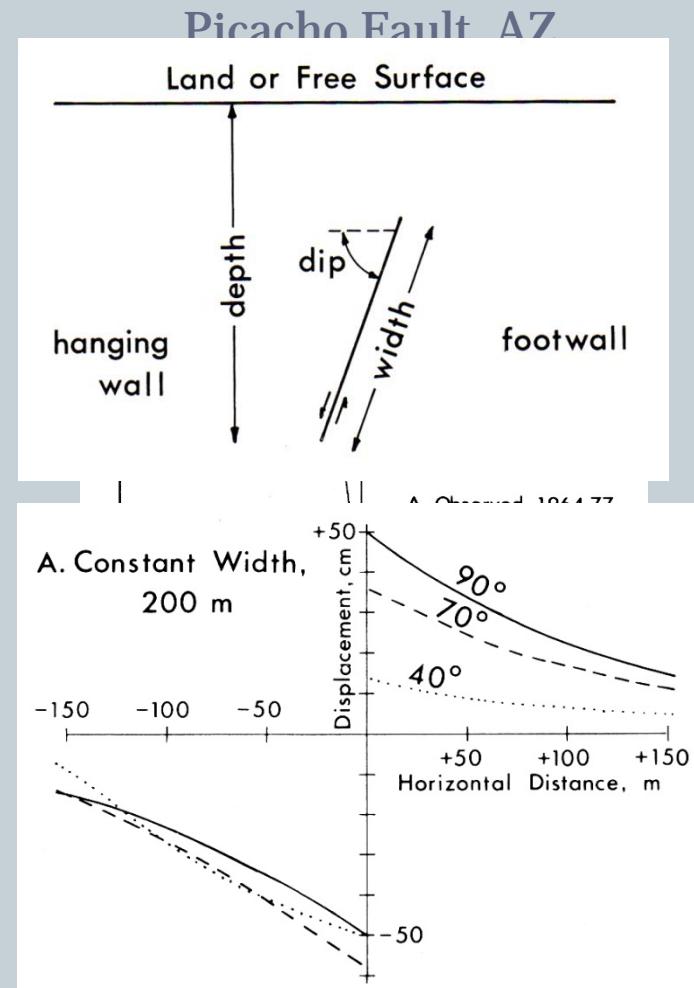
- Movement on Surface Faults
 - Elastic Dislocation Model

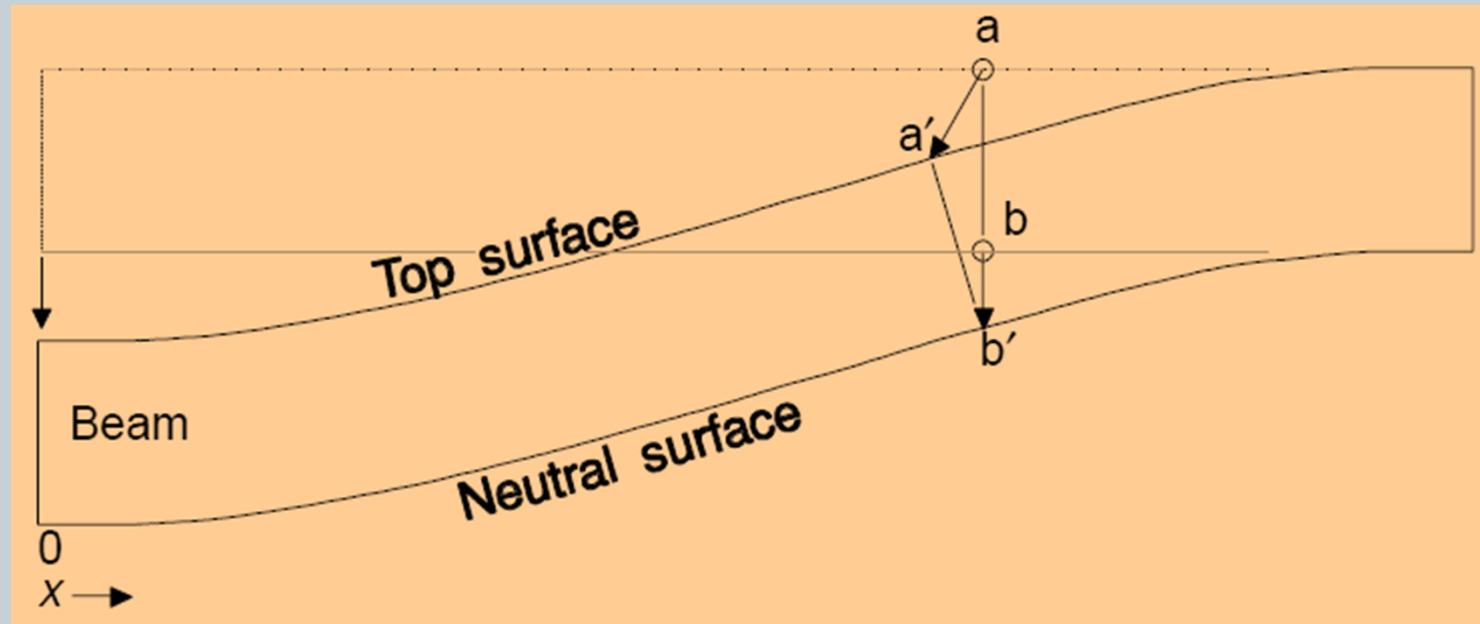
- Earth Fissures
 - Bending Beam Model

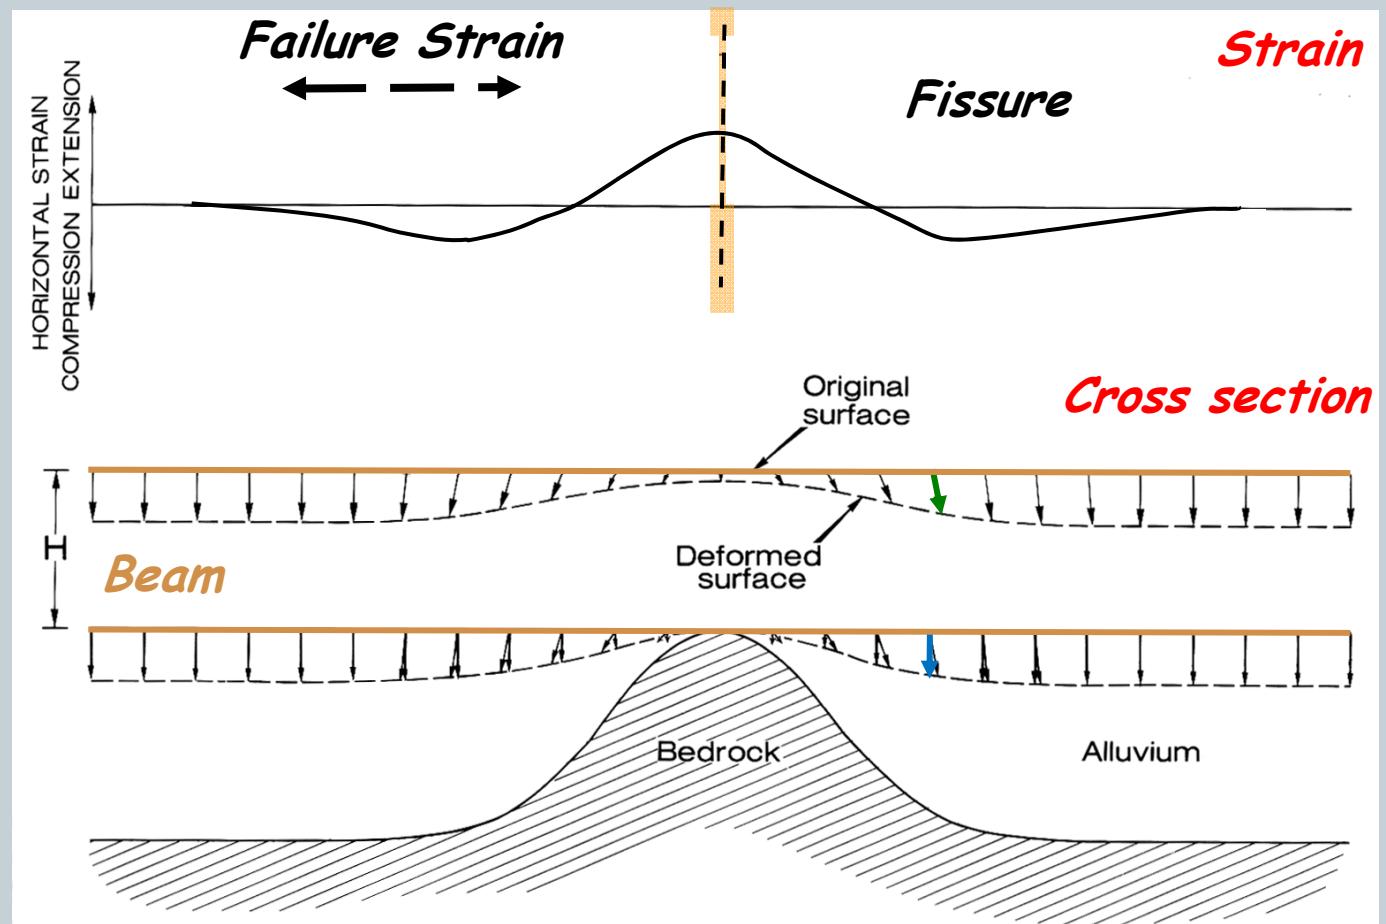
- Earth Fissures
 - Bending Beam Model
