Earth Fissures and Surface Faults Accompanying Aquifer-System Compaction and Land Subsidence in the USA

**DEVIN L. GALLOWAY
U.S. GEOLOGICAL SURVEY**

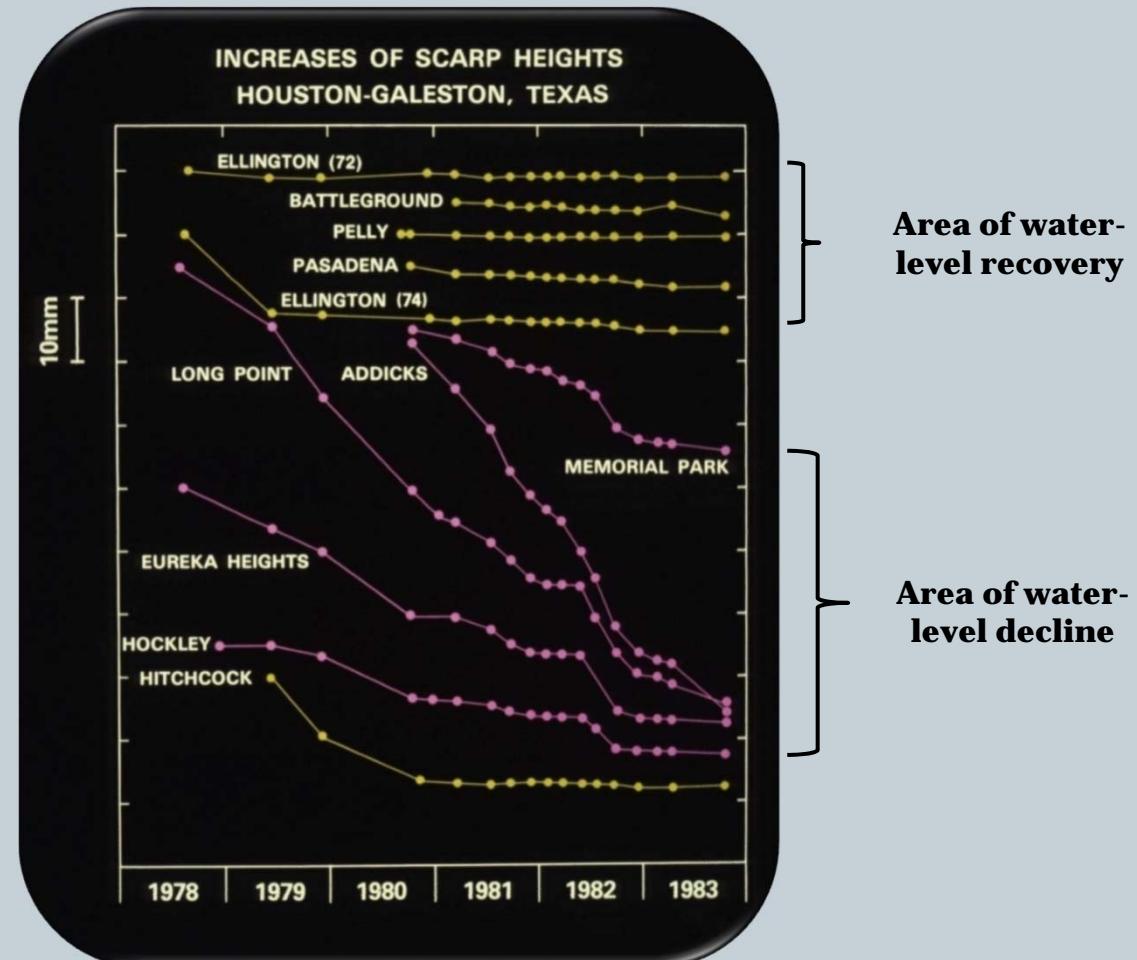
- Surface Faults
 - Houston Area, TX
